PERFLUORINATED COMPOUNDS PRELIMINARY ASSESSMENT SITE VISIT REPORT

BARNES AIR NATIONAL GUARD BASE WESTFIELD, MASSACHUSETTS

January 2016

BB&E, Inc. January 2016

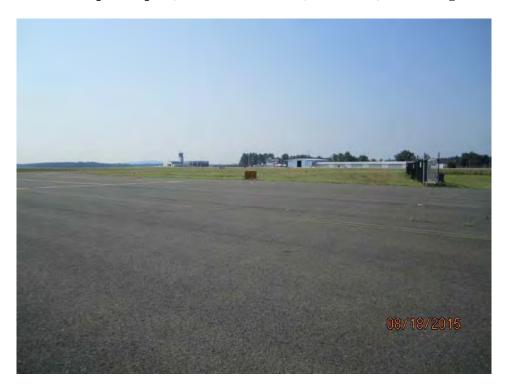
Former FTA-01 was used from approximately 1950 through 1987. The site consisted of a burn pit, a fire extinguisher training pit, a drum storage area, and a bermed area. The site received aviation gasoline (AVGAS), waste oils, solvents, and jet fuel #4 (JP-4). Approximately 300-500 gallons of mixed liquid wastes were used during each fire training exercise. The site was identified during the 1988 PA. In the spring of 2000, impacted soils from previous fire training activities were excavated and removed from the site. Groundwater investigation activities were conducted and the results indicated that the groundwater at the site was not impacted by fuel and chlorinated constituents likely used during fire training exercises. Site closure was obtained in 2002 (URS, 2011). Portions of site were redeveloped as part of the MA Army National Guard facility renovations including a new approach ramp and parking apron for Army National Guard aircraft. The site is generally covered with grass along with airfield pavements. Due to the timeframe of use, AFFF was likely utilized at Former FTA-01 during fire training exercises. Historic information regarding Former FTA-01 is included in Appendix C-3. It should be noted that there are discrepancies on whether Former FTA-01 was on or off the Base. Information from the original PA indicated ERP Site 1 (Former FTA-01) was located off-Base and not on current ANG property (HMTC, 1988). Information from the Final RI Report indicated FTA-01 extended onto the Base (Earth Tech, 1997) with portions of the Former FTA both on and off-Base. This was confirmed by Base personnel.

Photo 1: Former FTA-01 (IRP Site 1) Looking South

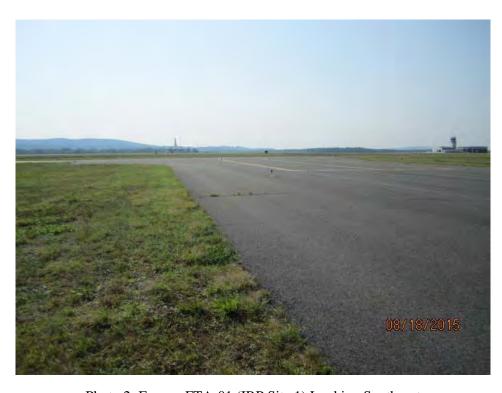
Photo 2: Former FTA-01 (IRP Site 1) Looking Southeast

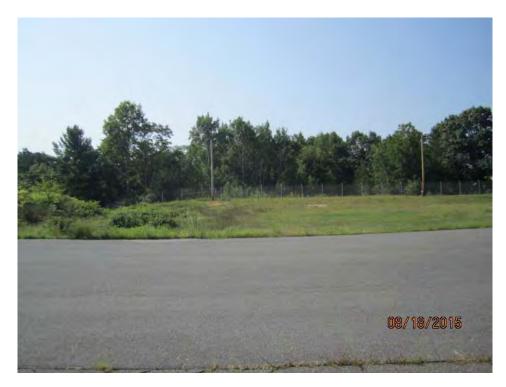
Former FTA-06 consisted of two areas referred to as Site 6 North (6N) and Site 6 South (6S). The ERP Site 6 FTAs were operational in the late 1950s and early 1960s (HMTC, 1988). Based on their operational timeframe, it was unlikely that AFFF was used at the Former FTA-06 during fire training exercises. Soil removal activities were conducted at ERP Site 6 (6N only) in 2003 to address apparent residual fuel constituents. Site investigation activities indicated no impacts

Photo 3: Former FTA-06 (IRP Site 6)

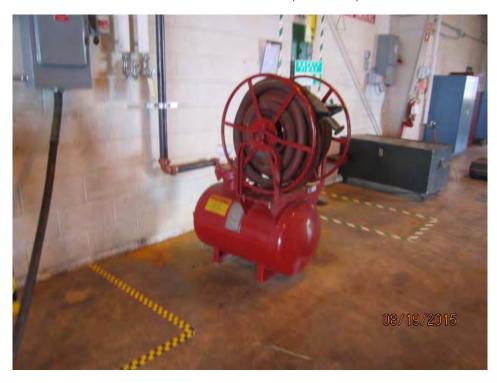
Each AFFF deck gun has an approximate 50-gallon AFFF reservoir. There are no documented releases of AFFF within these facilities. Releases that occurred in flight line area buildings before the early 1990s would have drained to the building floor and trench drains that drained to the drainage retention basin located at ERP Site 4 (discussed above). Building floor drains now go to the sanitary sewer system via an oil/water separator (OWS) system.

Photo 4: AFFF Deck Gun (four total) - Hangars 27A and 27B

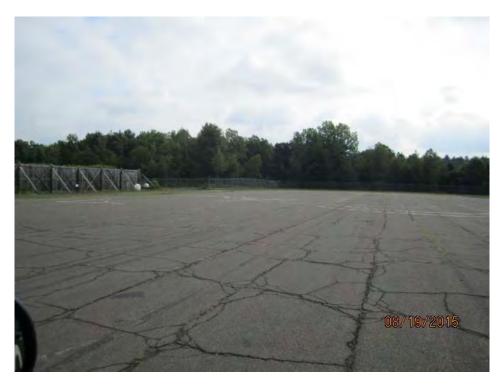
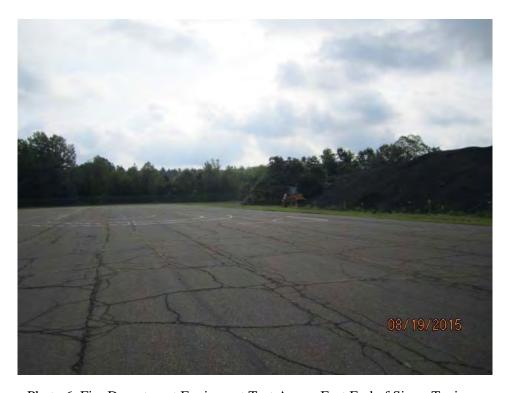
FD equipment testing occurred at the far east end of the Sierra Taxiway located on the far eastern portion of the Base. Testing was predominately done on the paved taxiway area with resulting spills or releases draining off the edges of the taxiway onto the ground surface or infiltrating through cracks in the paved surface. Three known foam tests or AFFF releases occurred in the mid-1990s with the last one occurring in 1996 or 1997. Quantities of AFFF utilized or released are unknown. No AFFF foam testing has been done in more than 15 years at this location. More recent fire equipment testing typically involves only water or if AFFF is utilized, very small amounts are used and captured in a portable drum for disposal or reuse. Fire equipment testing prior to current Base fire personnel being on duty (before 1993) is not clear. Based on the time frame of usage for FTA-01, fire equipment testing would likely have occurred at FTA-01 until at least 1987 (for actual fire training and fire equipment tests) but may have been used longer for just fire equipment testing including foam tests until the mid-1990s. Per Barnes ANG personnel, the Massachusetts DEP issued a letter in April 1987 informing the Base to cease all fire training activities.

Photo 5: Fire Department Equipment Test Area – East End of Sierra Taxiway

Photo 6: Fire Department Equipment Test Area – East End of Sierra Taxiway

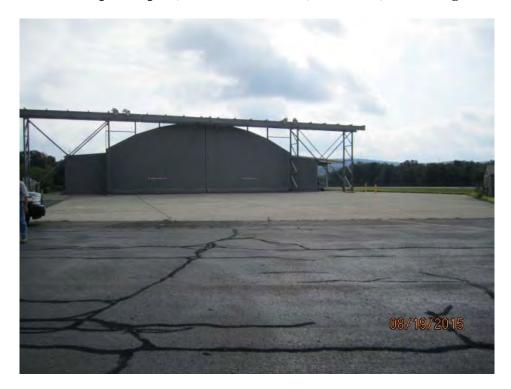
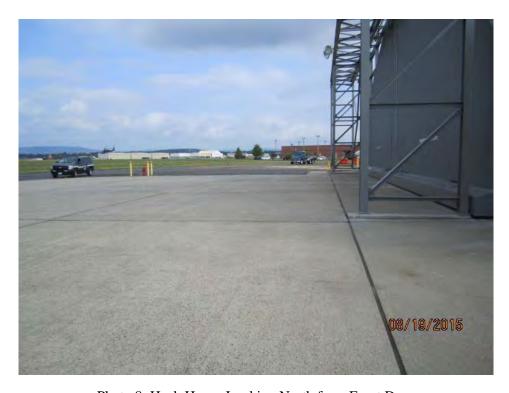
The Base's jet engine test cell facility or Hush House was constructed approximately in 1995. Initially, the Hush House had an AFFF fire suppression system from 1995 until the early 2000s when the system was converted to HEF. Only one AFFF release is known to have occurred during acceptance testing approximately in 1995. AFFF released during this event would have

Photo 7: Hush House

Photo 8: Hush House Looking North from Front Door

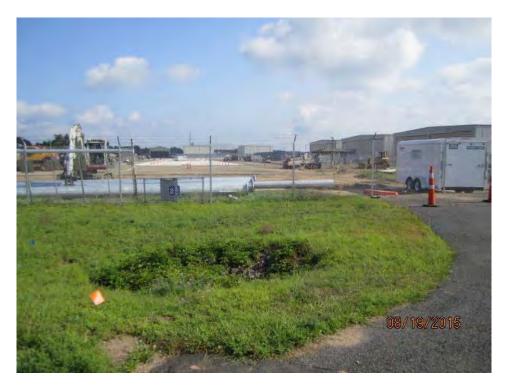
The former base fire station was in use from the 1940s until approximately 1992 when the new fire station was built. A review of old drawings and discussions with Base personnel indicated that the station's floor drains were connected to an OWS that discharged to the sanitary sewer system. Incidental spills and releases within the old fire station would likely have drained to the floor drains and entered the sanitary sewer system. There is no record of releases of AFFF within the former station. Based on the timeframe of use, the former station likely handled and stored AFFF. Various details of the old fire station are provided in Appendix C-4.

Photo 9: Approximate Former Location of Bldg 004 – Former Fire Station

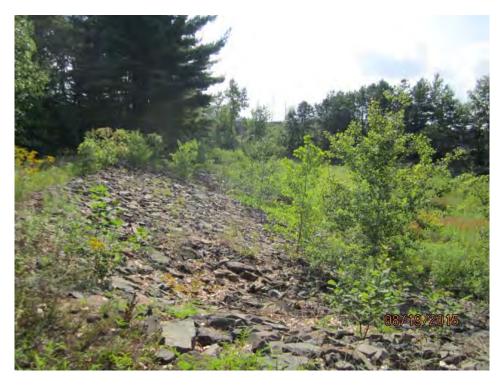
The Base stormwater drainage retention basin located adjacent to the POL was formerly investigated as ERP Site 4. The retention basin is approximately 100 feet (ft) wide by 200 ft long and 10 ft deep, lined with crushed rock and dirt. It is almost always dry. Stormwater which enters the drainage basin percolates to the subsurface through the generally permeable and sandy surface soils. Discussions with Base personnel indicated the Base utilized septic systems for all sanitary wastes up until the early 1980s when portions of the Base were converted to the City sanitary sewer system. Completion of the conversion from septic to sanitary sewers occurred in the early 1990s. Prior to connection to the sanitary sewer, floor drains within the hangars and buildings in the flight line area would have all drained to the drainage basin at ERP Site 4. Any AFFF releases (and other releases to the floor drains) would likely have drained to the ERP Site 4 drainage basin. The site was investigated under the ERP and closed in 1998 with no further action determined. There are no documented AFFF releases to the drainage basin.

Photo 10: Stormwater Drainage Pond (IRP Site 4)

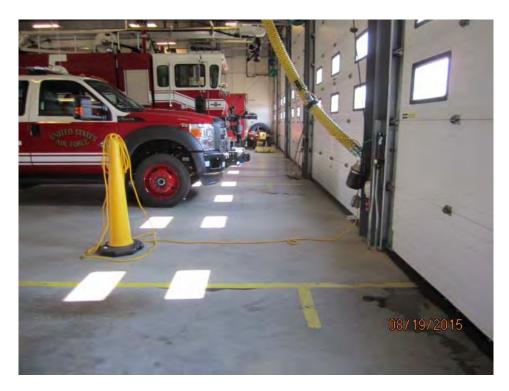
AFFF is stored by the Fire Department (FD) at the current crash fire station (Building 040) which was built in 1992 and occupied since. Renovations to the building were conducted in 2010. There are three FD crash trucks that hold 3% AFFF for a total of approximately 320 gallons of AFFF. There are also 5-gallon totes of 3% AFFF solution (approximately 250 gallons total) in inventory if needed to refill the crash trucks. All the trucks and AFFF storage areas are contained inside the fire station. The AFFF transfers occur via hand: either manually pouring the 5-gallon AFFF totes into the crash trucks or via a hand transfer pump within the fire station which has no floor drains. No spills or releases have been reported in the fire station.

Photo 11: Current Fire Station (Bldg 040)

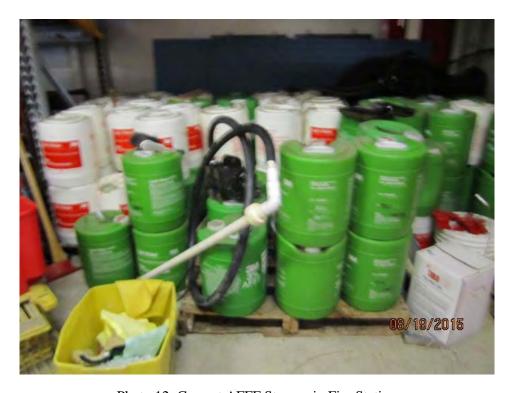
Photo 12: Current AFFF Storage in Fire Station
