Subject: W.R. Grace & Co.-Conn.
62 Whittemore Avenue, One Alewife Center, and
134 Alewife Brook Parkway
Cambridge, Massachusetts
RTNs 3-0277 and 3-3411

On behalf of W.R. Grace & Co.-Conn., we are submitting the Protective Cover Monitoring Plan (PCMP) Inspection Report No. 28. Haley & Aldrich completed the site inspection on 4 May 2011 in accordance with the PCMP, dated March 2006. Results of the inspection are provided in the attached log report. Please contact the undersigned if you have any questions.

Project	W.R. Grace & Co.-Conn.	Report No.	28
Location	62 Whittemore Avenue, One Alewife Center, 134 Alewife Brook Parkway	Date	4 May 2011
Address	Cambridge, Massachusetts	Page	1 of 6
Client	W.R. Grace & Co.	File No.	10063-066
Weather	Clear	Temperature	30s°
Field Rep.	John Kastrinos, Dave Croce		
LSP	John R. Kastrinos, P.G., LSP

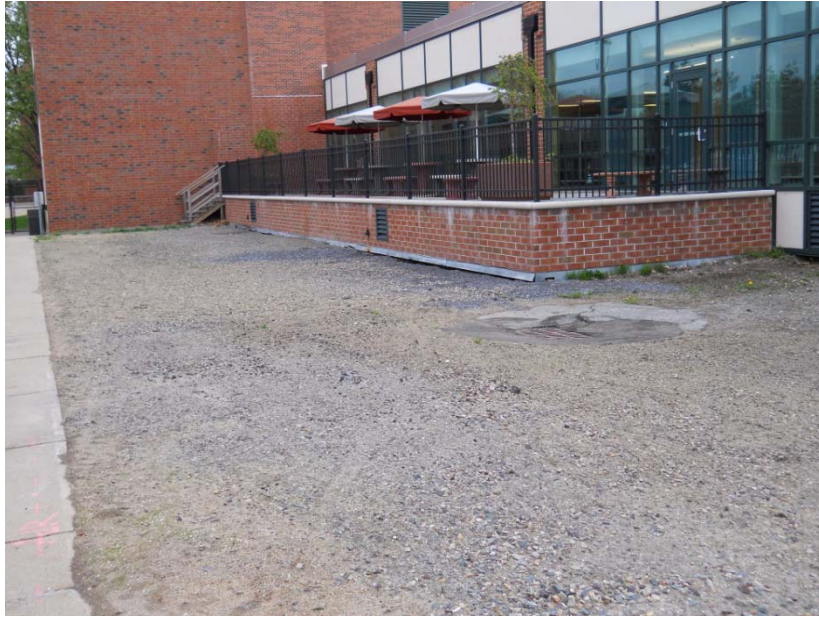
A1-9

Other Observations: Area where City of Cambridge completed their utility work associated with sewer separation has been backfilled to grade (see photograph 1-9). In addition, Grace has remedied the settlement observed around manhole in same area (reported in previous PCMP reports) by backfilling and paving.
