Subject: W.R. Grace & Co.-Conn.  
62 Whittemore Avenue, One Alewife Center, and  
134 Alewife Brook Parkway  
Cambridge, Massachusetts  
RTNs 3-0277 and 3-3411

On behalf of W.R. Grace & Co.-Conn., we are submitting the Protective Cover Monitoring Plan (PCMP) Inspection Report No. 29. Haley & Aldrich completed the site inspection on 11 August 2011 in accordance with the PCMP, dated March 2006. Results of the inspection are provided in the attached log report. Please contact the undersigned if you have any questions.

<b>Project Location</b>	W.R. Grace & Co.-Conn. 62 Whittemore Avenue, One Alewife Center, 134 Alewife Brook Parkway	<b>Report No.</b>	29
<b>Address</b>	Cambridge, Massachusetts	<b>Date</b>	11 August 2011
<b>Client</b>	W.R. Grace & Co.	<b>Page</b>	1 of 6
<b>Weather</b>	Clear	<b>File No.</b>	10063-066
<b>Field Rep.</b>	Jennifer Sweet, Dave Croce	<b>Temperature</b>	80s°
<b>LSP</b>	John R. Kastrinos, P.G., LSP

**PROTECTIVE COVER MONITORING PLAN INSPECTION REPORT**

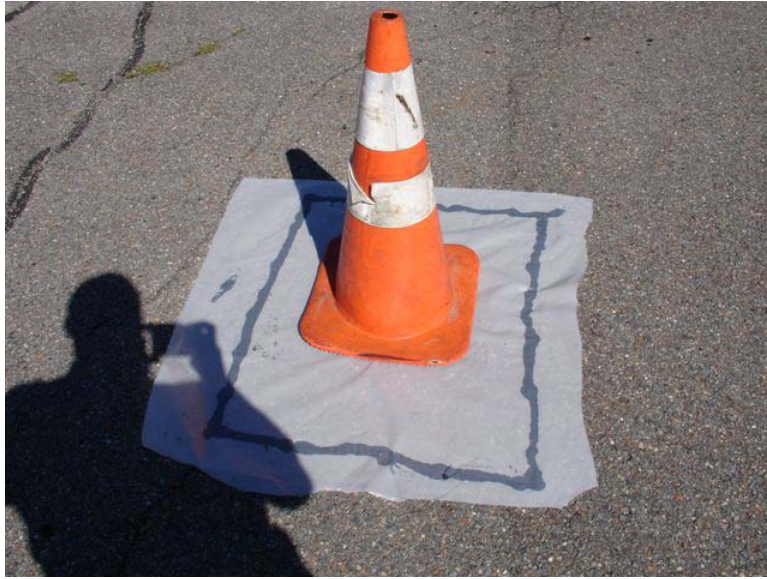
**Area 1 Parking Lot Sinkhole**

Yes  No Are there bare spots, signs of erosion, or large potholes in pavement? (If yes, attach photographs and figure showing location and extent): Describe eroded area or areas of potholes: A small sinkhole has developed in the middle of the parking lot located on the northern end of the property (see Figure for location and photo). The hole has been covered with plastic sheeting and the area coned off. W.R. Grace is conducting non-soil disturbing investigations to determine the cause of the sinkhole and will fill it in and patch the pavement once the cause has been determined.

Were there changes in the Protective Cover noted during the inspection that require actions to be taken to maintain and/or repair the Cover? If yes, describe: See description of sinkhole under Area 1 description.
