Subject: Notice of Placement in Public Repositories
Protective Cover Monitoring Plan (PCMP) Inspection Report No. 31
W.R. Grace & Co. Properties
62 Whittemore Avenue, One Alewife Center, 134 Alewife Brook Parkway
Cambridge, Massachusetts
RTNs 3-0277 and 3-3411

Project Location	W.R. Grace & Co.-Conn. 62 Whittemore Avenue, One Alewife Center, 134 Alewife Brook Parkway	Report No.	31
Address	Cambridge, Massachusetts	Date	22 March 2012
Client	W.R. Grace & Co.	Page	1 of 6
Weather	Clear	File No.	10063-066
Field Rep.	Jennifer Sweet, Dave Croce	Temperature	60s°
LSP	John R. Kastrinos, P.G., LSP

PROTECTIVE COVER MONITORING PLAN INSPECTION REPORT

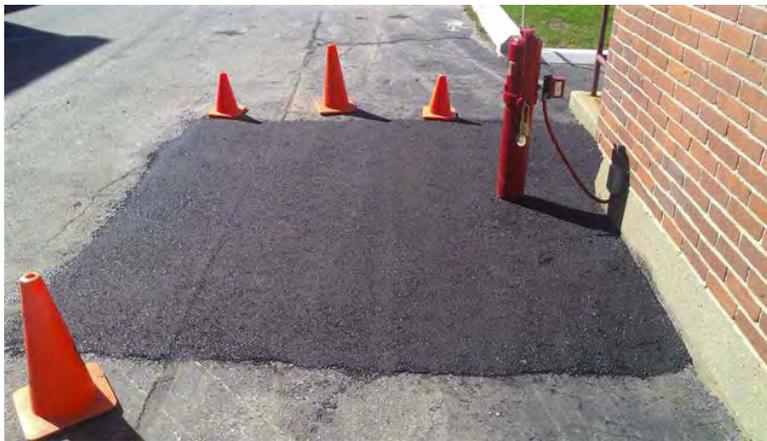
Yes No Are there bare spots, signs of erosion, or large potholes in pavement? (If yes, attach photographs and figure showing location and extent): Describe eroded area or areas of potholes: Three excavations were completed within Area 1 to make emergency repairs to underground piping and valves of the existing building sprinkler system, a backflow preventer valve, and a small sinkhole during the period September to December 2011 (these areas are shown on the attached figure). The excavations were completed under a URAM (RTN 3-30341). The protective cover was replaced/repared in each excavation area, which included recent paving (see attached photos).

URAM Excavation Area 1 Paved

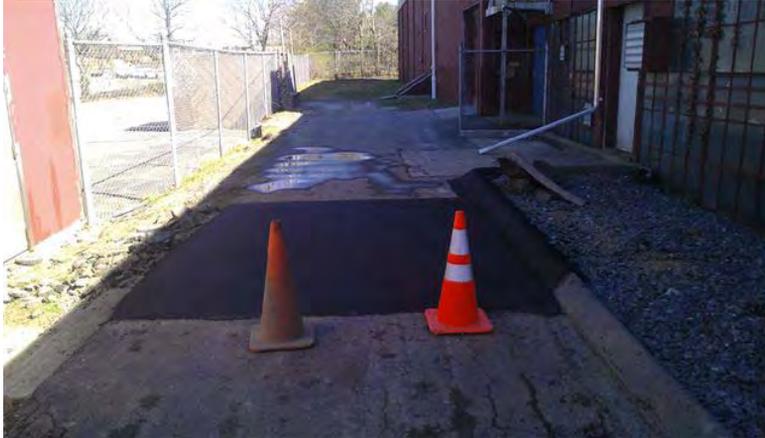
URAM Excavation Area 2 Paved

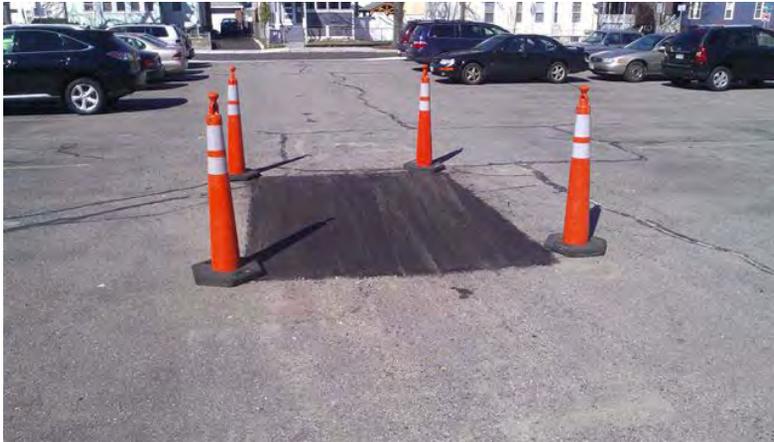
URAM Excavation Area 3 Paved
