Subject: W.R. Grace & Co.-Conn.
62 Whittemore Avenue, One Alewife Center, and
134 Alewife Brook Parkway
Cambridge, Massachusetts
RTNs 3-0277 and 3-3411

PROTECTIVE COVER MONITORING PLAN INSPECTION REPORT

| Project | W.R. Grace & Co. | Report No. | 17 |
| Location | 62 Whittemore Avenue, One Alewife Center, 134 Alewife Brook Parkway | Date | 1 July 2008 |

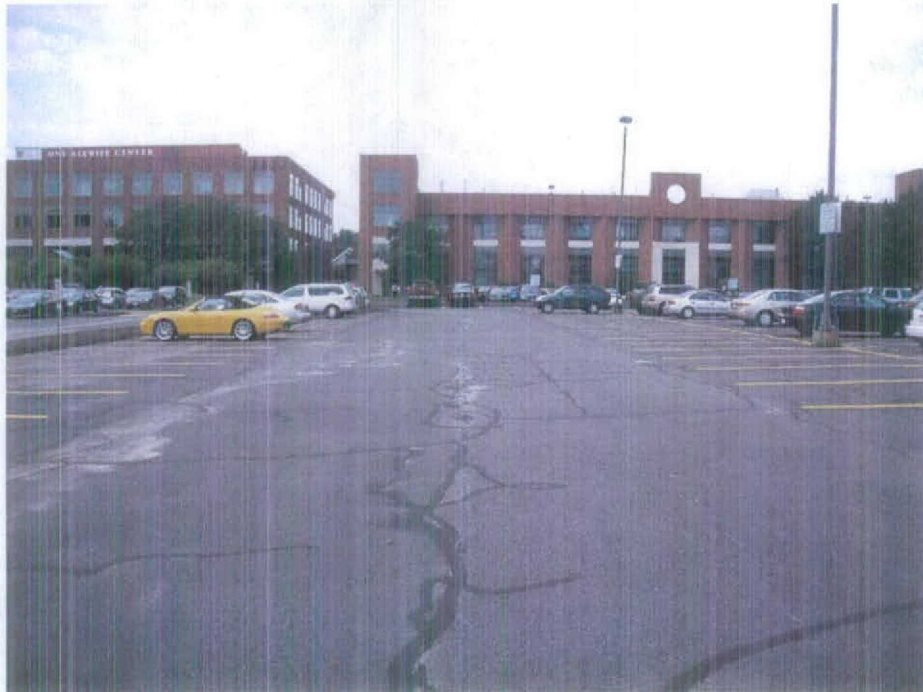
Yes No Is Protective Cover in Area 1 observed to be in same conditions compared to "baseline conditions"? If no, describe change(s) in conditions: Repairs were made to minor pavement damage identified in the last inspection report (NO. 16).
See photo: Area 1 Repaired Pavement

Yes No Were changes in the Protective Cover noted during the inspection that require actions to be taken to maintain and/or repair the Cover? If yes, describe: Repairs to minor pavement damage in Area 1 were completed. Repairs to minor pavement damage noticed in Area 3 should be considered.

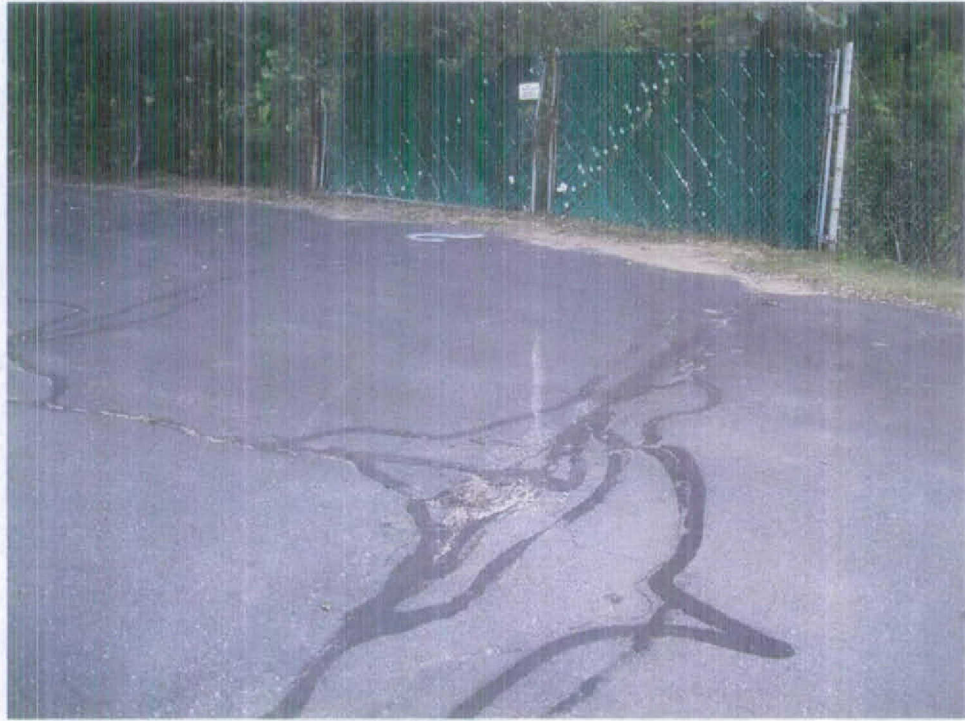
Area 3 Pavement

Yes No Are there bare spots, signs of erosion? (If yes, attach photographs and figure showing location and extent): Describe eroded area or areas of potholes: Minor pavement damages (less than 1 inch deep) were noticed. See photo: Area 3 pavement
