Subject: W.R. Grace & Co.-Conn.
62 Whittemore Avenue, One Alewife Center, and
134 Alewife Brook Parkway
Cambridge, Massachusetts
RTNs 3-0277 and 3-3411 → *130 ALEWIFE BROOK PKWY
MA*

On behalf of W.R. Grace & Co.-Conn., we are submitting the Protective Cover Monitoring Plan (PCMP) Inspection Report No. 20. The Site inspection was completed by Haley & Aldrich on 18 March 2009 in accordance with the PCMP, dated March 2006. Results of the inspection are provided in the attached log report. Please contact the undersigned if you have any questions.

PROTECTIVE COVER MONITORING PLAN INSPECTION REPORT

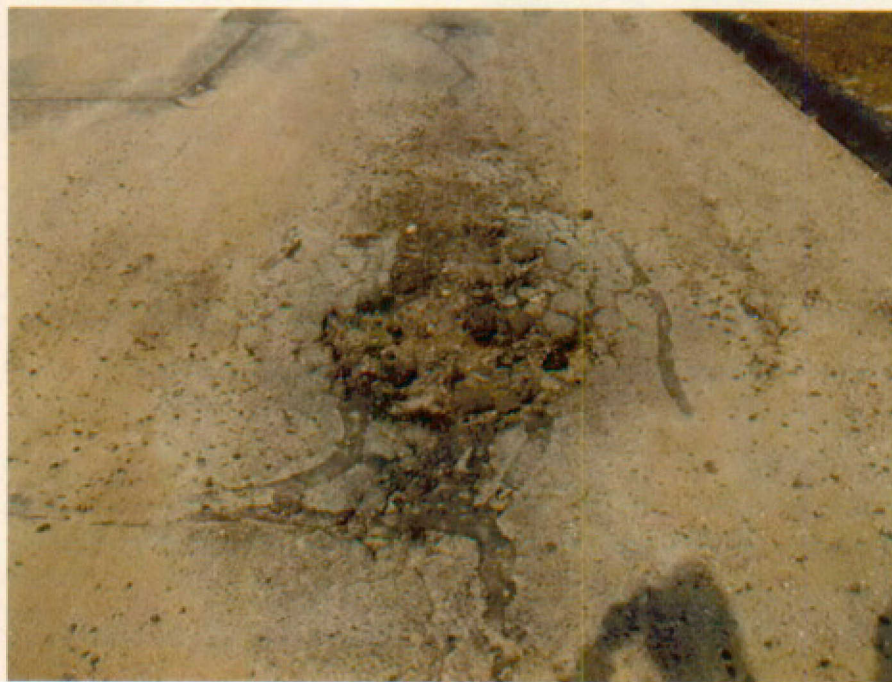
Pothole

Yes No Are there bare spots, signs of erosion, or large potholes in pavement? (If yes, attach photographs and figure showing location and extent): Describe eroded area or areas of potholes:
Several small potholes were observed in the parking lot in Area 1. The potholes were limited to the top 6 inches or less of pavement. (see attached photo "pothole")

Were changes in the Protective Cover noted during the inspection that require actions to be taken to maintain and/or repair the Cover? If yes, describe: Several potholes were observed in the parking lot in Area 1. Another inspection will be conducted in April after street sweeping is complete to identify all location requiring repair. Repairs to the potholes will be

4. Other Comments: completed to maintain the Protective Cover.
