Subject: **W.R. Grace & Co.-Conn.**
62 Whittemore Avenue, One Alewife Center, and
134 Alewife Brook Parkway
Cambridge, Massachusetts
RTNs 3-0277 and 3-3411

On behalf of W.R. Grace & Co.-Conn., we are submitting the Protective Cover Monitoring Plan (PCMP) Inspection Report No. 21. The Site inspection was completed by Haley & Aldrich on 25 June 2009 in accordance with the PCMP, dated March 2006. Results of the inspection are provided in the attached log report. Please contact the undersigned if you have any questions.

PROTECTIVE COVER MONITORING PLAN INSPECTION REPORT

Project	W.R. Grace & Co.	Report No.	21
Location	62 Whittemore Avenue, One Alewife Center, 134 Alewife Brook Parkway	Date	25 June 2009
Address	Cambridge, Massachusetts	Page	1 of 6
Client	W.R. Grace & Co.	File No.	10063-066
Weather	Partly Sunny	Temperature	70°
Field Rep.	Jennifer Sweet, Dave Croce		
LSP	John R. Kastrinos, P.G., LSP

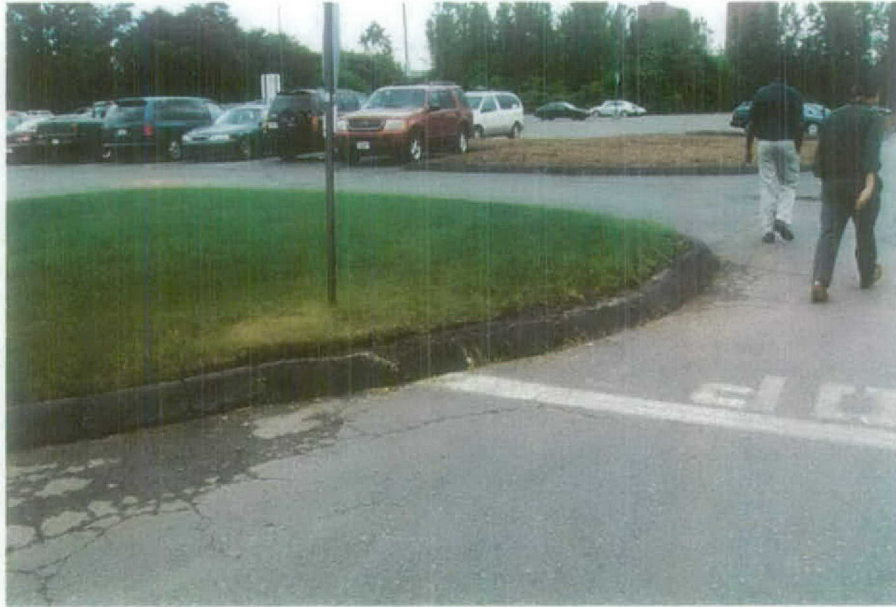
Other Observations: Repairs were made to pavement & curbs in parking lot. (see photos)

A1-Pavement

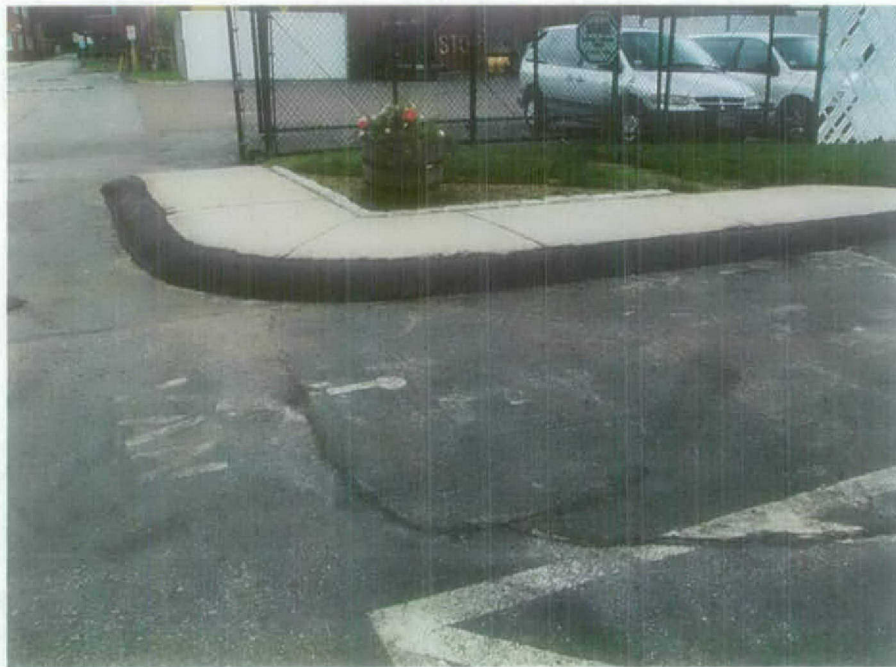
A1-Pavement-Curb-Repair
