Copies	Date	Description
1	26 April 2010	Protective Cover Monitoring Plan (PCMP) Inspection Report No. 24

On behalf of W.R. Grace & Co.-Conn., we are submitting the Protective Cover Monitoring Plan (PCMP) Inspection Report No. 24. The Site inspection was completed by Haley & Aldrich on 15 April 2010 in accordance with the PCMP, dated March 2006. Results of the inspection are provided in the attached log report. Please contact the undersigned if you have any questions.

**PROTECTIVE COVER MONITORING PLAN INSPECTION REPORT**

<b>Project</b>	W.R. Grace & Co.	<b>Report No.</b>	24
<b>Location</b>	62 Whittemore Avenue, One Alewife Center, 134 Alewife Brook Parkway	<b>Date</b>	15 April 2010
<b>Address</b>	Cambridge, Massachusetts	<b>Page</b>	1 of 6
<b>Client</b>	W.R. Grace & Co.	<b>File No.</b>	10063-066
<b>Weather</b>	Sunny	<b>Temperature</b>	60°
<b>Field Rep.</b>	Jennifer Sweet, Dave Croce		
<b>LSP</b>	John R. Kastrinos, P.G., LSP

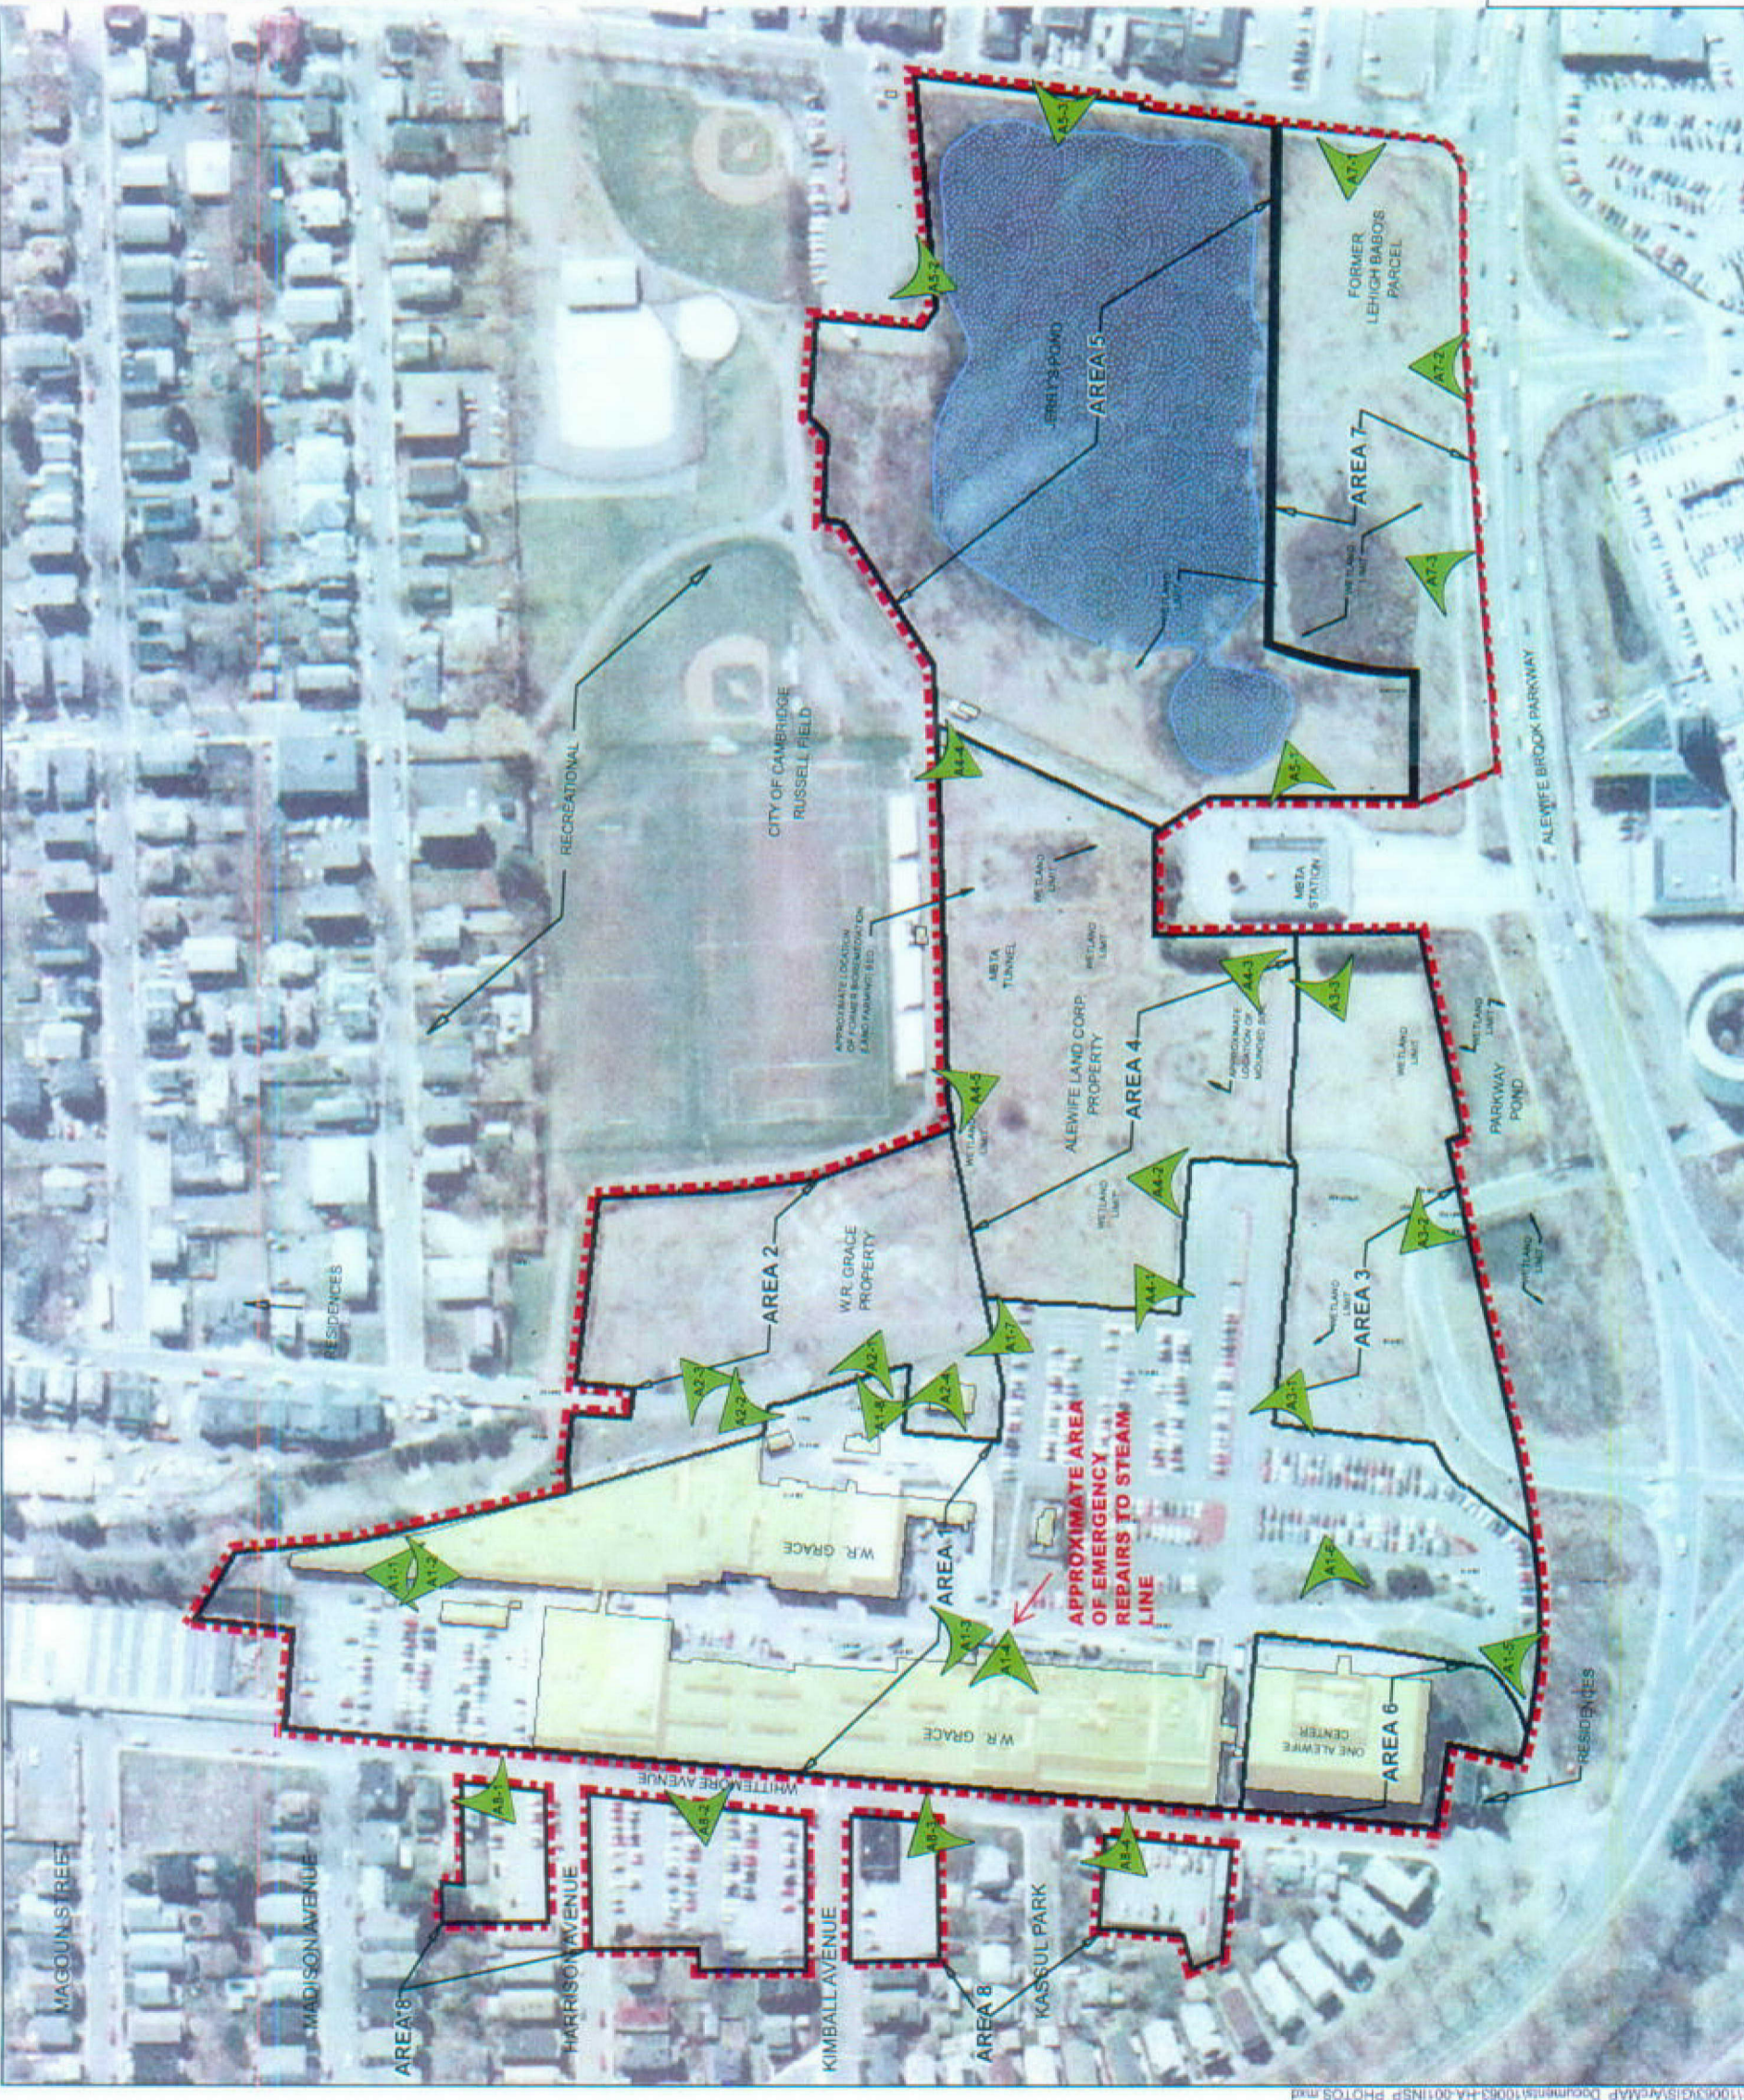
**SITE ORTHOPHOTO**

Emergency repairs to the steam line were completed between 22 February and 2 March 2010 in Area 1 (see Figure for approximate location). Monitoring activities were reported in the URAM Completion Report, dated 30 March 2010, and submitted to MassDEP. The Protective Cover has been restored. Asbestos was not encountered during the excavation activities.
