Subject W.R. Grace & Co.-Conn.  
62 Whittemore Avenue, One Alewife Center, and  
134 Alewife Brook Parkway  
Cambridge, Massachusetts  
RTNs 3-0277 and 3-3411

PCMP Inspection Report No. 26

**PROTECTIVE COVER MONITORING PLAN INSPECTION REPORT**

<b>Project</b>	W.R. Grace & Co.	<b>Report No.</b>	26
<b>Location</b>	62 Whittemore Avenue, One Alewife Center, 134 Alewife Brook Parkway	<b>Date</b>	11 November 2010
<b>Address</b>	Cambridge, Massachusetts	<b>Page</b>	1 of 6
<b>Client</b>	W.R. Grace & Co.	<b>File No.</b>	10063-066
<b>Weather</b>	Clear	<b>Temperature</b>	40s°
<b>Field Rep.</b>	John R. Kastrinos, Dave Croce		
<b>LSP</b>	John R. Kastrinos, P.G., LSP

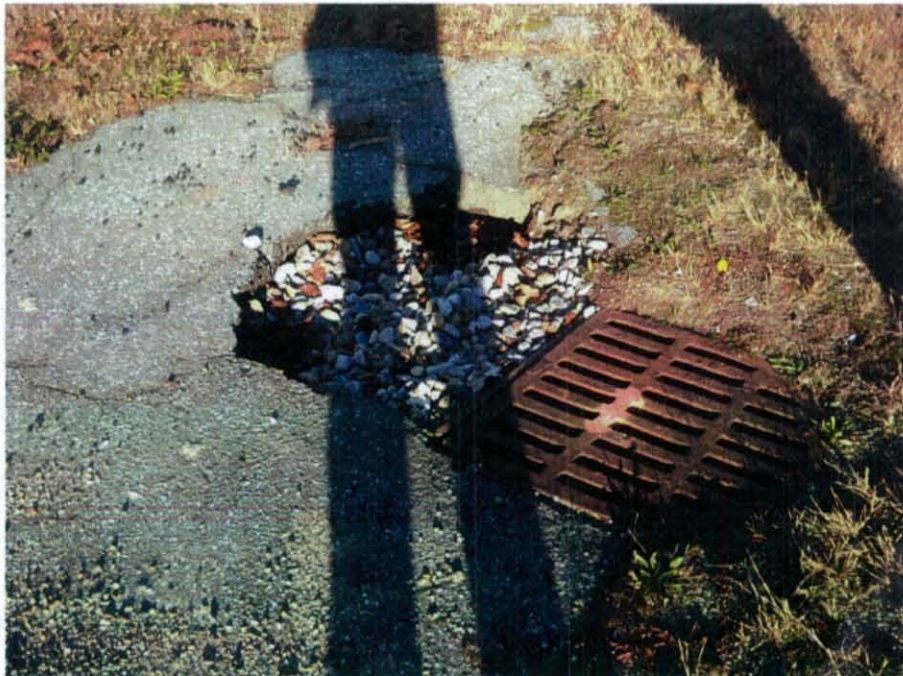
CB

Other Observations: Concrete walkways and steps replaced a wooden bridge; no soil disturbed.  
Settlement around catch basin repaired by backfilling with stone (see photograph CB).

Sinkhole need to be monitored for settlement of stone backfill.  
\_\_\_\_\_  
\_\_\_\_\_  
\_\_\_\_\_  
\_\_\_\_\_
