PCMP Inspection Report No. 26

PROTECTIVE COVER MONITORING PLAN INSPECTION REPORT

Project	W.R. Grace & Co.	Report No.	26
Location	62 Whittemore Avenue, One Alewife Center, 134 Alewife Brook Parkway	Date	11 November 2010
Address	Cambridge, Massachusetts	Page	1 of 6
Client	W.R. Grace & Co.	File No.	10063-066
Weather	Clear	Temperature	40s°
Field Rep.	John R. Kastrinos, Dave Croce		
LSP	John R. Kastrinos, P.G., LSP

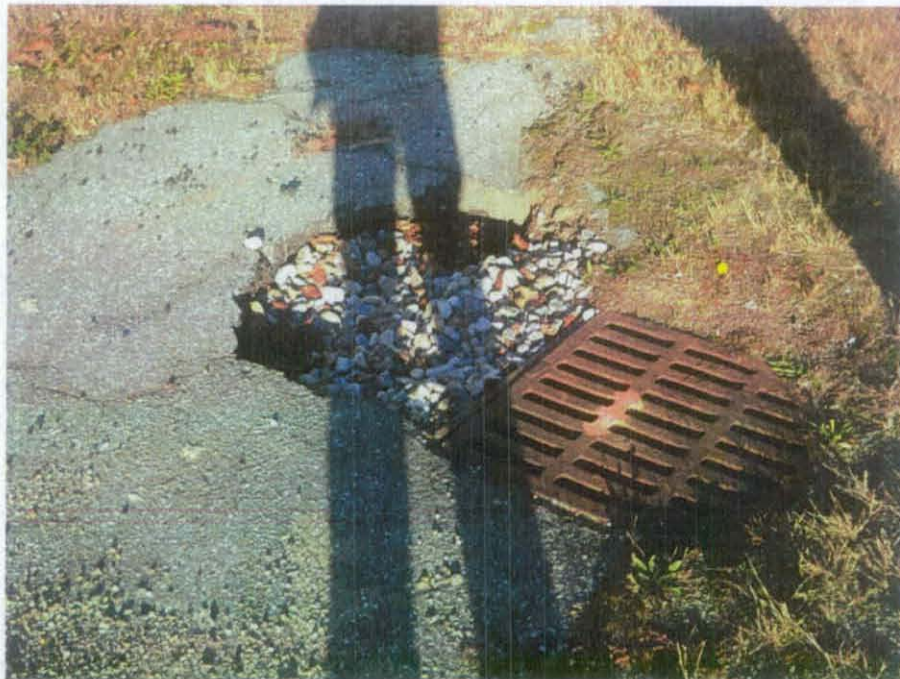
CB

Other Observations: Concrete walkways and steps replaced a wooden bridge; no soil disturbed.
Settlement around catch basin repaired by backfilling with stone (see photograph CB).

Sinkhole need to be monitored for settlement of stone backfill.
