Subject: Notice of Placement in Public Repositories
Protective Cover Monitoring Plan (PCMP) Inspection Report No. 37
W.R. Grace & Co. Properties
62 Whittemore Avenue, One Alewife Center, 134 Alewife Brook Parkway Cambridge, Massachusetts
RTNs 3-0277 and 3-3411

HALEY& ALDRICH	PROTECTIVE COVER MONITORING PLAN INSPECTION REPORT		REPORT
Project	W.R. Grace & CoConn.	Report No.	37
Location	62 Whittemore Avenue, One Alewife Center, 134 Alewife Brook Parkway	Date	24 October 2013
Address	Cambridge, Massachusetts	Page	1 of 6
Client	W.R. Grace & Co.	File No.	10063-141
Weather	Clear	Temperature	60s°
Field Rep.	Jennifer Sweet, Dave Croce		
LSP	John R. Kastrinos, P.G., LSP

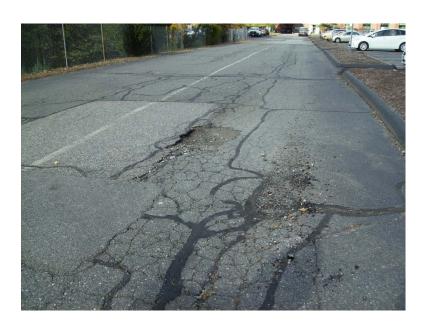
A1 - Pavement

Are there bare spots, signs of erosion, or large potholes in pavement? (If yes, attach photographs and figure showing location and extent) Describe eroded area or areas of potholes: There are a few potholes located along the roadway in Area 1. The depth of the potholes are less than 6-inches. Repairs are planned to be completed by end of December, weather permitting, and will be documented in the next inspection report.
