**REMOVAL PROGRAM
PRELIMINARY ASSESSMENT/
SITE INVESTIGATION REPORT
FOR THE
AEROVOX SITE
NEW BEDFORD, BRISTOL COUNTY, MASSACHUSETTS
2 AUGUST 2007 AND 15 THROUGH 16 AUGUST 2007**

U.S. Environmental Protection Agency
Region I
Emergency Planning and Response Branch
1 Congress Street, Suite 1100
Boston, MA 02114-2023

Weston Solutions, Inc.
Region I
Superfund Technical Assessment and Response Team III (START)
3 Riverside Drive
Andover, MA 01810

November 2007

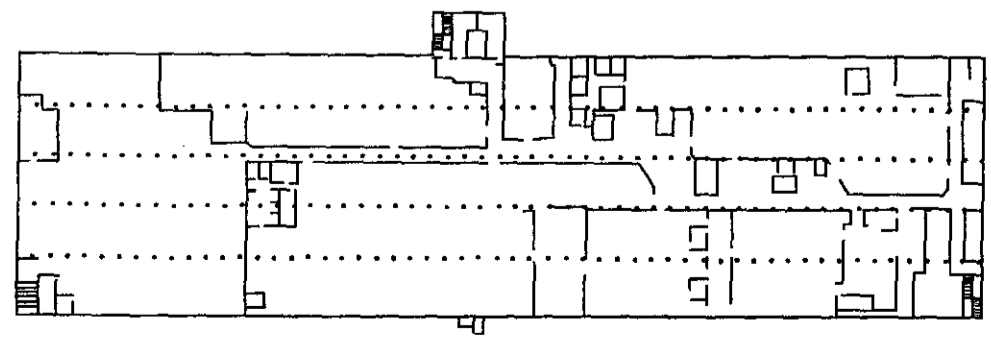
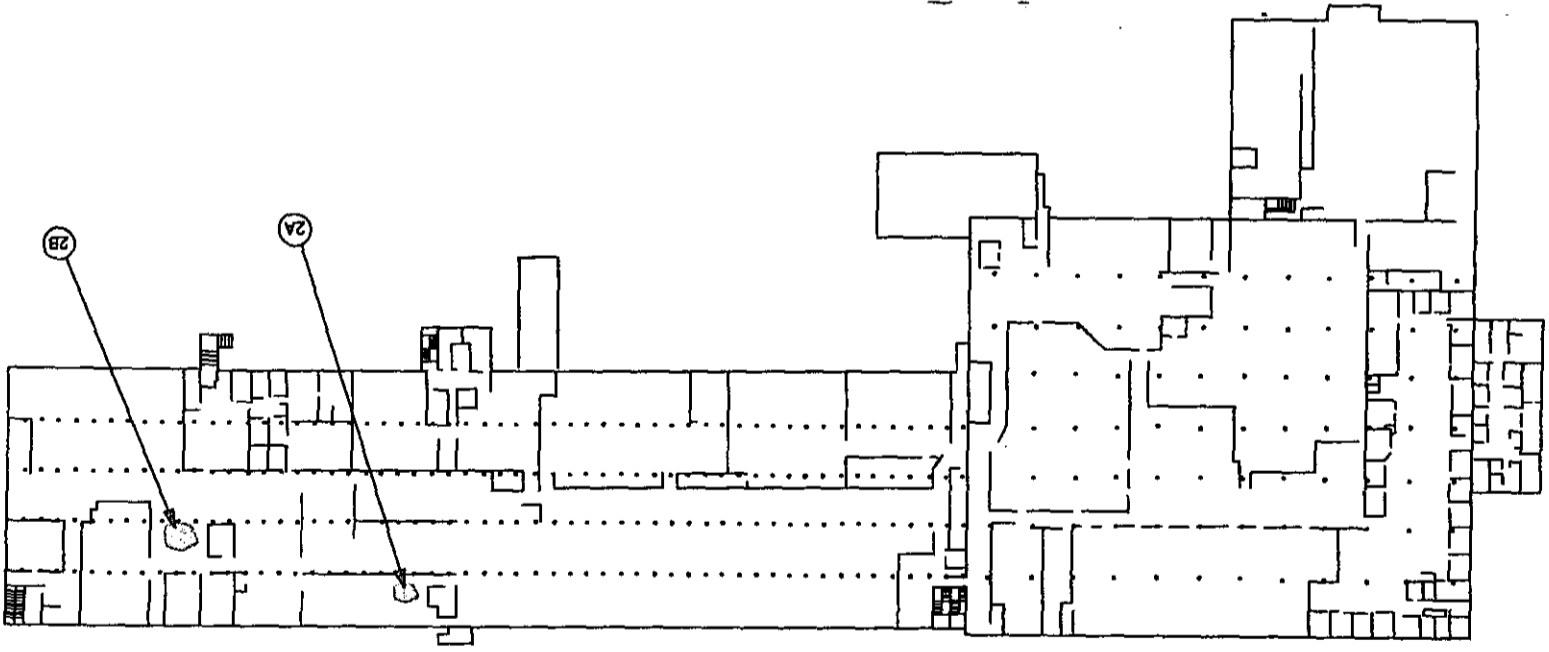
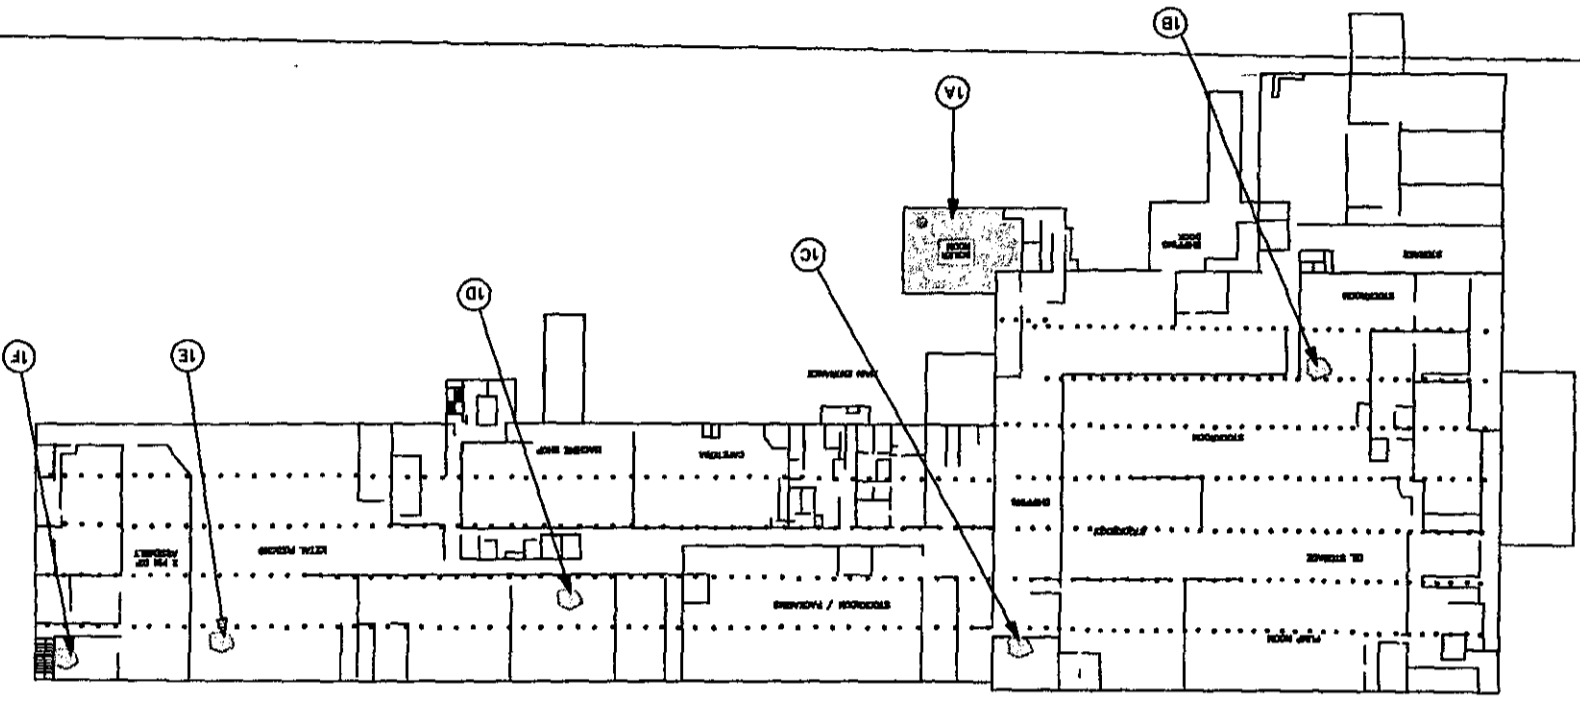
MERCURY SOURCE LOCATIONS

LOCATION	DESCRIPTION
1A	BOILER ROOM - ELEVATED MERCURY READINGS (>50,000 ng) ON FLOOR AND IN PIPE CHASE.
1B	VISIBLE MERCURY ON PALLET AND FLOOR (FLOOR MARKED WITH SPRAY PAINT).
1C	DISMANTLED IGNITONS & VISIBLE MERCURY ON FLOOR (FLOOR MARKED WITH SPRAY PAINT).
1D	VISIBLE MERCURY IN FLOORING - ELEVATED READINGS (FLOOR MARKED WITH SPRAY PAINT).
1E	LOCATION OF TWO INTACT IGNITONS (EQUIPMENT MARKED WITH SPRAY PAINT).
1F	CARDBOARD BOX ON PALLET CONTAINING BROKEN FLOW METER (FLOOR MARKED WITH SPRAY PAINT).
2A	FORMER LOCATION OF FIBER DRUM - ELEVATED READINGS (FLOOR MARKED WITH SPRAY PAINT).
2B	BROKEN THERMOMETER ON FLOOR - ELEVATED READINGS (FLOOR MARKED WITH SPRAY PAINT).

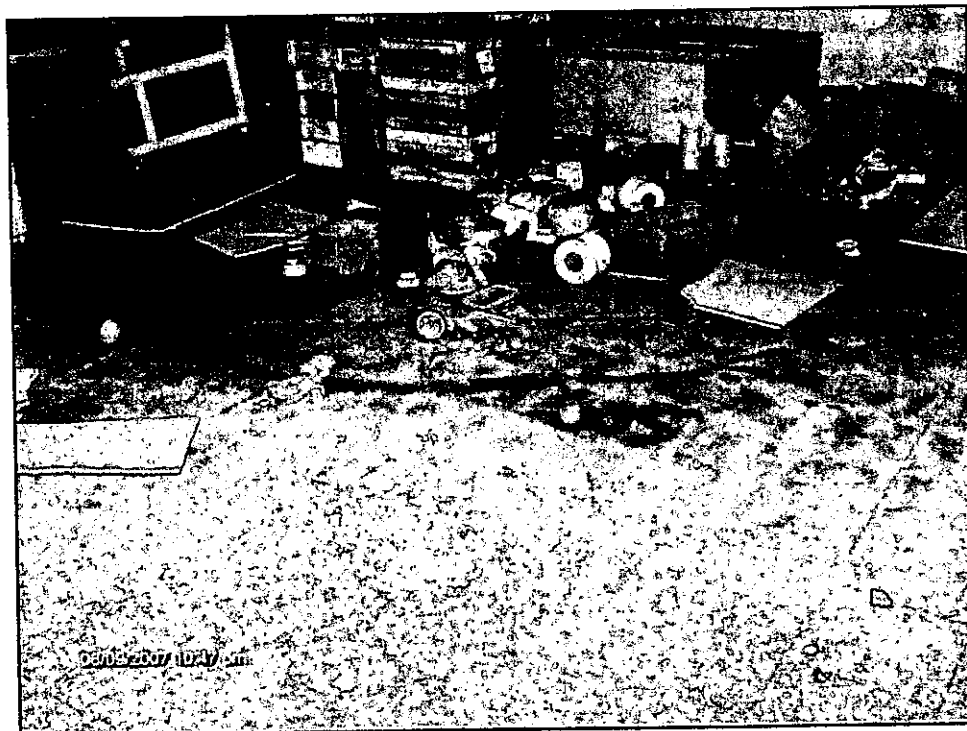
PHOTOGRAPH NO. : 22 (HPIM0534.jpg)

SCENE: View of a damaged thermometer on the second floor. Photograph taken facing southeast.

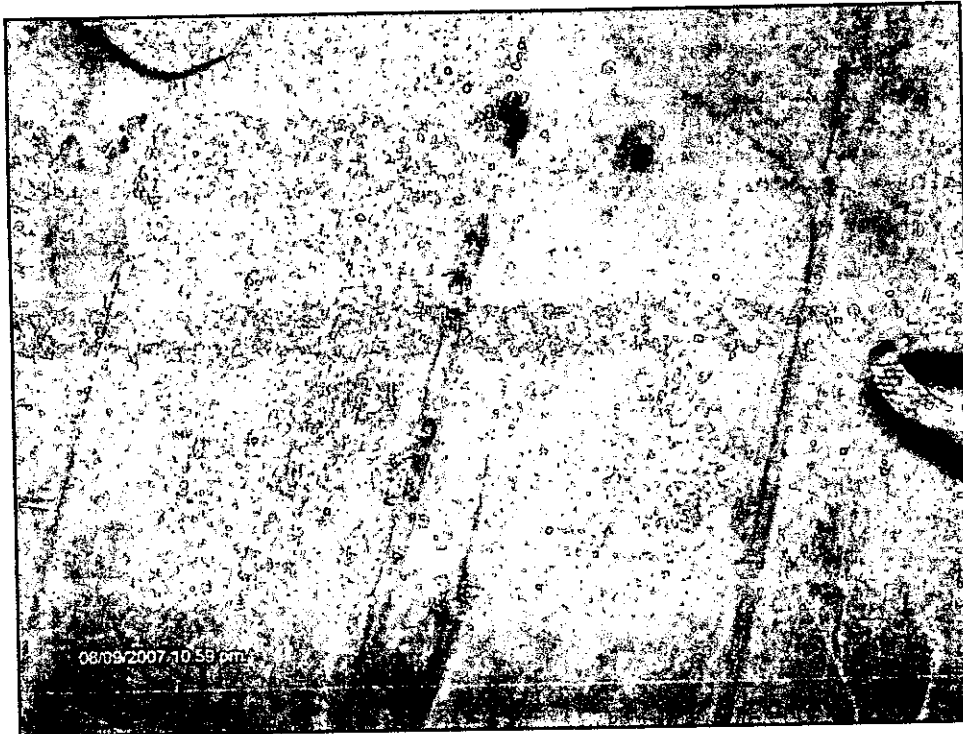
PHOTOGRAPH NO. : 25 (HPIM0541.jpg)

SCENE: View of beads of metallic mercury on the floor of the machine shop storage area of the first floor of the Aerovox building.

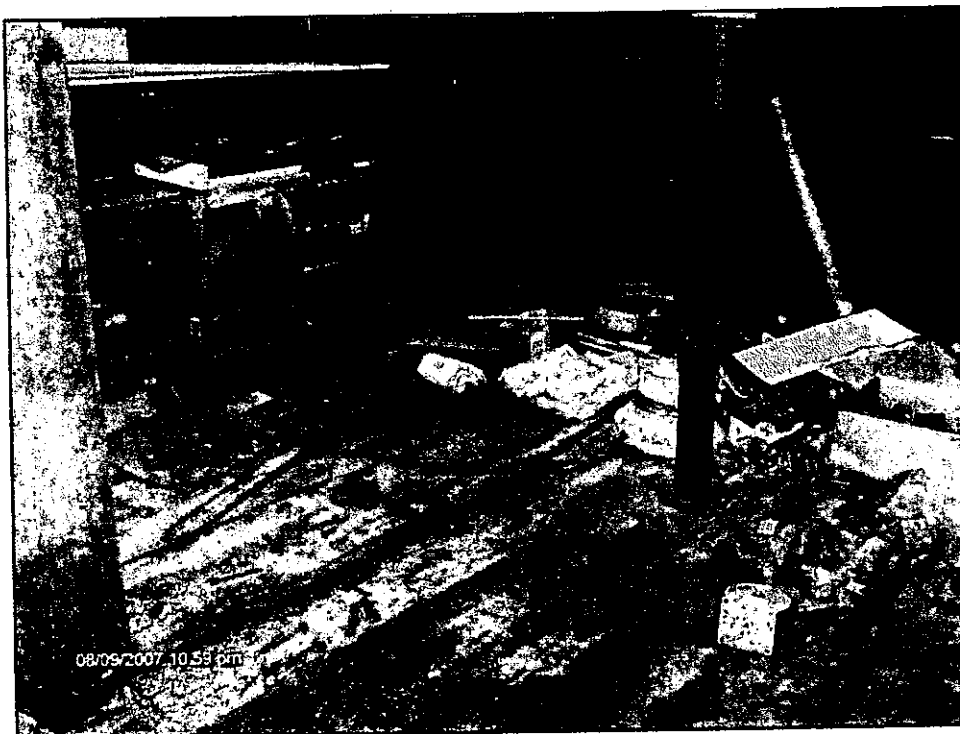
PHOTOGRAPH NO. : 26 (HPIM0539.jpg)

SCENE: View of beads of metallic mercury on the floor of the machine shop storage area of the first floor of the Aerovox building. Photograph taken facing southeast.

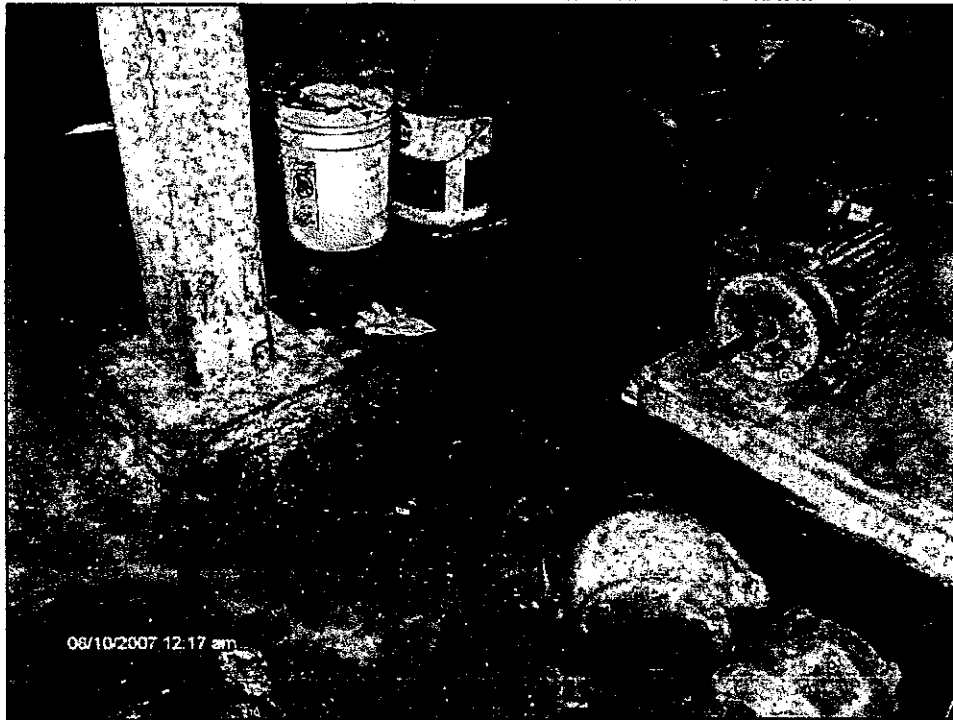
PHOTOGRAPH NO. : 31 (HPIM0552.jpg)

SCENE: View of beads of mercury in the stockroom area of the Aerovox building. Photograph taken facing southeast.

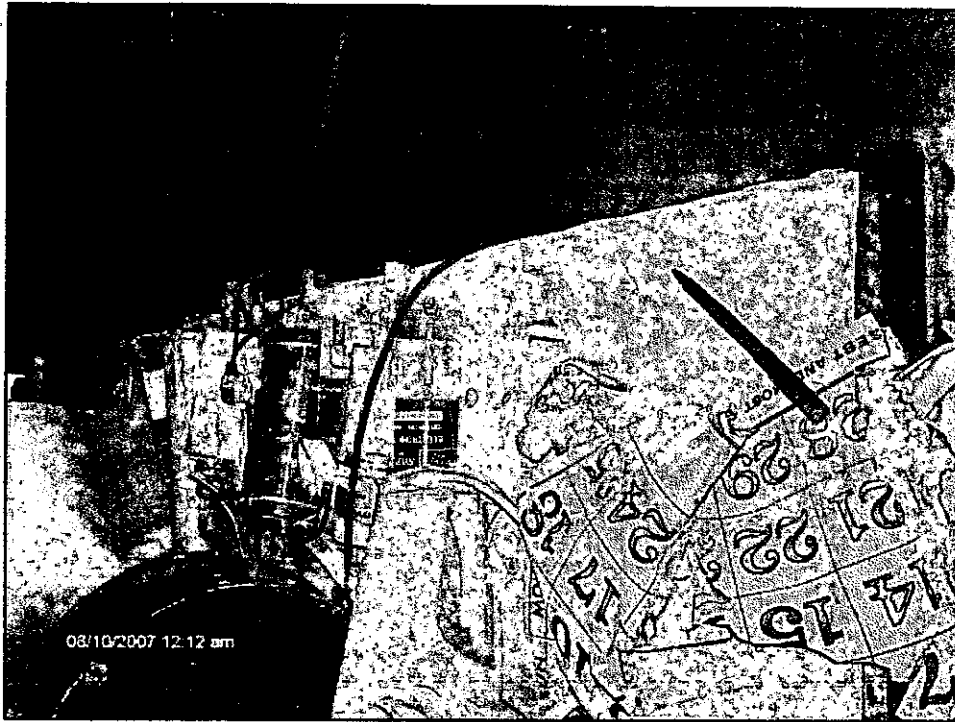
PHOTOGRAPH NO. : 35 (HPIM0543.jpg)

1-34	433	---	---	
1-35	422	---	---	
1-36	354	---	---	
1-37	138	---	---	
1-38	245	---	---	
1-39	289	---	---	
1-40	339	---	---	
1-41	342	---	---	
1-42	161	---	---	
1-43	239	---	---	
1-44	163	---	---	
1-45	5008	---	4722	Ignitrons on workbench - mercury beads observed.
1-46	2833	---	3168	Ignitrons on workbench - mercury beads observed.
1-47	397	---	---	
1-48	313	---	---	
1-49	196	---	---	
1-50	188	---	---

SCENE: View of ignitrons and mercury on a workbench in the storage room on the north side of the building. Photograph taken facing west.

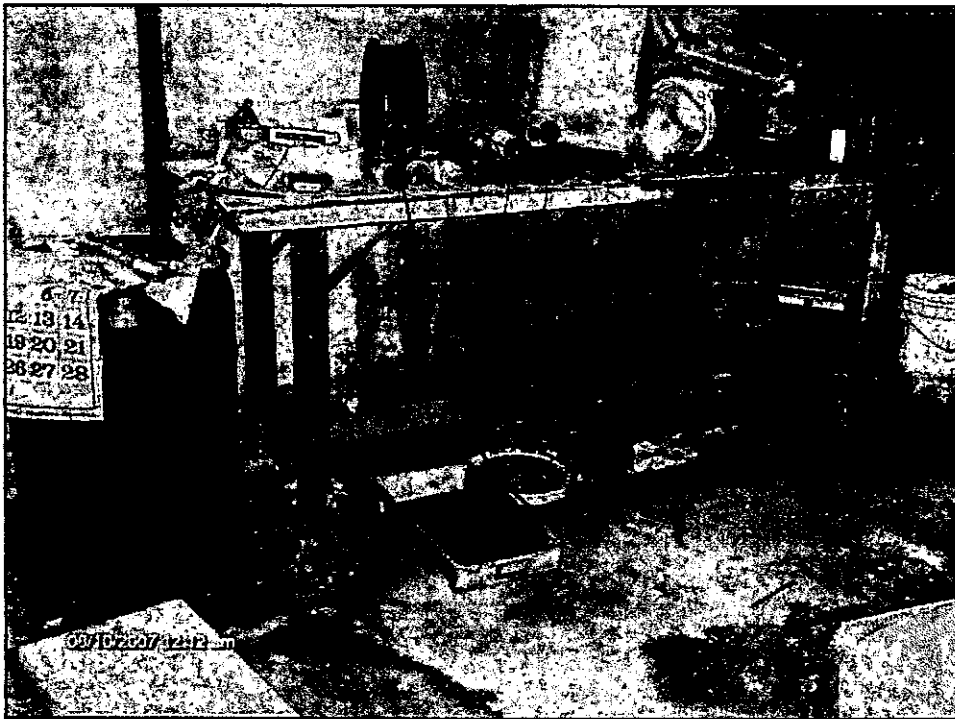
PHOTOGRAPH NO. : 36 (HPIM0542.jpg)

SCENE: View of ignitrons and mercury on a workbench in the storage room on the north side of the building. Photograph taken facing southwest.
