Environmental Notification Form

Project Name: Waquoit Bay Yacht Club Revetment Repair		
Street: 20 Seapit Road		
Municipality: Falmouth	Watershed: Waquoit Bay	
Universal Transverse Mercator Coordinates:	Latitude: 41° 34.739' N Longitude: 70° 31.595' W	
Estimated commencement date: Winter 2004-2005	Estimated completion date: Winter 2004-2005	
Approximate cost: \$30,000	Status of project design: 100 %complete	
Proponent: Waquoit Bay Yacht Club, Inc.		
Street: 20 Seapit Road		
Municipality: Falmouth	State: MA	Zip Code: 02536
Name of Contact Person From Whom Copies of this ENF May Be Obtained: Kirk Bosma		
Firm/Agency: Woods Hole Group	Street: 81 Technology Park Drive	
Municipality: East Falmouth	State: MA	Zip Code: 02536
Phone: 508 540 8080	Fax: 508 540 1001	E-mail: kbosma@whgrp.com

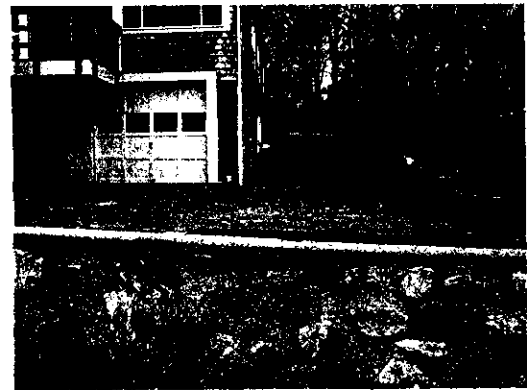
Figure 3. Concrete patio directly landward of existing revetment.

- Inclusion of a drainage trench that will inhibit direct stormwater and upland runoff from draining directly into Waquoit Bay. Currently, upland runoff advances directly down the concrete patio and empties into the bay unimpeded. The proposed project includes a drainage trench that will allow for some natural filtering through bedding and drainage stone.
- Beach replenishment that will expand coastal beach resources, provides additional protection to upland areas, and provides a sediment source to the beach regions.
- Although a small portion of salt marsh will be covered during the beach replenishment, the entire region will be planted following replenishment and salt marsh growth and expansion will be encouraged.

Construction access from the upland will be gained via the existing driveway to the north of the yacht club building as indicated on the Proposed Plans. The access paths will be used by light construction machinery, as necessary. The existing concrete patio/pad will be cut as needed and material behind the structure will be evacuated as required. The cavity will be replaced with bedding/drainage stone and backed with the Mirafi FW 403 filter fabric. The excavation will go as deep as possible, while maintaining structural stability, in order to wrap the filter fabric around an armor unit near the base of the structure. In order to maintain stability of the existing revetment, armor units near the crest of the structure may be temporarily removed during the excavation and placement process. Additional voids behind the stone layer will be filled with clean fill as necessary. The concrete pad will be replaced except for the inclusion of a 1 to 2 foot wide drainage trench at the seaward end of the concrete pad. Construction will occur during the winter and within appropriate construction windows to protect fish and wildlife.
