IMMEDIATE RESPONSE
ACTION STATUS REPORT #1

FORMER AEROVOX FACILITY
740 BELLEVILLE AVENUE
NEW BEDFORD, MA
RTN 4-0601

August 2014

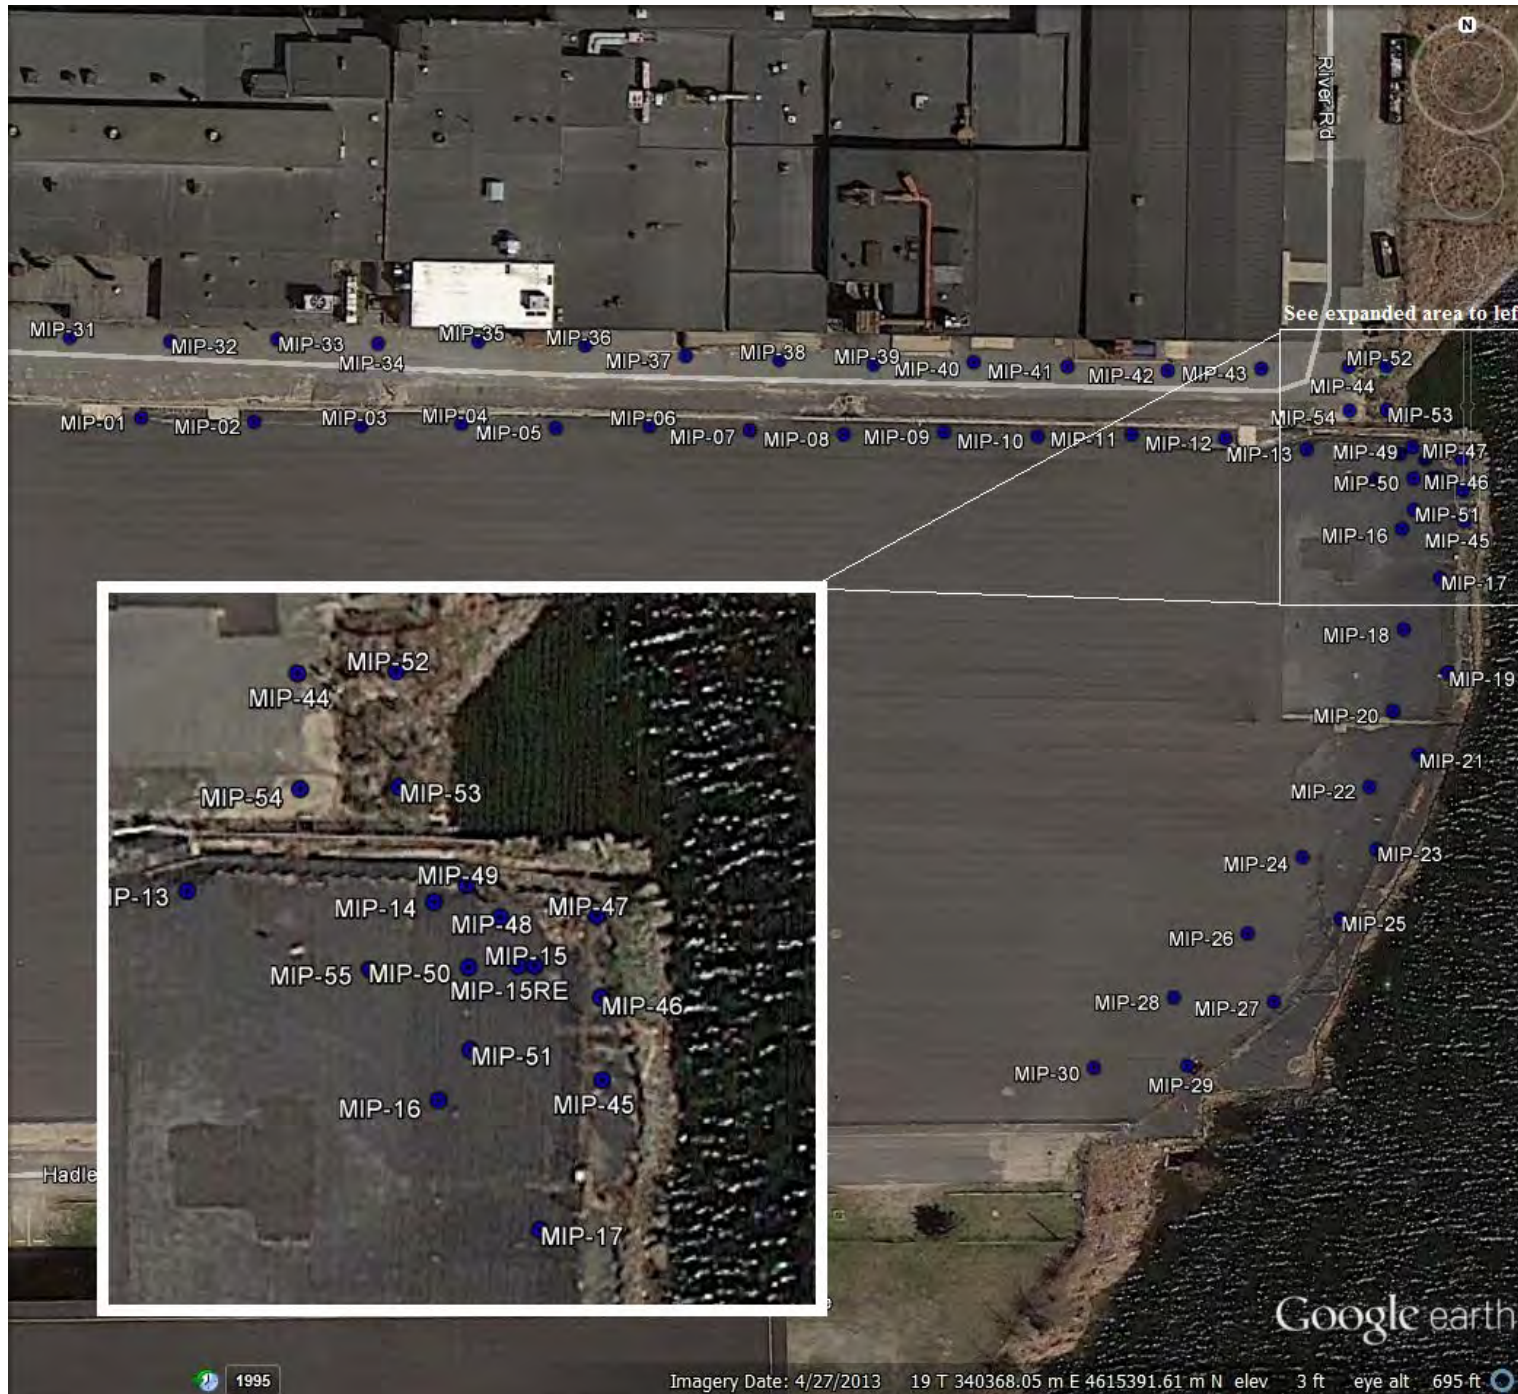
Figure 1 Sitemap and Locations
 November 18th, 2013 – November 26th, 2013, July 14th, 2014 – July 15th, 2014

● MiHpt Location

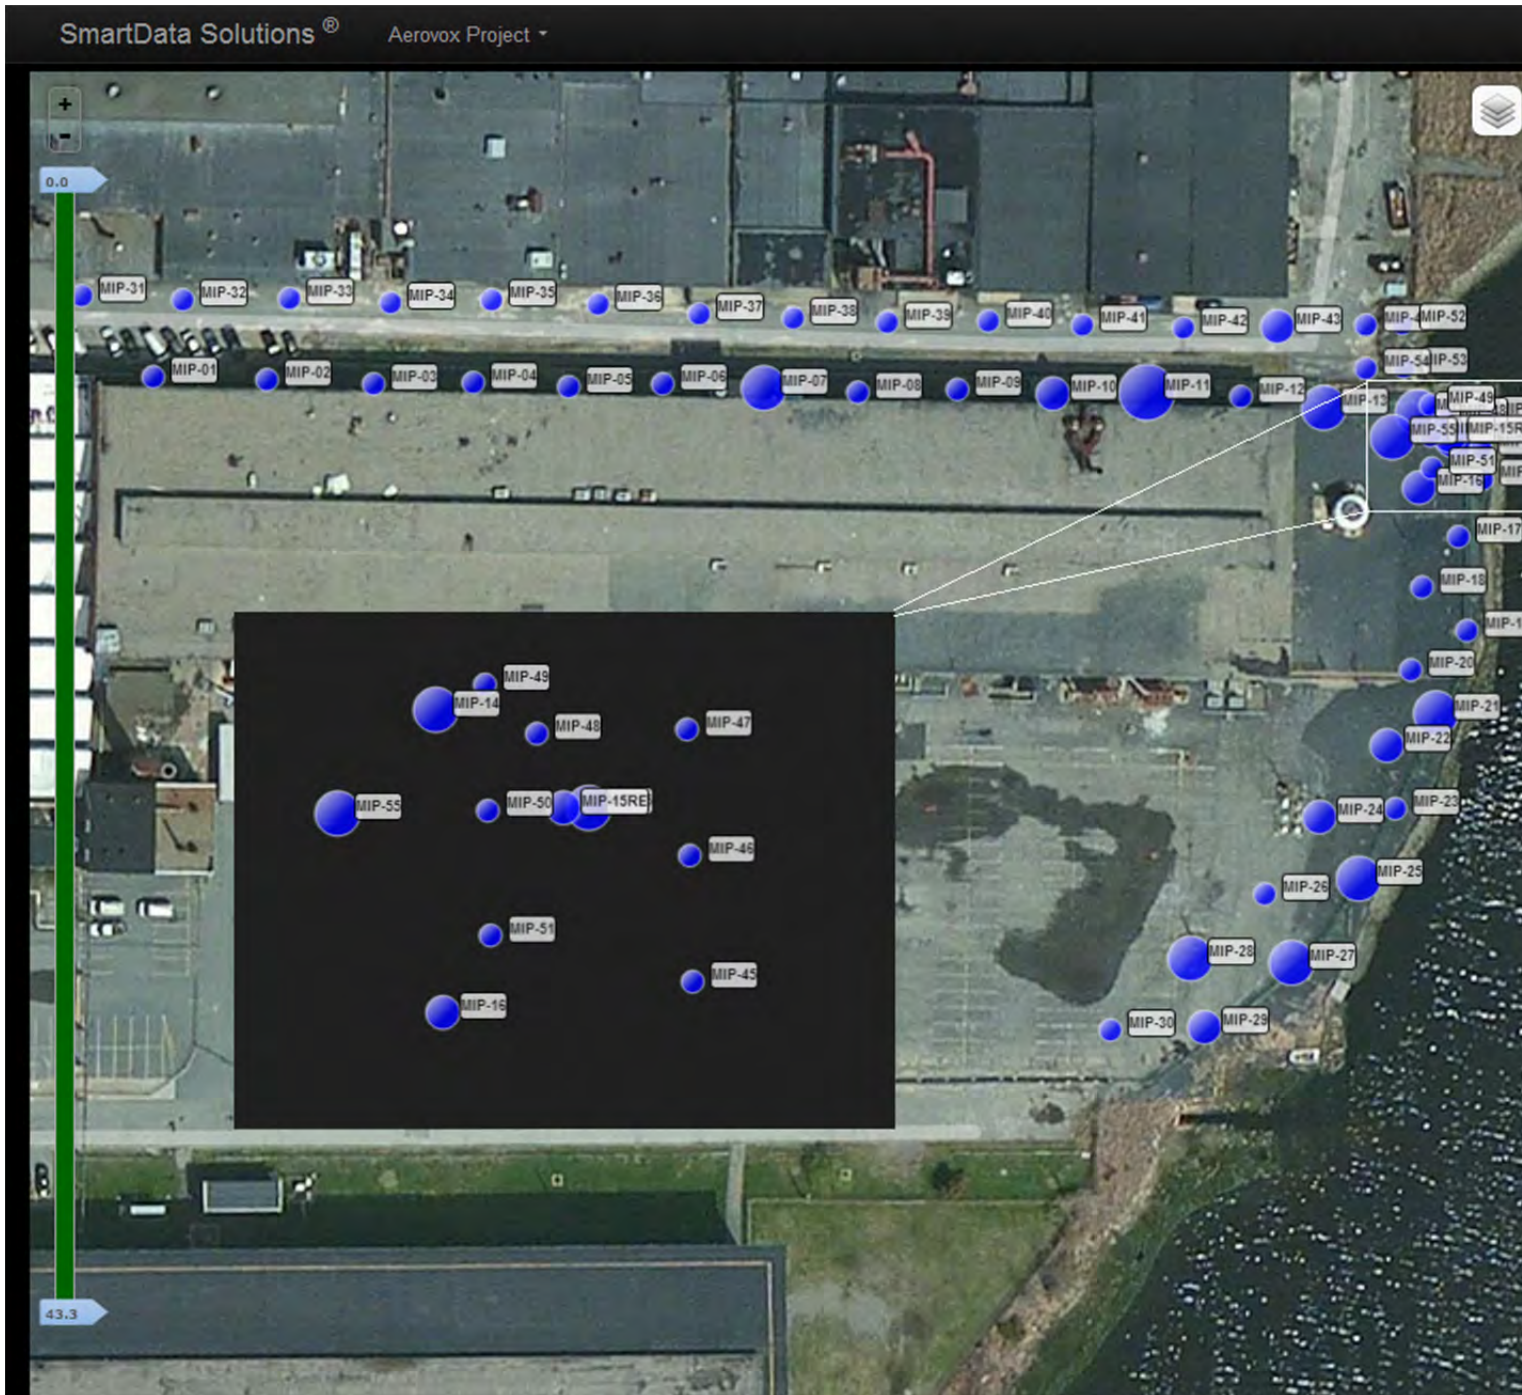
Figure 2 Maximum PID Response in Entire Borehole, Size Graded Icons
 November 18th, 2013 – November 26th, 2013, July 14th, 2014 – July 15th, 2014

- PID 0 to 5.0E+05uV
- PID 5.0E+05uV to 1.0E+06uV
- PID 1.0E+06uV to 5.0E+06uV
- PID 5.0E+06uV and Greater

Additional details, including the full graphs of the PID, FID and XSD readings at each location are provided in the MIP report in Appendix A. A notable decrease in the MIP readings during this investigation was observed compared to the first MIP investigation, conducted in November 2013. During the November 2013 MIP survey, the “background” (non- or less-impacted soils) were represented by XSD readings hovering around the 1.0E+05mV to 3.0E+05mV). As a result, another MIP was advanced adjacent to the MIP-15 location (identified as MIP-15RE) for comparison purposes. A comparison of the two logs indicates that the November 2013 MIP profile readings were approximately 2 to 5 times that of the July 2014 readings. Based on the relative response of the July MIP, locations for subsequent Geoprobe™ boring installation and soil sampling were selected.

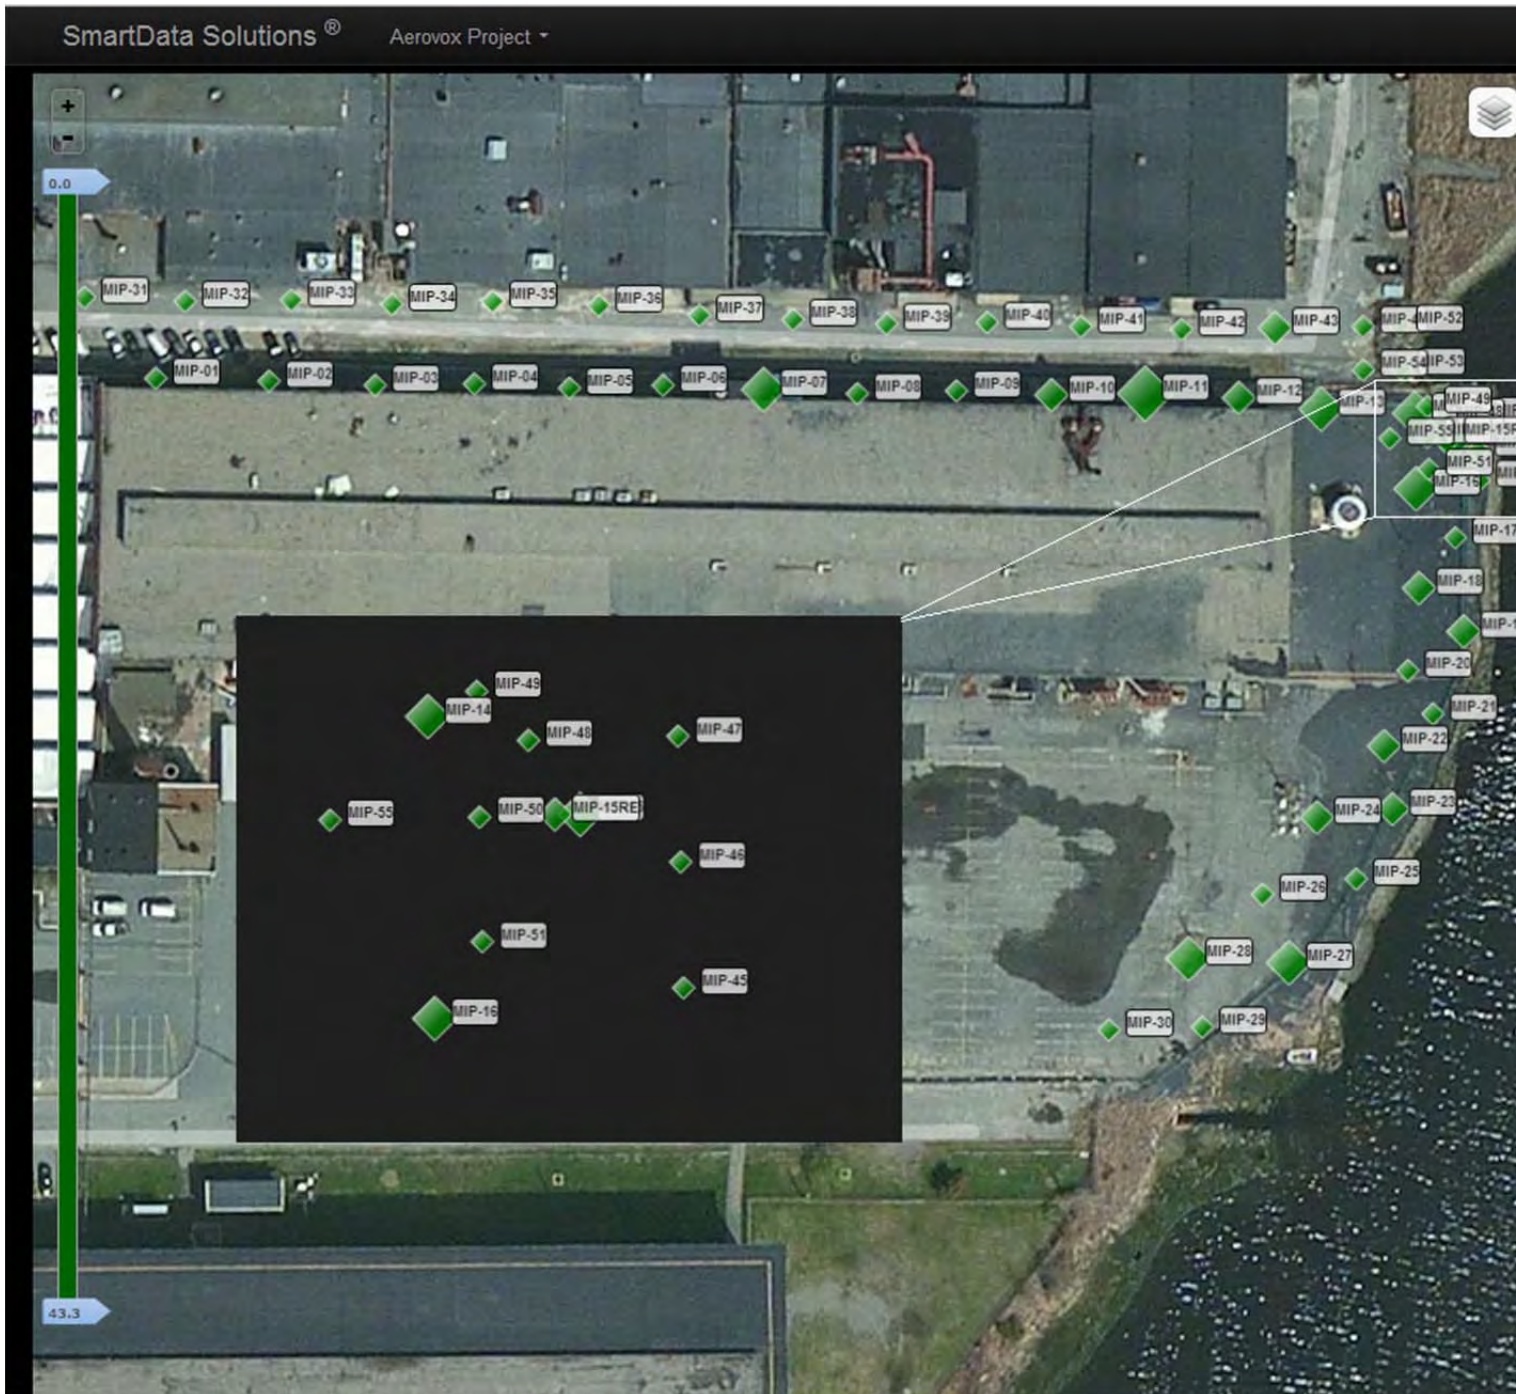
- ◆ XSD 0 to 5.0E+05uV
- ◆ XSD 5.0E+05uV to 1.0E+06uV
- ◆ XSD 1.0E+06uV to 5.0E+06uV
- ◆ XSD 5.0E+06uV and Greater
