IMMEDIATE RESPONSE ACTION
STATUS REPORT #6

FORMER AEROVOX FACILITY
740 BELLEVILLE AVENUE
NEW BEDFORD, MA
RTN 4-0601

February 2016

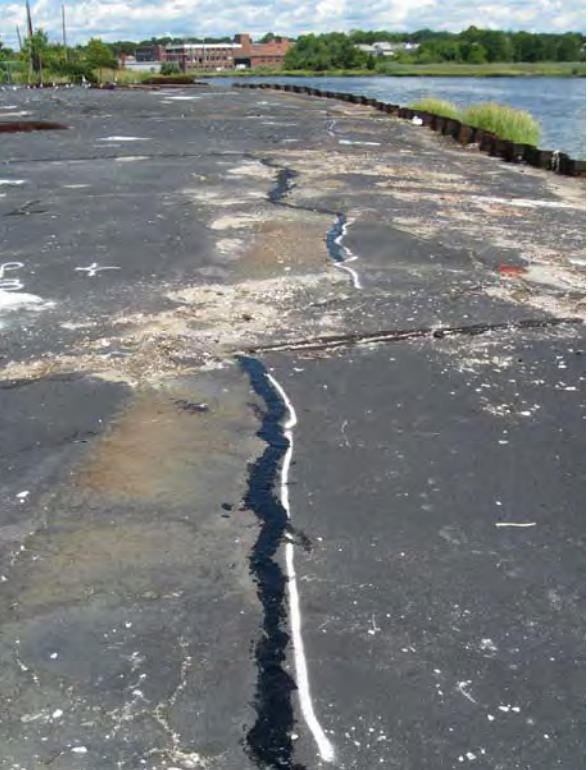
Client Name: AVX Corporation		Site Location: Former Aerovox Property, New Bedford, MA	Project No.: 60422003
Photo No.: 5	Date: Aug. 2015

- Numerous cracks with a width of greater than ½-inch were identified for sealing along the HAC cap area along the shoreline.
- Numerous cracks were identified in the HAC cap with a width of great than ½-inch between the former north drainage ditch north of the former building and the northern fence line.

Direction Photo Taken: North			
Description: Crack sealing of waterfront area.

Based on the above observations, crack sealing and pavement replacement were undertaken at the Site in August 2015. CHES was retained to perform the cap repairs (as summarized above) as well as removal of weeds protruding through the cap surface. These activities were performed by CHES between August 10-13, 2015. All weeds and degraded asphalt removed from the cap during the repair and maintenance activities were placed into 55-gallon drums for off-site disposal. All identified cracks were filled with a commercial grade sealant. All larger areas requiring asphalt removal were refilled and compacted with hot-top asphalt. A memo and photographic log summarizing the cap repair activities is attached in **Appendix H**.

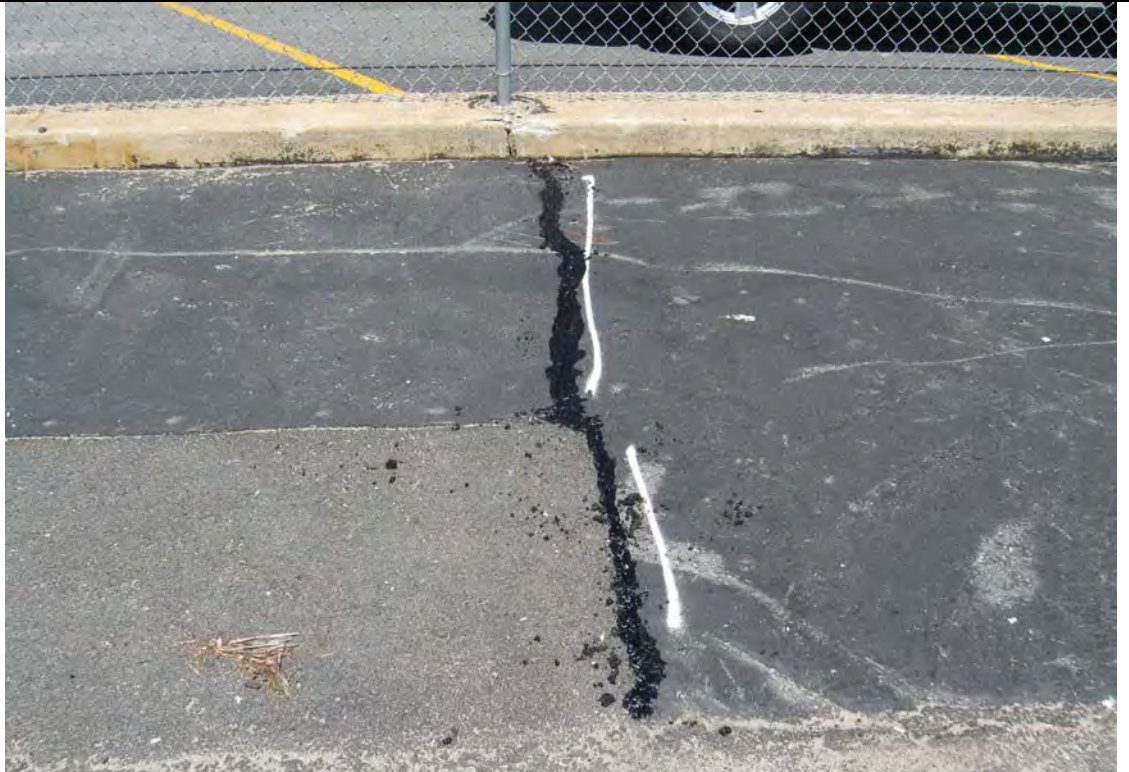
Crack sealing along northern property line.

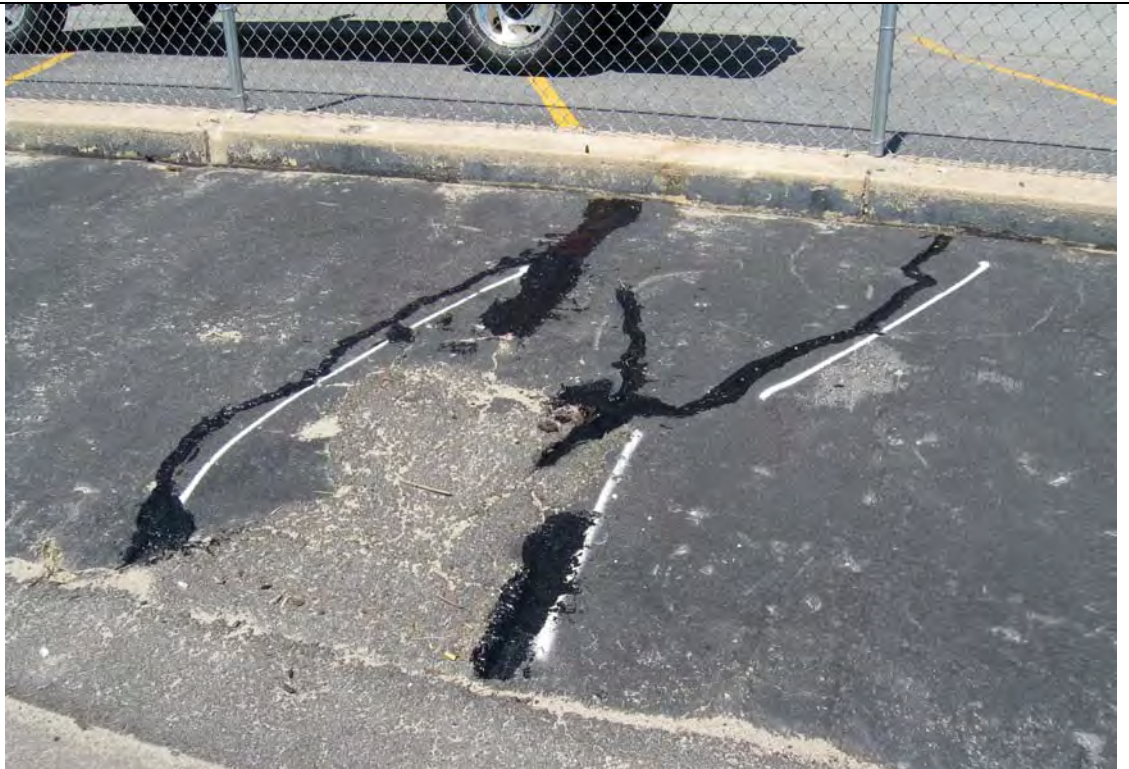
Photo No.:
20

Crack sealing along northern property line.

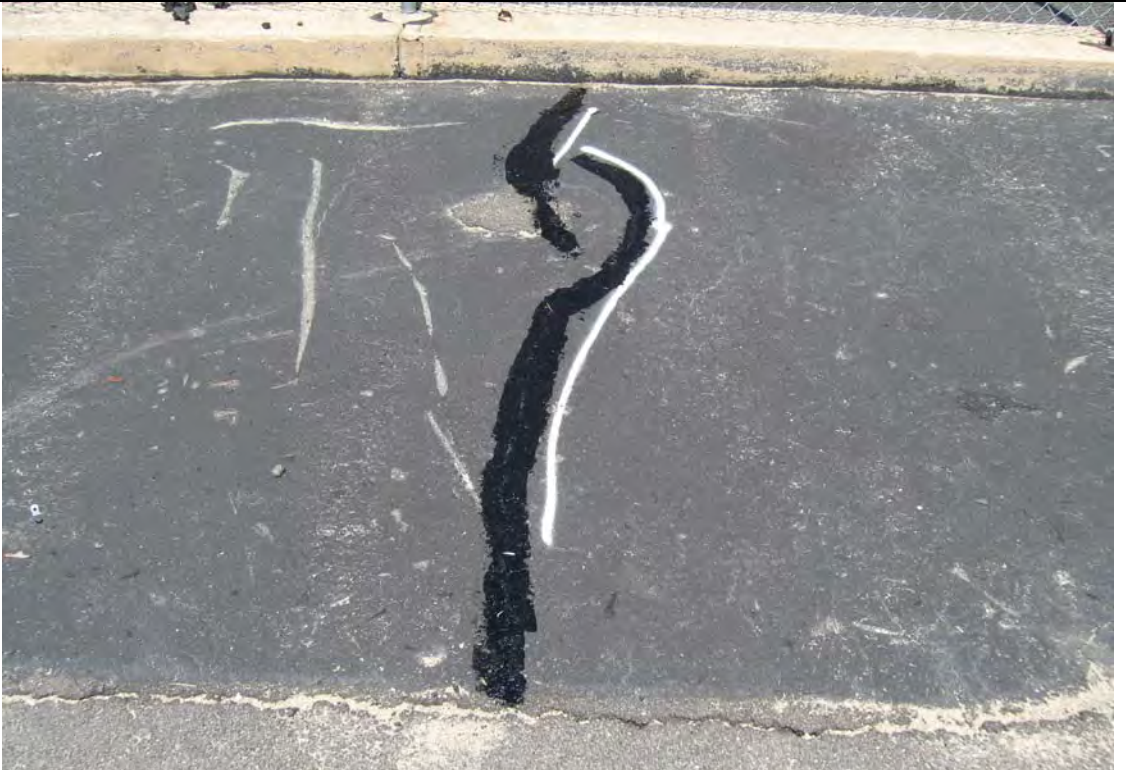
Client Name: AVX Corporation		Site Location: Former Aerovox Property, New Bedford, MA	Project No.: 60422003
Photo No.: 21	Date: Aug. 2015

Direction Photo Taken: North			
Description: Crack sealing along northern property line.

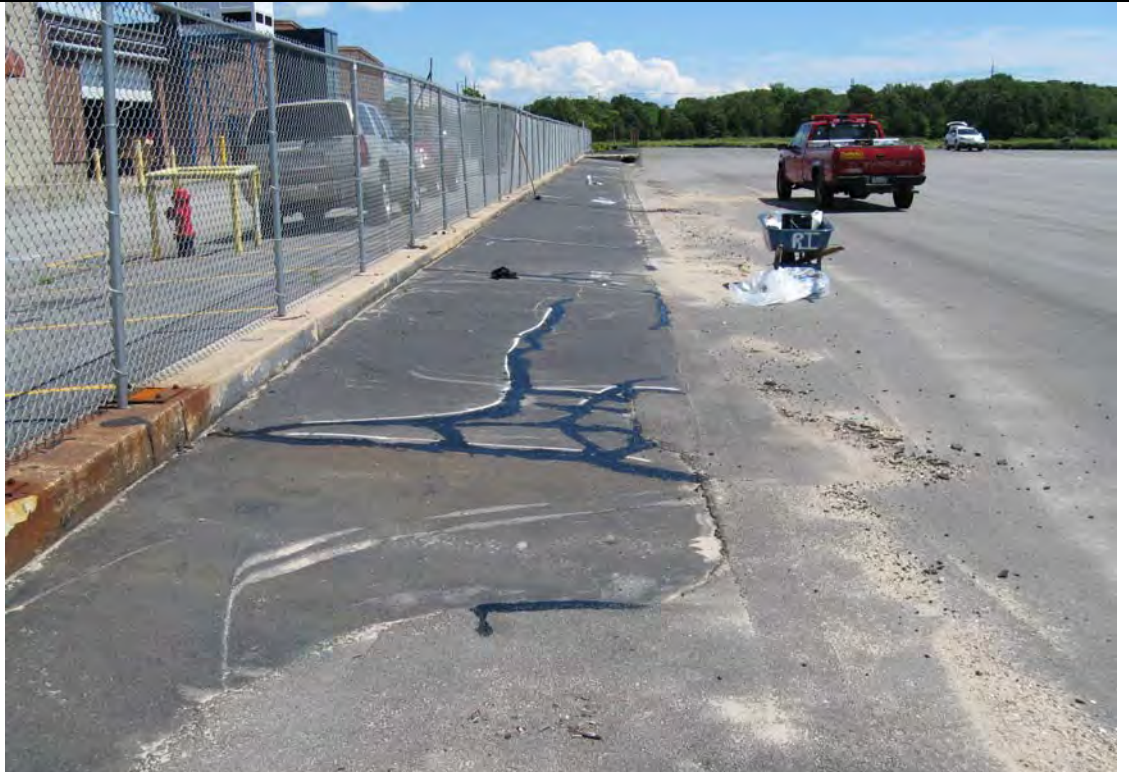
Crack sealing along northern property line.

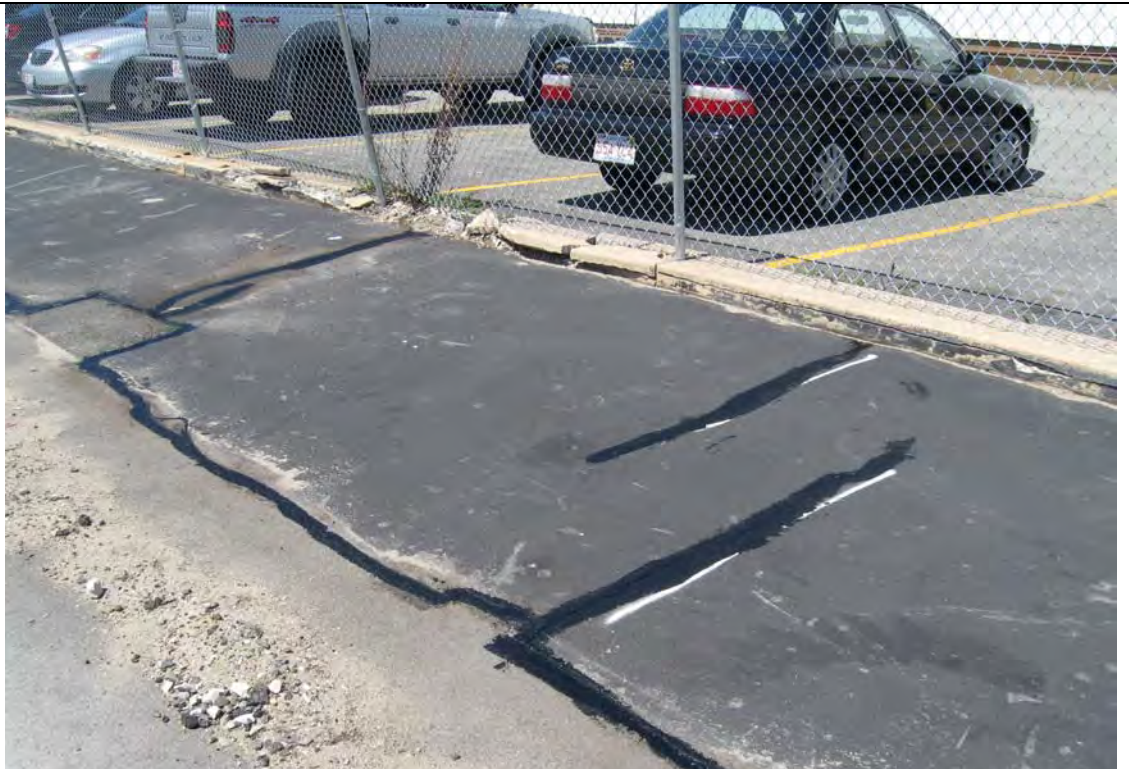
**Photo No.:**
24**Date:**
Aug. 2015**Direction Photo Taken:**

Crack sealing along northern property line.
