S-1758-020
November 11, 2019

Re: **Immediate Response Action (IRA) Status Report**
Gallows Hill Park
Salem, Massachusetts
RTN 3-35355

**Gallows Hill Park
50 Proctor Street
Salem, Massachusetts**

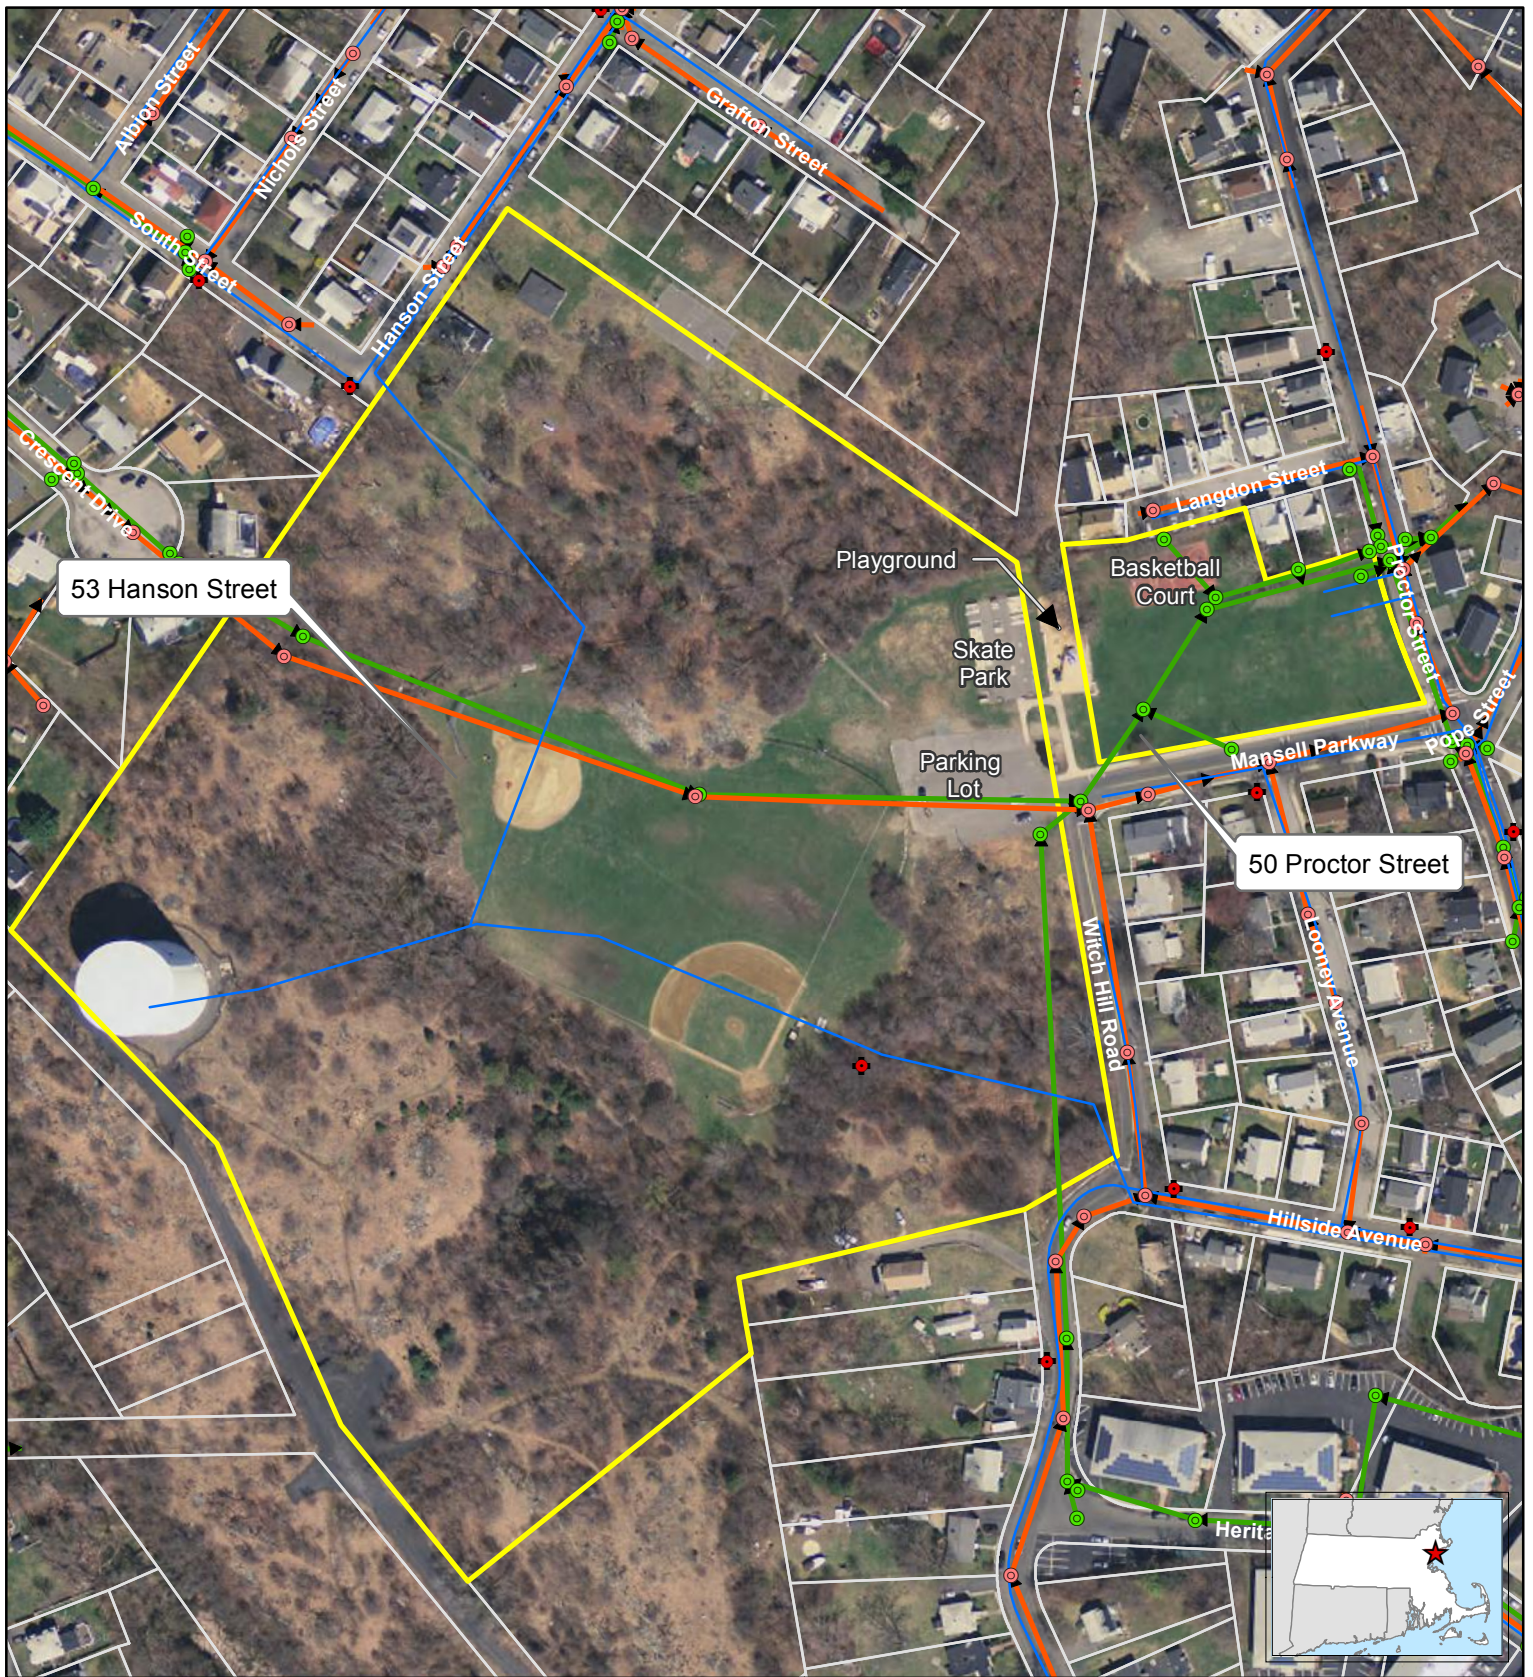
FIGURE 3 ORTHOGRAPH

The Gallows Hills Park area consists of two parcels, listed at 53 Hanson Street (the main park parcel) and 50 Proctor Street (sometimes referred to as Mansell Field). The two parcels are separated by a right-of-way area, which is also owned by the City and part of the park area. These features are depicted on Figure 3.

- Sewer Manholes
- Drain Manholes
- + Hydrants
- Water Mains
- Sewer Pipes
- Drain Pipes
- Approximate Site Parcel

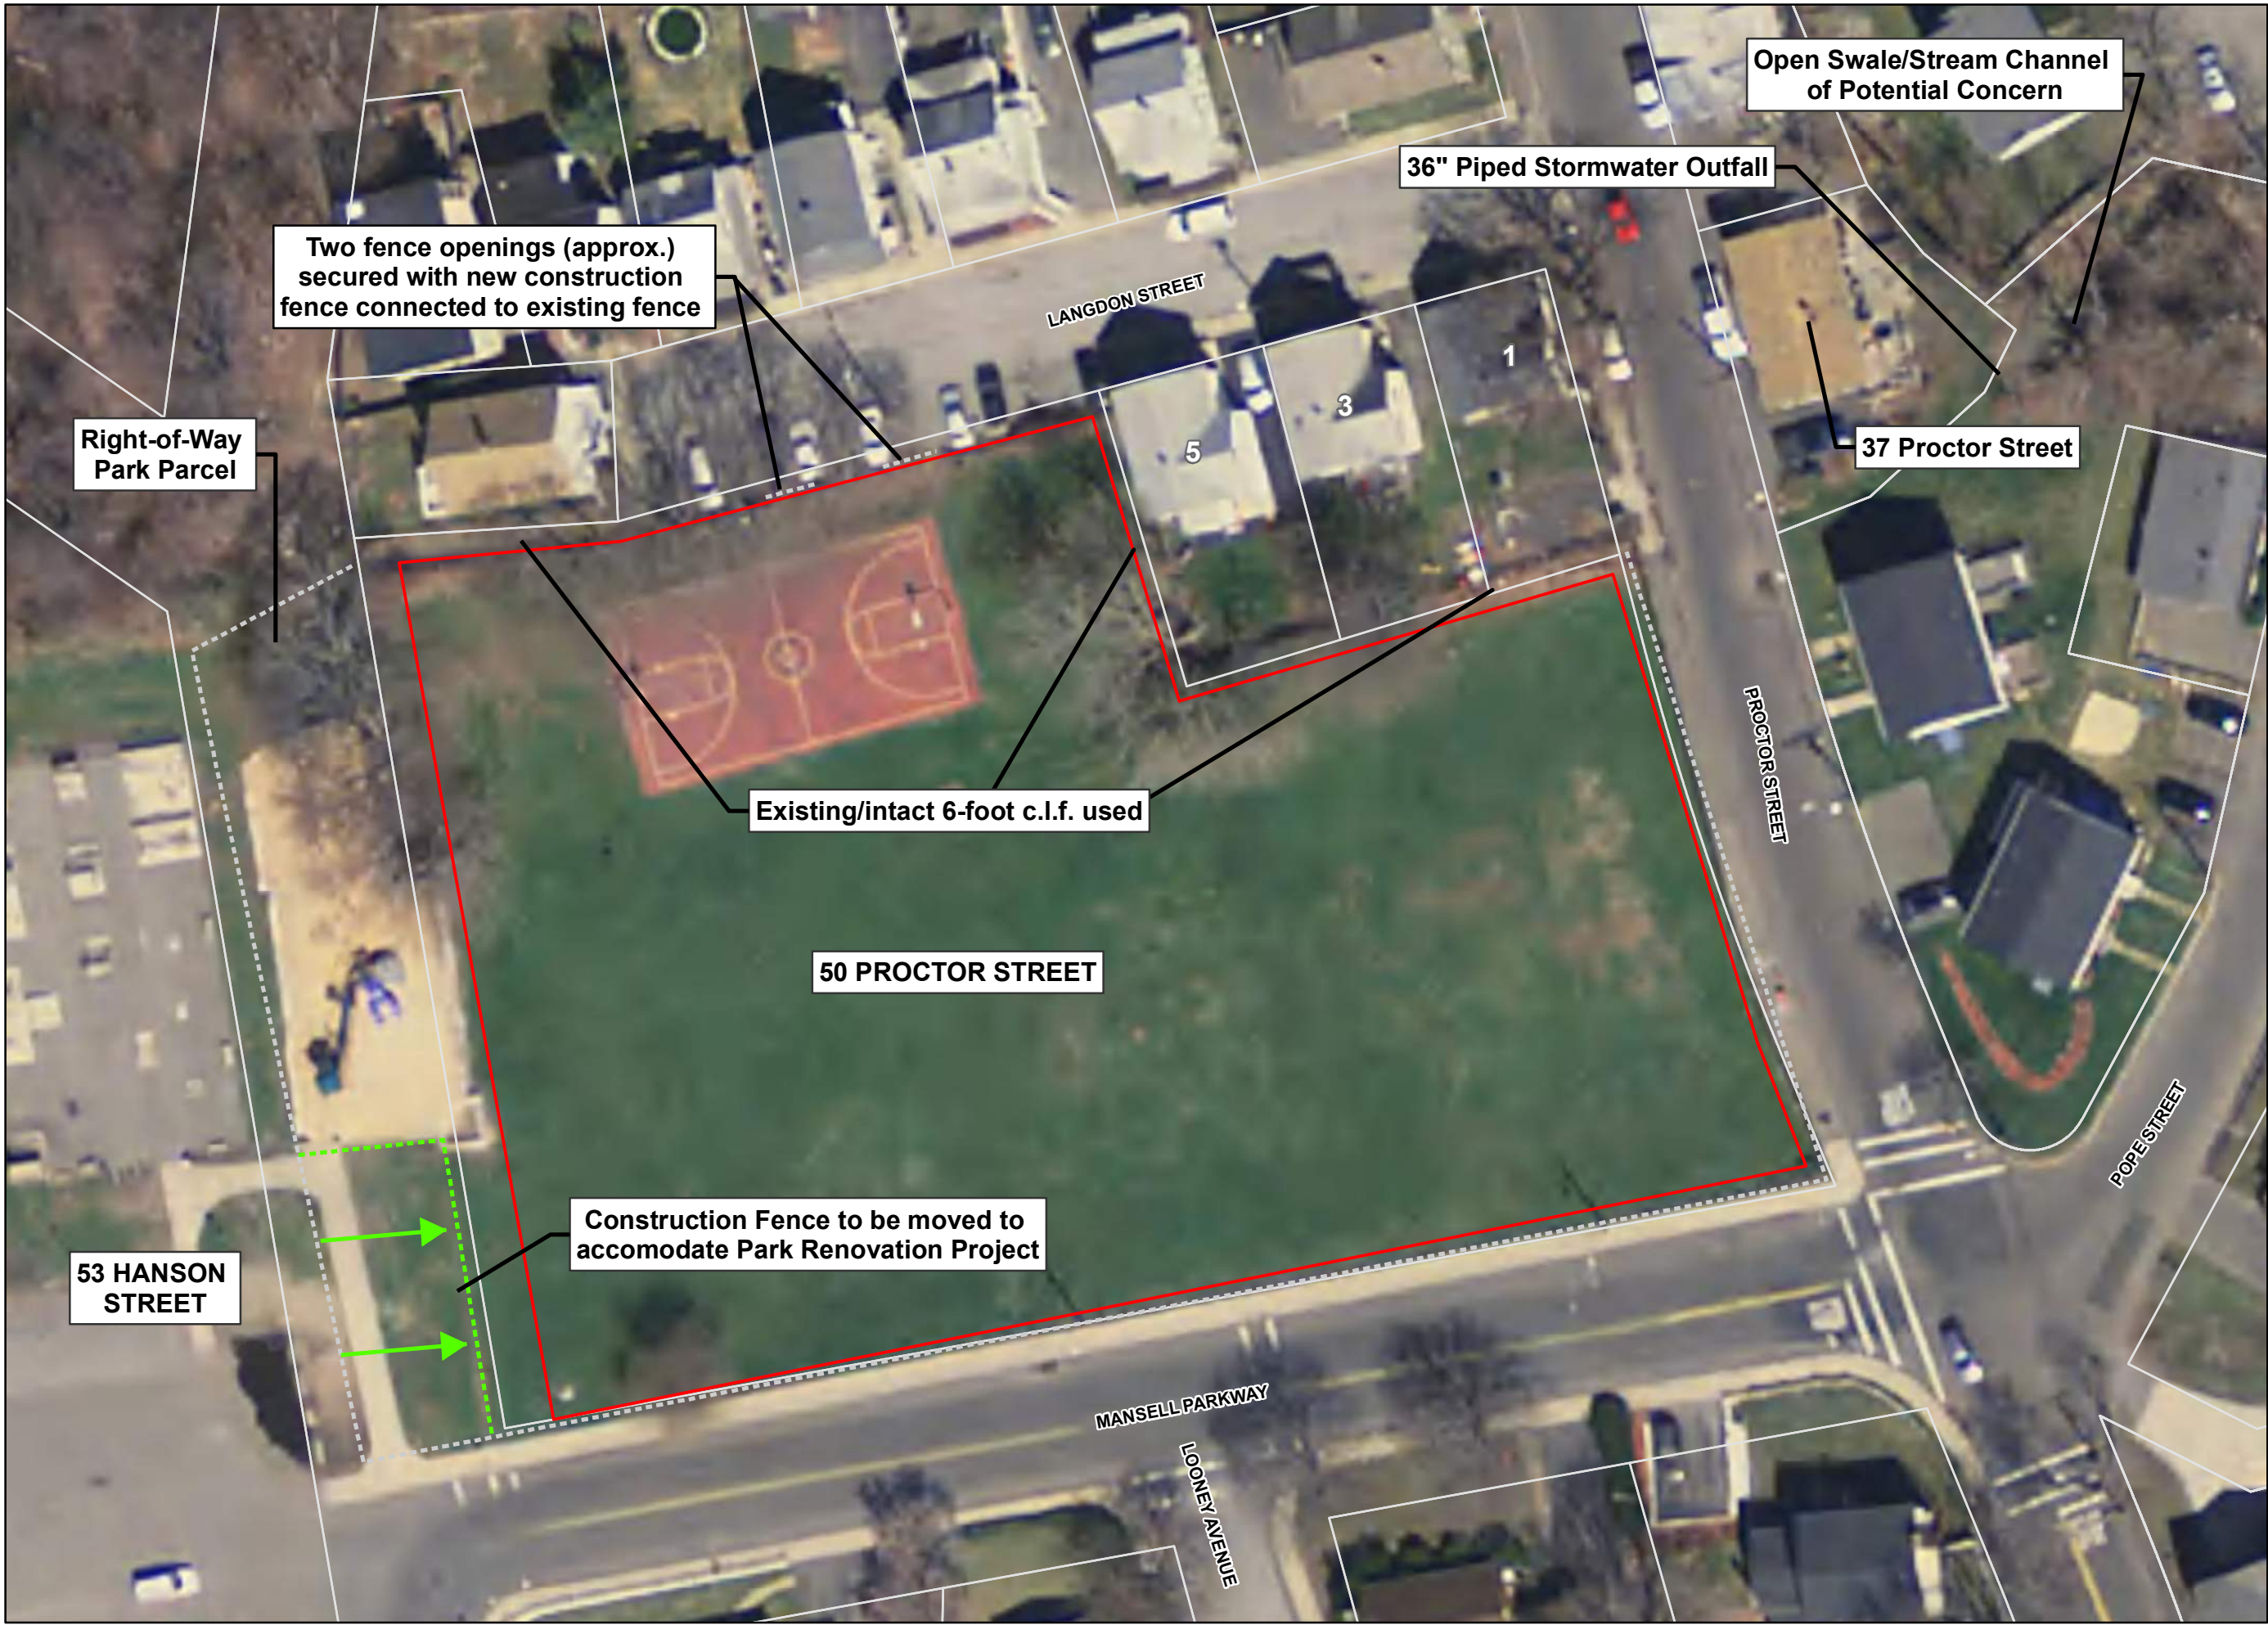
**FIGURE 4
IRA FENCE
MONITORING PLAN**

Fence Maintenance and Monitoring: Consistent with the program reviewed in the September 2019 IRA Status Report submittal, the City has continued their weekly inspections of the temporary construction fencing as part of IRA “maintenance and monitoring program” for the site. Copies of field sheets for the first two inspection events are provided in Appendix D.

It should be also mentioned that MassDEP visited the site with Tighe & Bond on October 21, 2019 and it was noted that one section of the construction fence was missing. Following an email notification between the City, MassDEP, and Tighe & Bond on this date, the City had this fence section area replaced.

- Approximate Location of
construction chain link
fence installation
- Disposal Site Boundary
Subject RTN 3-35355

As documented in earlier submittals, the IRA condition at the site has not been eliminated because the construction fence is "temporary" in nature, and therefore the IH condition in site soils is still a concern that requires continued monitoring and maintenance until either permanent fencing is installed and/or cleanup response actions are completed. Therefore, the City will continue the fence maintenance and monitoring program, until either a permanent fence is installed and/or site remediation occurs.

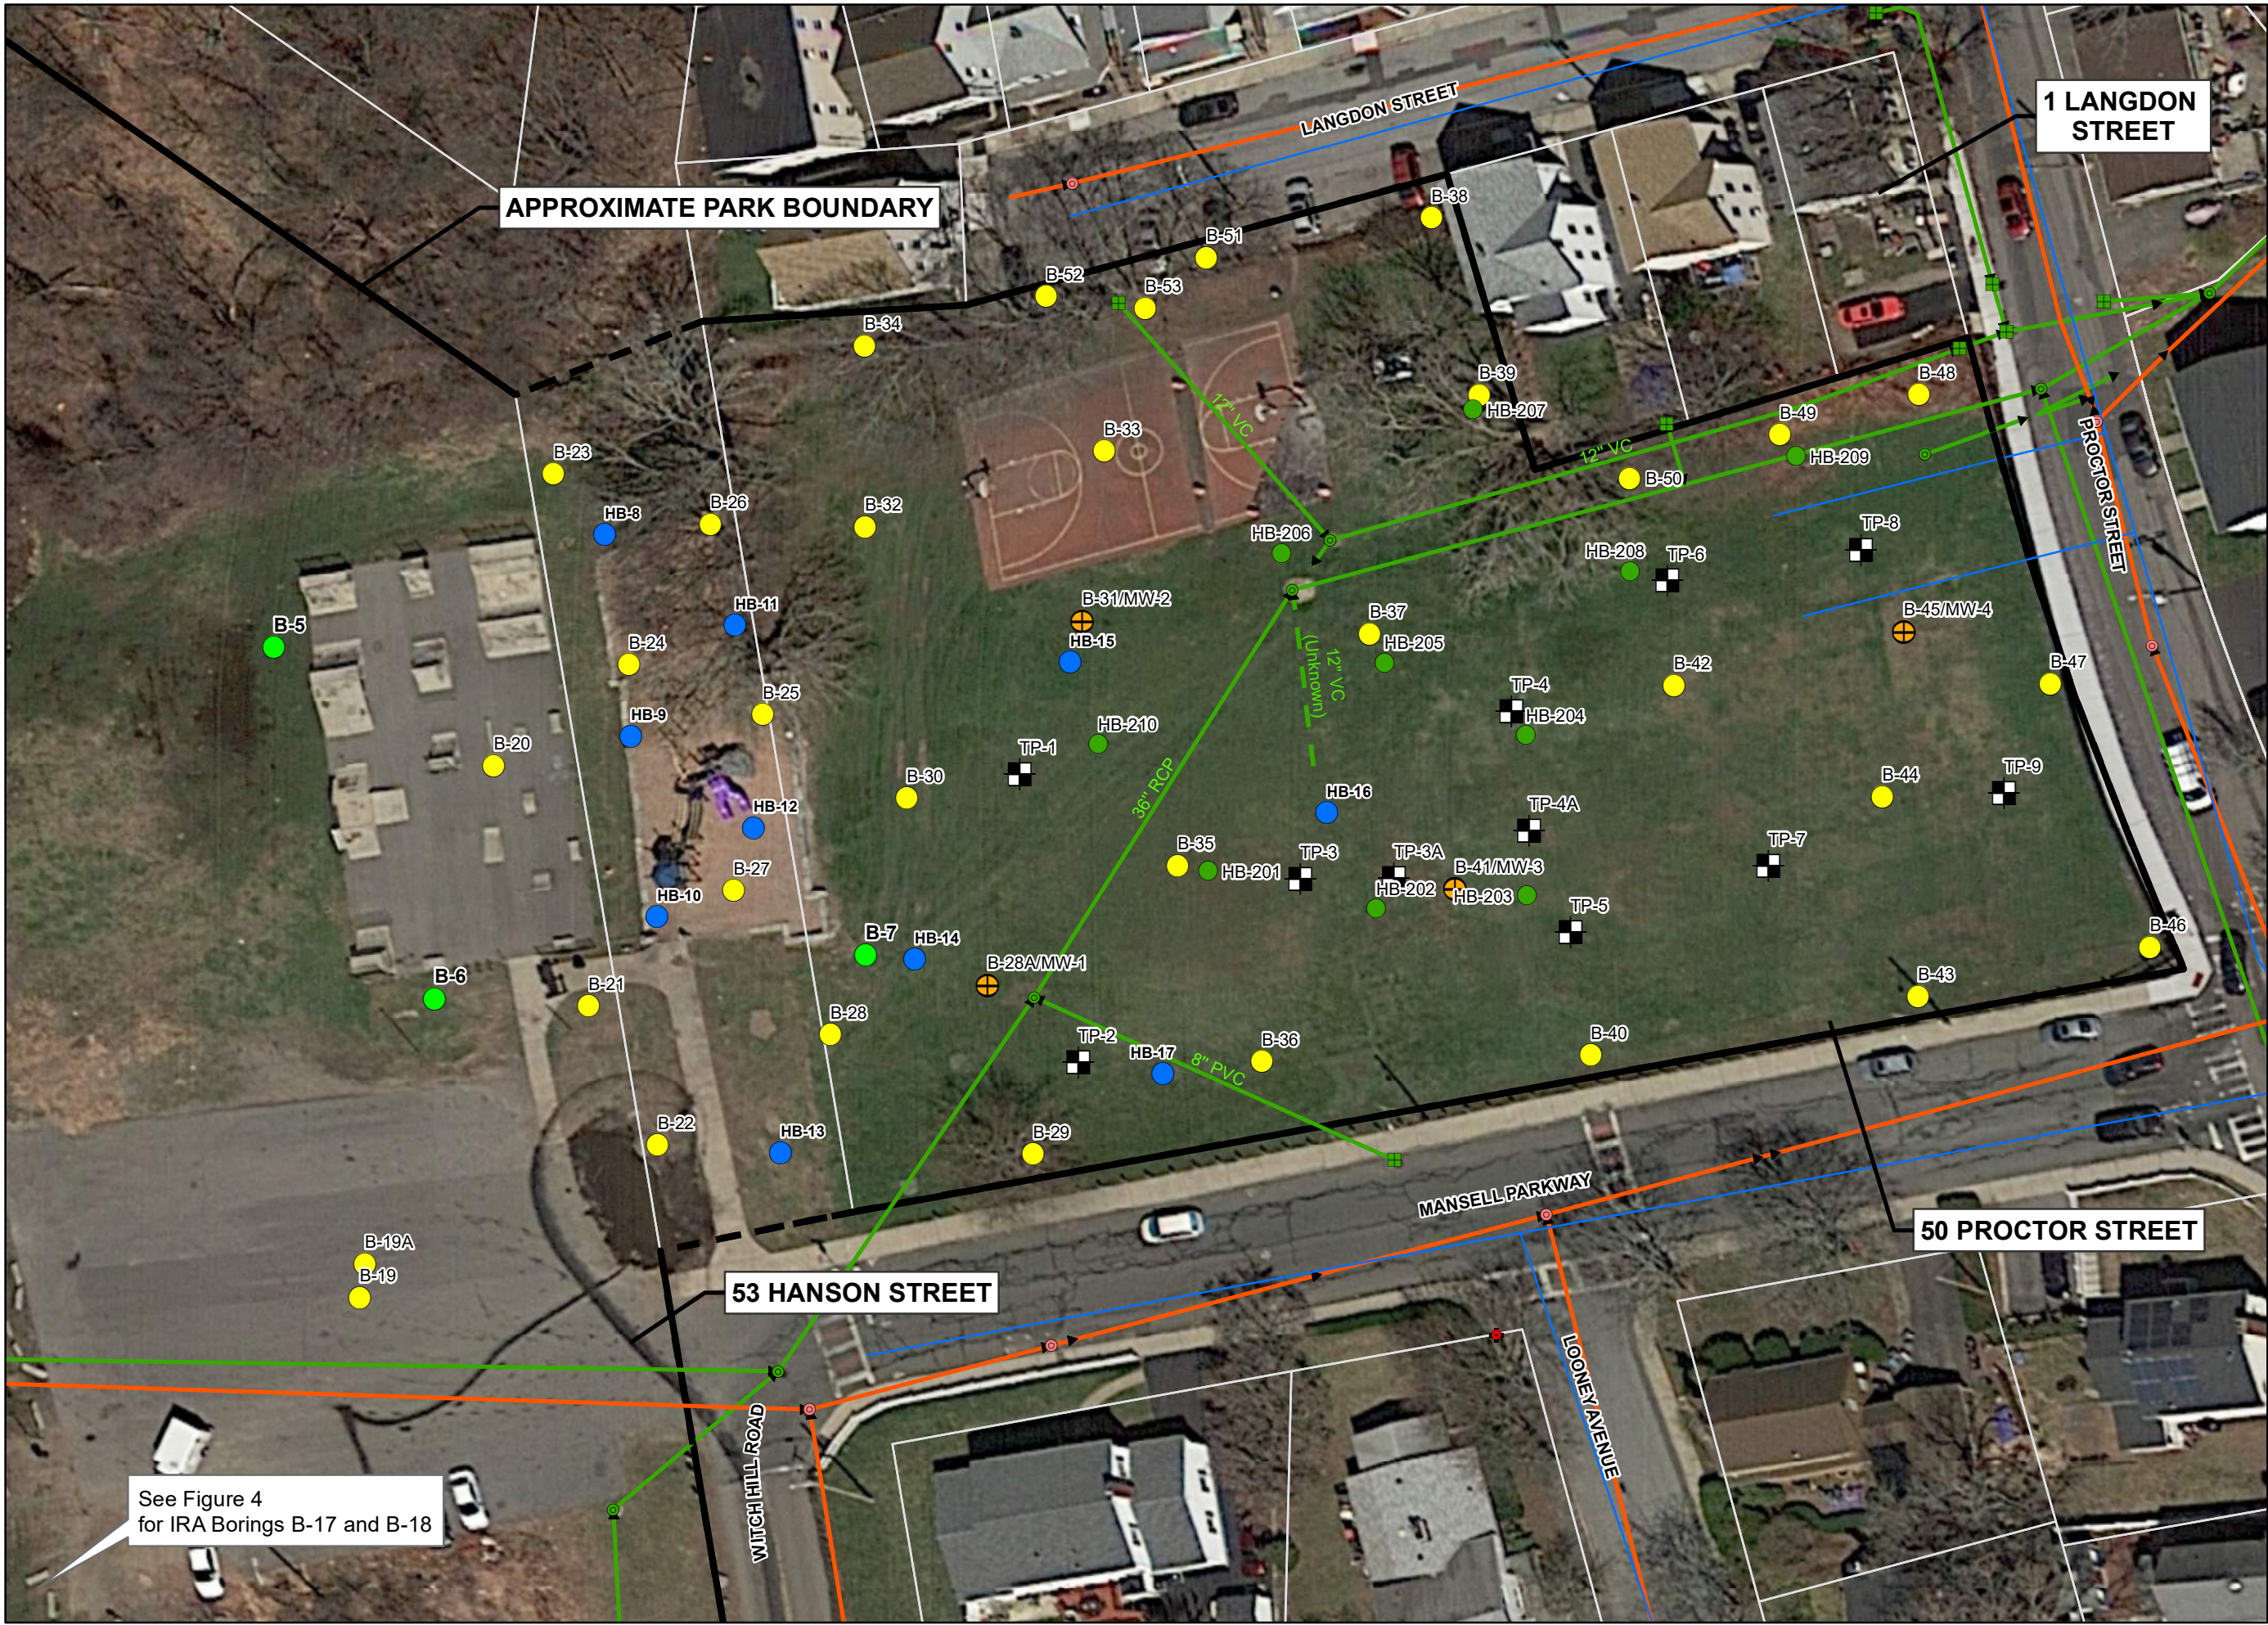
FIGURE 5
Preliminary In-Situ Disposal
Characterization Sampling
Plan

On October 21, 2019, Tighe & Bond personnel collected 10 soil samples (HB-201 through HB-210) from the subject site in areas where total arsenic concentrations had previously been detected at concentrations above 500 milligrams per kilogram in shallow soils. During this event, Tighe & Bond surveyed the approximate sampling locations using a Global Positioning System (GPS) unit with sub-meter accuracy. The approximate locations of these additional shallow soil samples are depicted on Figure 5 in Appendix A.

The soil samples were collected using hand tools from the top two feet (or less) from below the grass and organic layer in these areas. Between sampling locations, the equipment was wiped down and then washed with a brush and non-phosphate detergent (i.e.,alconox) solution. Each sample was submitted for toxicity characteristic leaching procedure (TCLP) analysis for arsenic.

- October 2019 Hand Borings for Preliminary Soil Disposal Characterization
- IRA Soil Boring
- IRA Boring Completed as Well
- IRA Test Pit
- Earlier Hand Boring Location (Approximate)
- Earlier Drilling Location (Approximate)
- Approximate Park Boundary

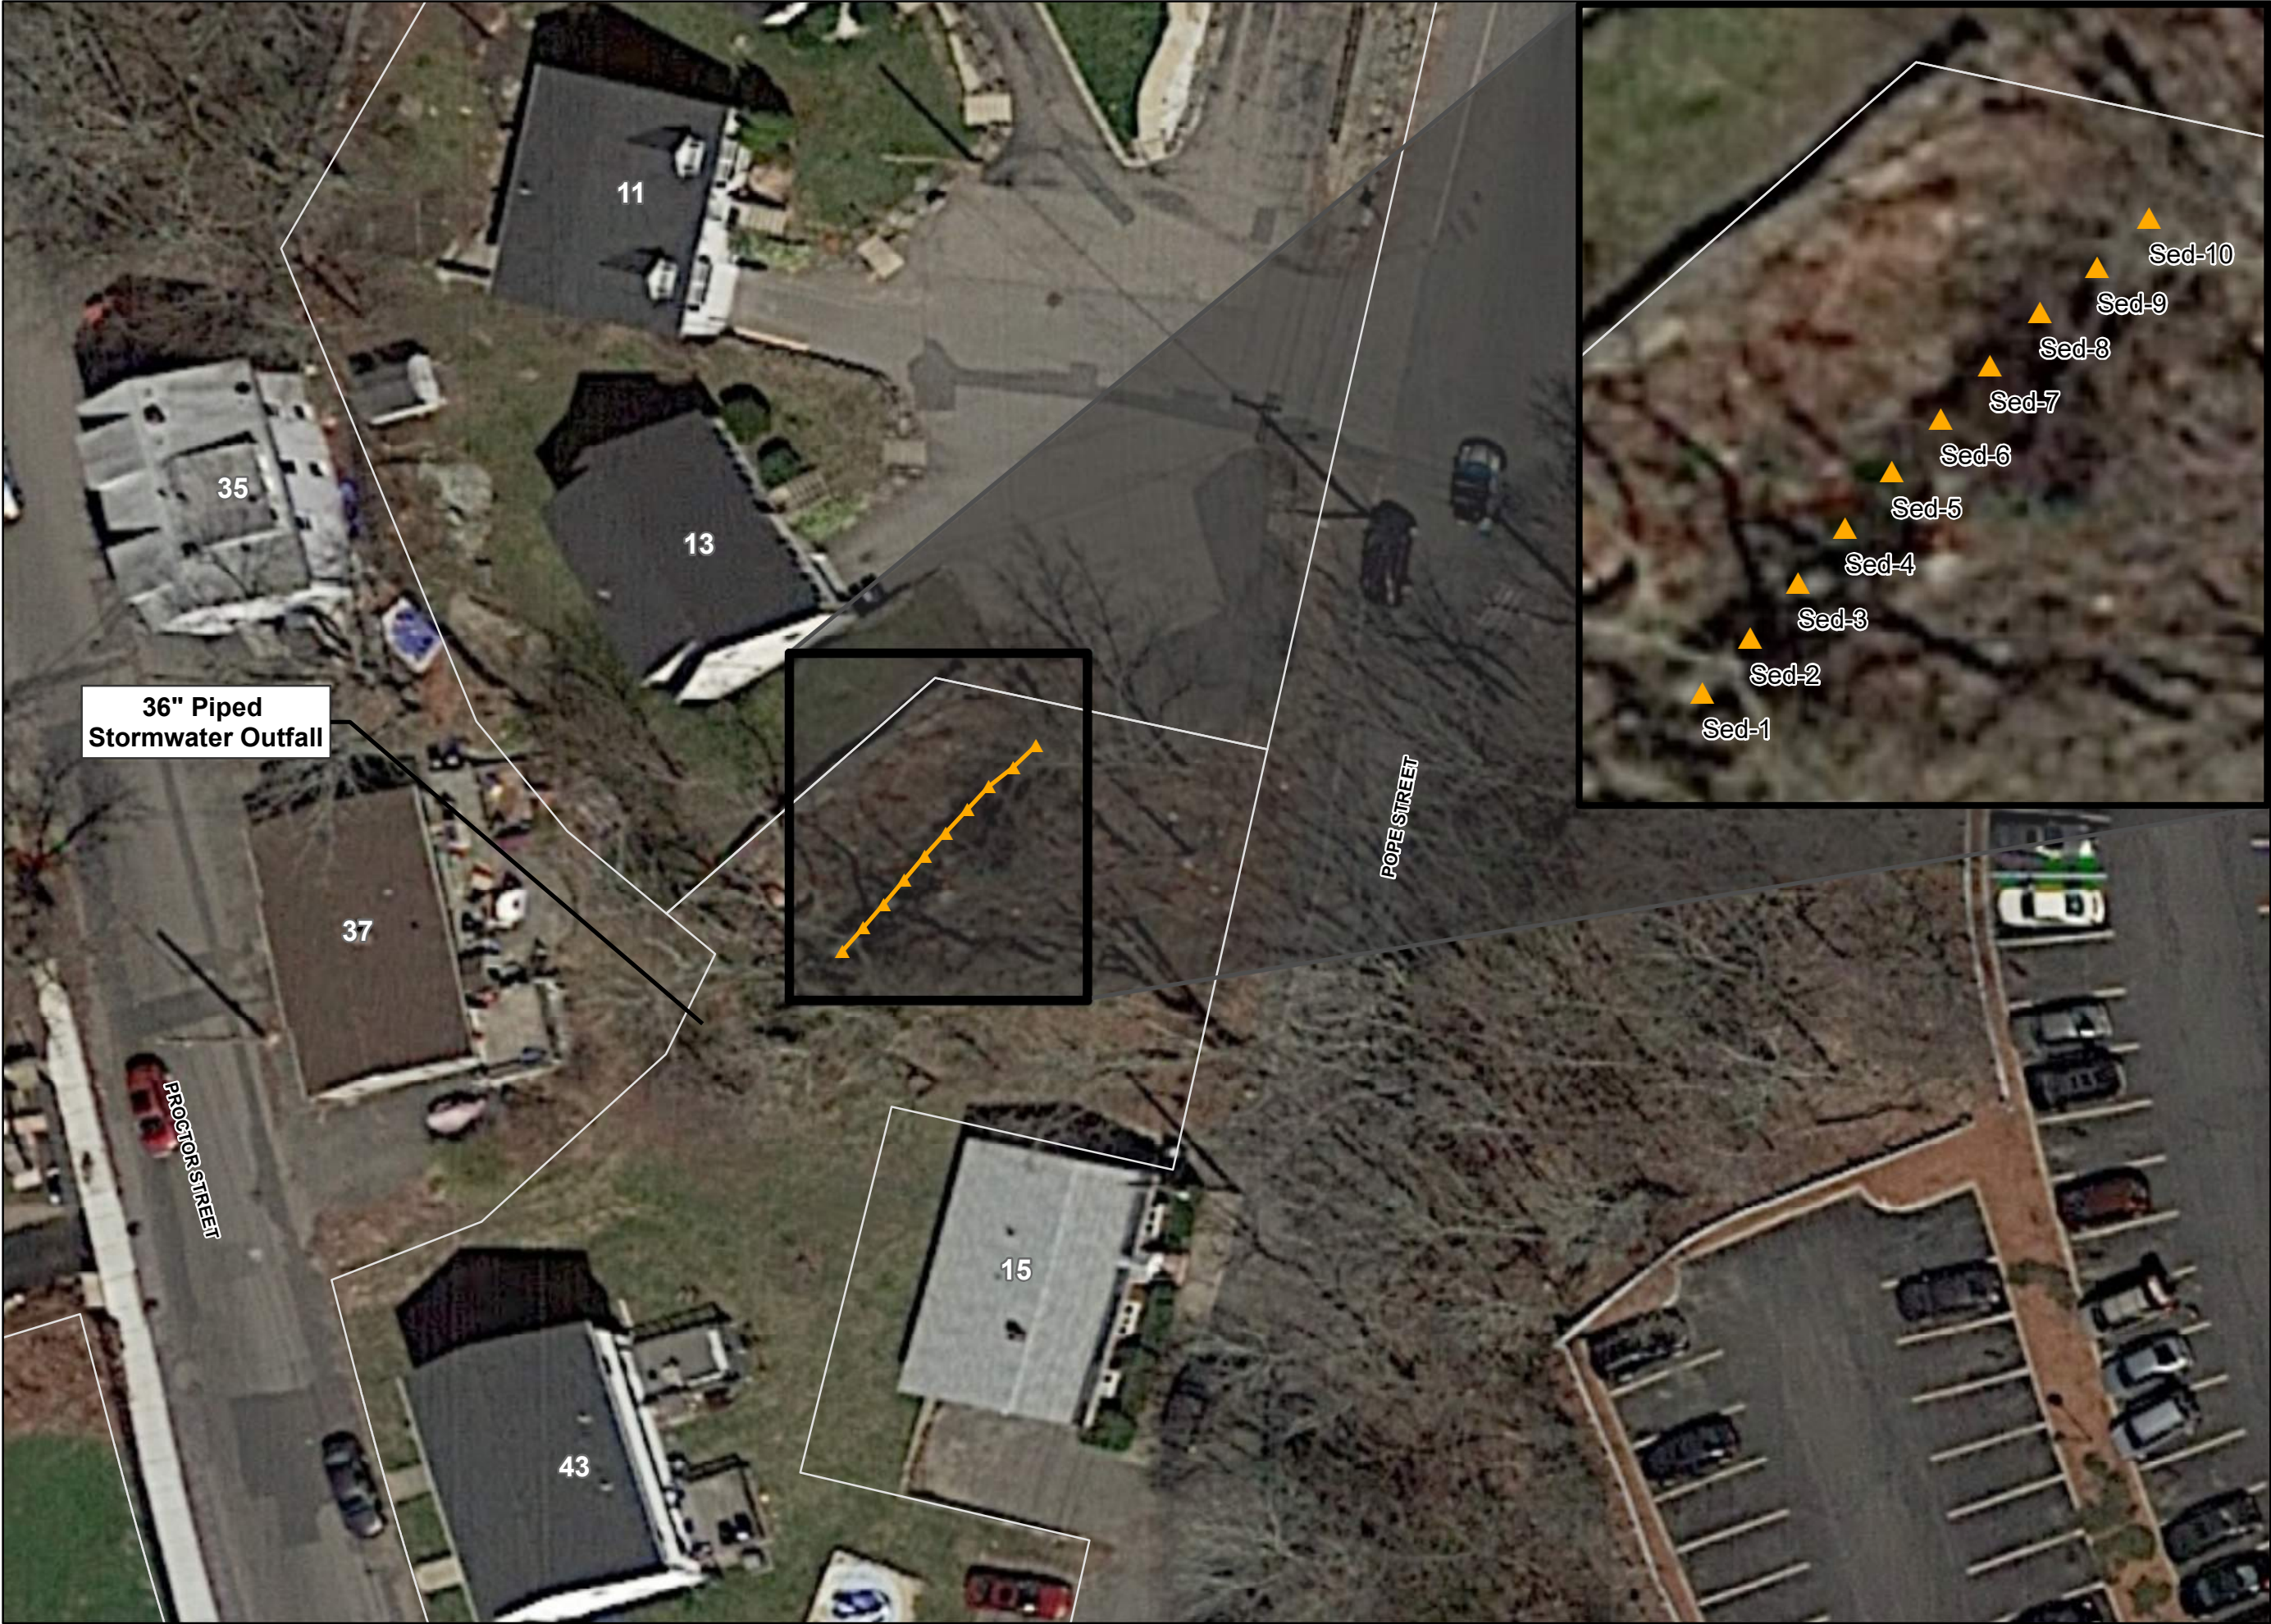
FIGURE 6
Off-Site Drainage
Swale Sampling Plan

Tighe & Bond collected 10 sediment samples (ID: SED-1 through SED-10) from the swale. The base of this open "stream channel" is approximately 50 feet in length, and sampling was conducted from "downstream to upstream" at approximate 5-foot intervals. The approximate locations of the samples are depicted on the Off-Site Sediment Sampling Plan provided as Figure 6 in Appendix A. At the time of this event, the water level in the drainage swale was generally 6 to 10 inches in depth, with slightly deeper depths where the drainage swale begins (i.e., at the discharge culvert for the stream). The width of the surface flow within the drainage swale was generally between approximately 3 and 4 feet, as it narrows to the

approximate 18-inch concrete effluent culvert pipe on the downstream portion of the drainage swale. In general, no stagnant water was observed in the swale. The steep bank areas surrounding the base of the drainage swale generally consists of rip-rap rock and/or small boulders, with overgrown vegetation.

Using dedicated scoopulas , Tighe Bond collected sediment samples from approximately 0 to 6-inches below surface grade at each location. In general, the sample descriptions were very consistent at each location (except SED-1), with sediment samples generally consisting of coarse sand, some gravel and trace silt. At sample SED-1 location, fine to coarse sand, little gravel, and trace silt were encountered. No organics were encountered in the sediments at each location.

▲ Approximate Sediment Sample Location
