Subject: Notice of Placement in Public Repositories
Protective Cover Monitoring Plan (PCMP) Inspection Report No. 31
W.R. Grace & Co. Properties
62 Whittemore Avenue, One Alewife Center, 134 Alewife Brook Parkway
Cambridge, Massachusetts
RTNs 3-0277 and 3-3411

Project Location	W.R. Grace & Co.-Conn. 62 Whittemore Avenue, One Alewife Center, 134 Alewife Brook Parkway	Report No.	31
Address	Cambridge, Massachusetts	Date	22 March 2012
Client	W.R. Grace & Co.	Page	1 of 6
Weather	Clear	File No.	10063-066
Field Rep.	Jennifer Sweet, Dave Croce	Temperature	60s°
LSP	John R. Kastrinos, P.G., LSP

PROTECTIVE COVER MONITORING PLAN INSPECTION REPORT

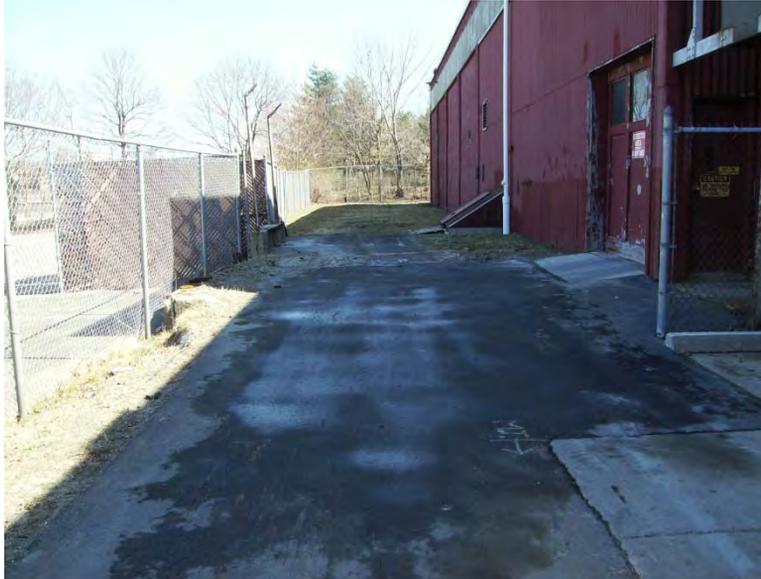
A1-1

Yes No Are there bare spots, signs of erosion, or large potholes in pavement? (If yes, attach photographs and figure showing location and extent): Describe eroded area or areas of potholes: Three excavations were completed within Area 1 to make emergency repairs to underground piping and valves of the existing building sprinkler system, a backflow preventer valve, and a small sinkhole during the period September to December 2011 (these areas are shown on the attached figure). The excavations were completed under a URAM (RTN 3-30341). The protective cover was replaced/repared in each excavation area, which included recent paving (see attached photos).
