**REMOVAL PROGRAM
PRELIMINARY ASSESSMENT/
SITE INVESTIGATION REPORT
FOR THE
AEROVOX SITE
NEW BEDFORD, BRISTOL COUNTY, MASSACHUSETTS
2 AUGUST 2007 AND 15 THROUGH 16 AUGUST 2007**

U.S. Environmental Protection Agency
Region I
Emergency Planning and Response Branch
1 Congress Street, Suite 1100
Boston, MA 02114-2023

Weston Solutions, Inc.
Region I
Superfund Technical Assessment and Response Team III (START)
3 Riverside Drive
Andover, MA 01810

November 2007

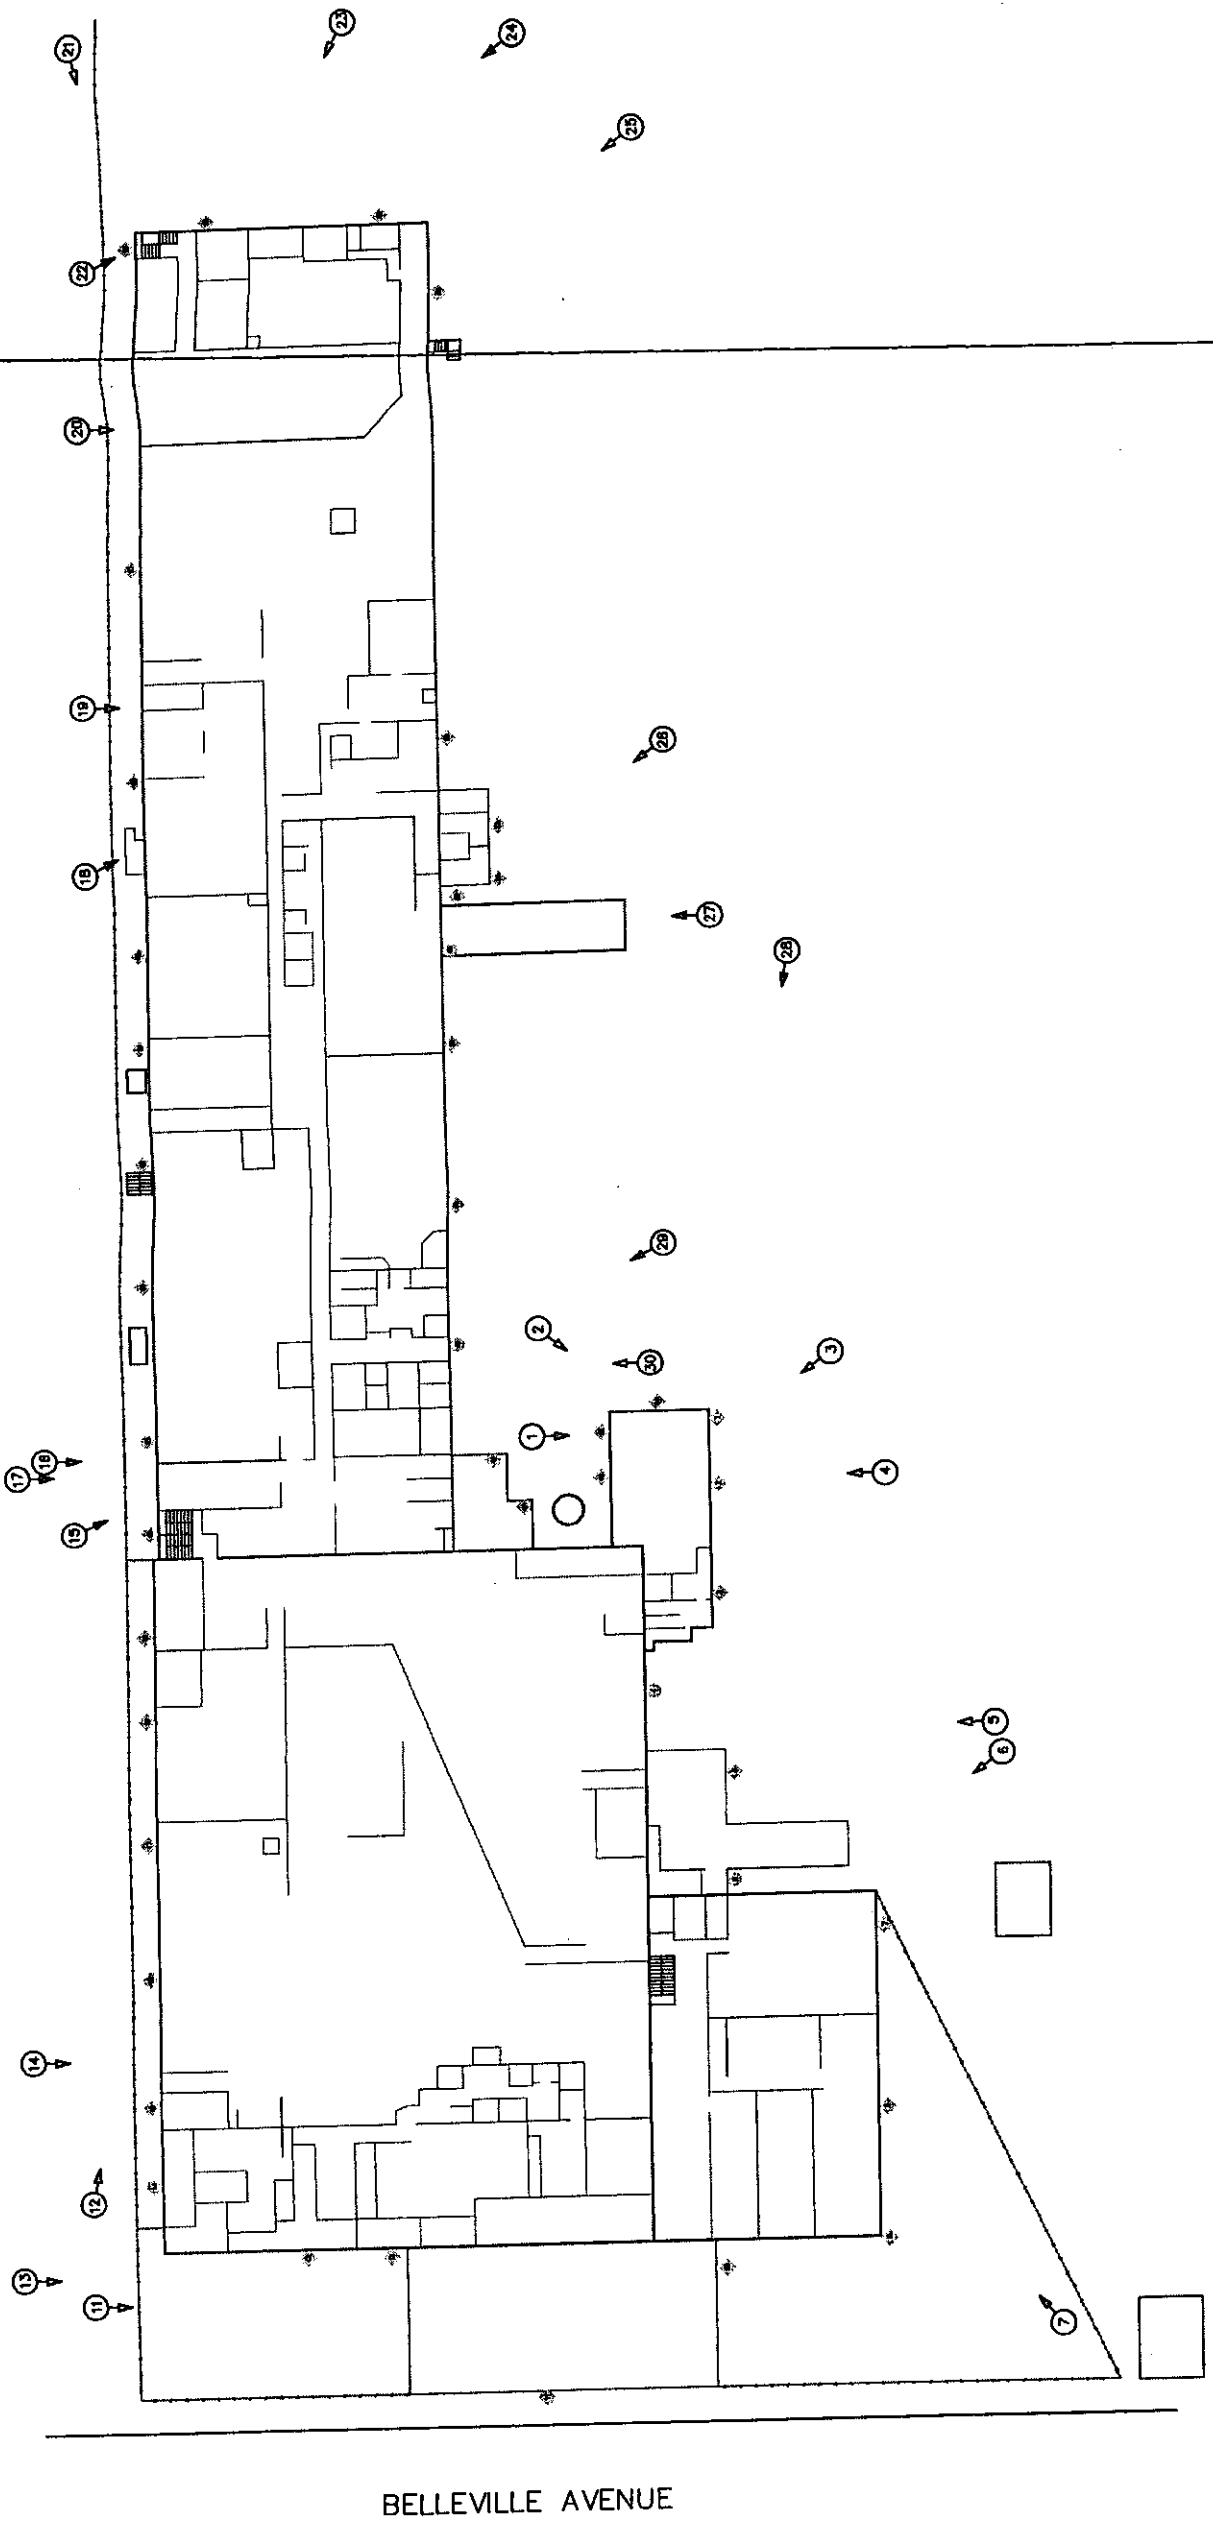
FILE NAME: R:\07070007\Fig3.DWG
FIGURE 3

LOCATION	DESCRIPTION
1A	BOILER ROOM - ELEVATED MERCURY READINGS (>50,000 ng) ON FLOOR AND IN PIPE CHASE.
1B	VISIBLE MERCURY ON PALLET AND FLOOR (FLOOR MARKED WITH SPRAY PAINT).
1C	DISMANTLED IGNITONS & VISIBLE MERCURY ON FLOOR (FLOOR MARKED WITH SPRAY PAINT).
1D	VISIBLE MERCURY IN FLOORING - ELEVATED READINGS (FLOOR MARKED WITH SPRAY PAINT).
1E	LOCATION OF TWO INTACT IGNITONS (EQUIPMENT MARKED WITH SPRAY PAINT).
1F	CARDBOARD BOX ON PALLET CONTAINING BROKEN FLOW METER (FLOOR MARKED WITH SPRAY PAINT).
2A	FORMER LOCATION OF FIBER DRUM - ELEVATED READINGS (FLOOR MARKED WITH SPRAY PAINT).
2B	BROKEN THERMOMETER ON FLOOR - ELEVATED READINGS (FLOOR MARKED WITH SPRAY PAINT).
