### **FINAL REPORT** FOR **254 OLD GREAT ROAD PROPERTY** PRELIMINARY ASSESSMENT NORTH SMITHFIELD, RHODE ISLAND

Prepared For: U.S. Environmental Protection Agency Region I Office of Site Remediation and Restoration 5 Post Office Square, Suite 100 Boston, MA 02109-3912

Submitted by: Weston Solutions, Inc. Region I Superfund Technical Assessment and Response Team IV (START) 101 Billerica Avenue, Building 5, Suite 103 North Billerica, Massachusetts 01862 March 2017

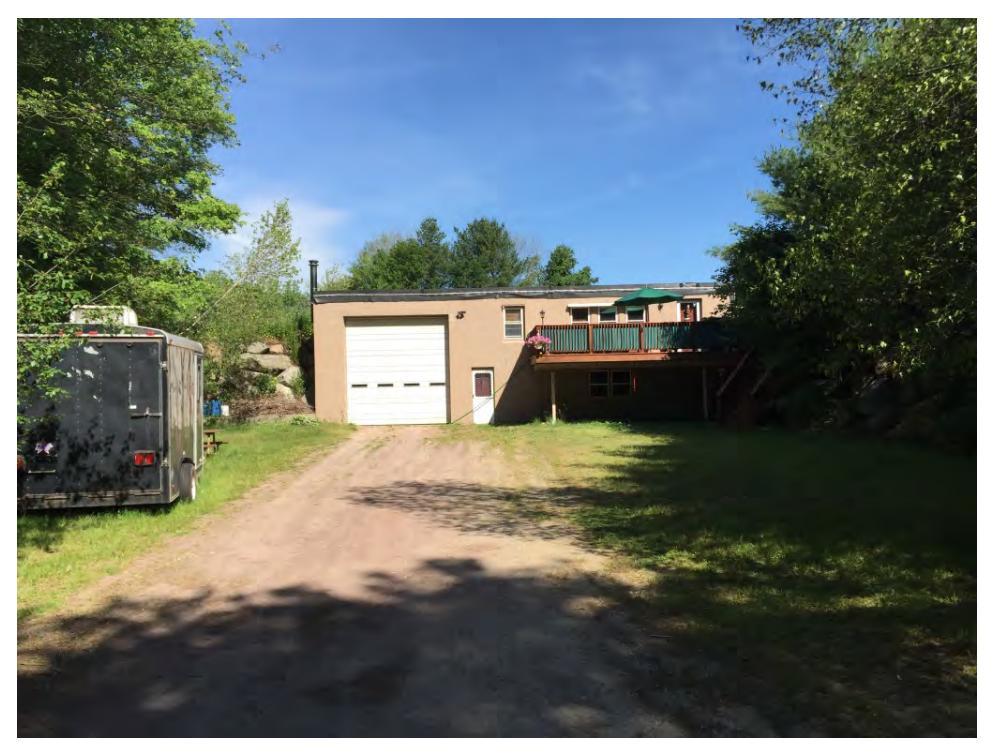
**SCENE:** View of 254 Old Great Road residence. The two-story house is buried on three sides by fill material, including large boulders apparently from a blast excavation area (blast drill holes noted), as well as silt, sand, gravel, and cobble size material. Photograph taken facing northwest.

START observed two main areas on the property, a residential area and a commercial area. The residential area contains a partially buried modern subterranean house, surrounded by fill material on three sides. The front (southeast) side of the two-story house is open to the air, overlooking a lawn and driveway area. Along the driveway and observable corners of the house, START observed that the fill material included large boulders apparently from a blast excavation area, as well as silt, sand, gravel, and cobble size materials. The fill material surrounding the house forms a grass-covered, elevated platform area, approximately 1-2 feet below the flat roof-line of the house. The elevated area conforms to the local topography of the remainder of the northern portion of the property (Attachment B, Photodocumentation Log) [1; 2]. Mr. David Laliberte, current occupant of the house and son of the property owner, stated that he did not know the origin of the fill material surrounding the house [1].

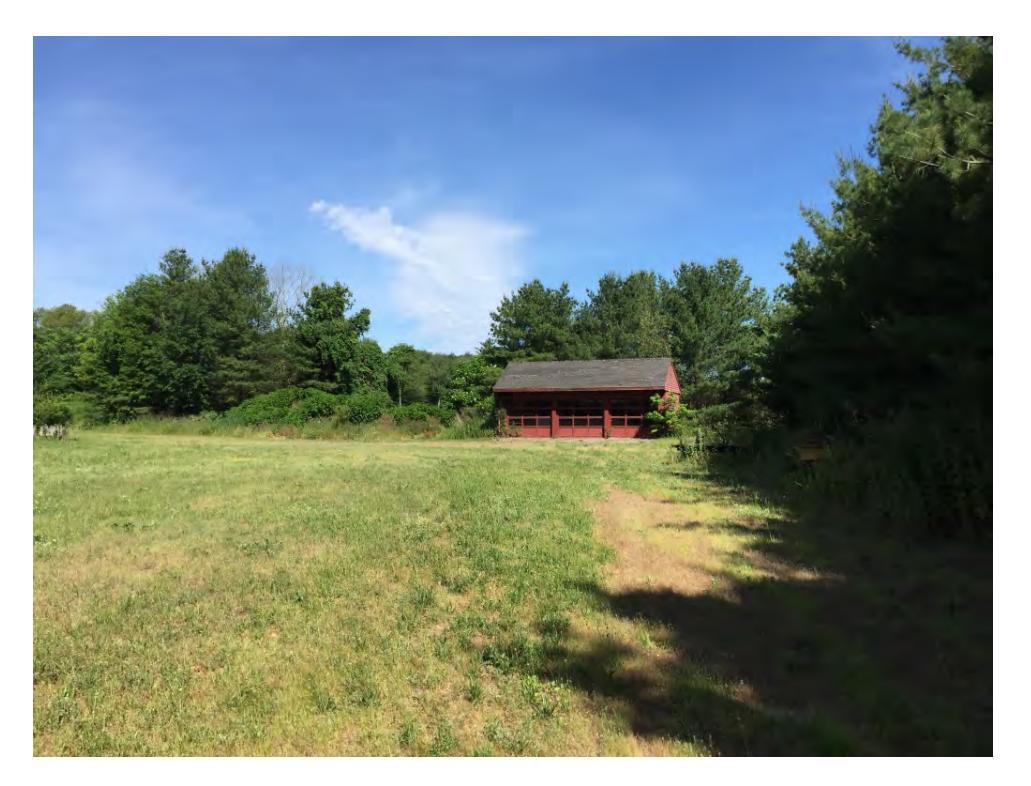
SCENE: View of the red garage/storage shed north of the residence on the elevated portion of the property. Photograph<br/>taken facing northwest.TIME: 0930 hoursDATE: 23 June 2016TIME: 0930 hoursPHOTOGRAPHER: S. EvartsCAMERA: iPhone 6

On the elevated area, north of the house, START observed a Red Garage/Storage Shed located along the northeastern portion of the property. The building appeared to be used for storage of vehicle and lawn equipment. Four empty and partially corroded 30-gallon steel drums were observed in the wooded area, northwest of the Red Garage/Storage Shed. One of the drums is marked on the top along the outer ring circle as "E.I. DU PONT DE NEMOURS & CO. INC. WILMINGTON DEL."; with four lines of center text labeling reads "DUPONT"; "REG. U.S. PAT. OFF."; MADE IN U.S.A.; and lowest line read "D-151". The other three 30-gallon drums

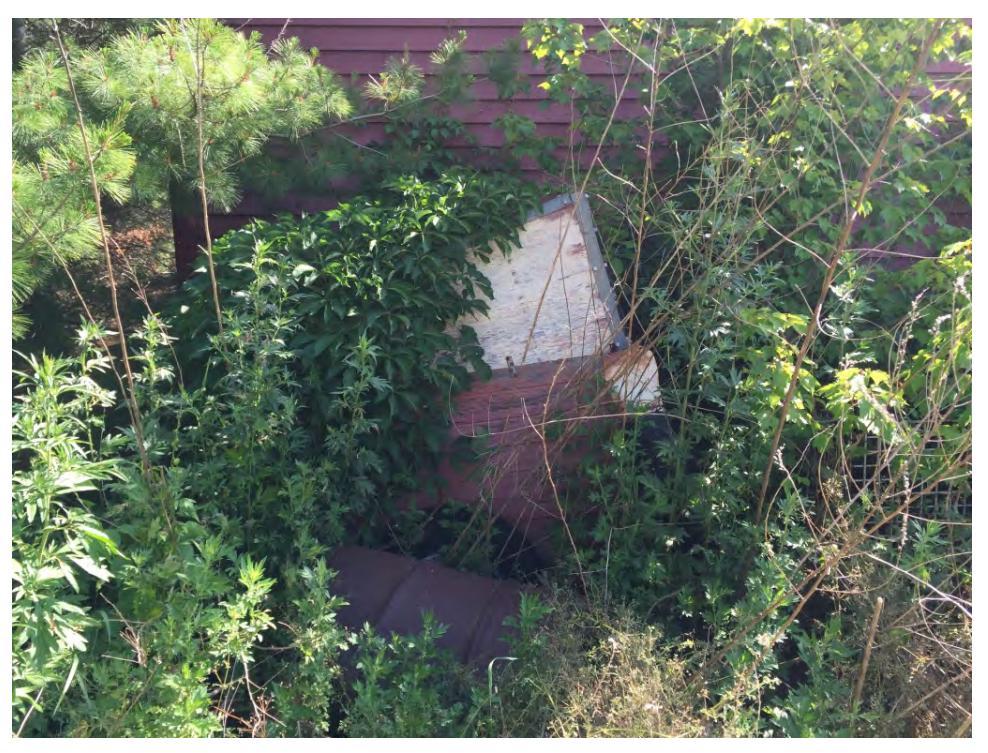
SCENE: View of empty, partially corroded 55-gallon steel drum located along the southwest side of the red garage/storage shed. Photograph taken facing northeast.
 DATE: 23 June 2016
 TIME: 0933 hours

did not have any labeling. An empty and partially corroded 55-gallon steel drum was observed at the southwest side of the Red Garage/Storage Shed within the vegetation/brush [1; 2].

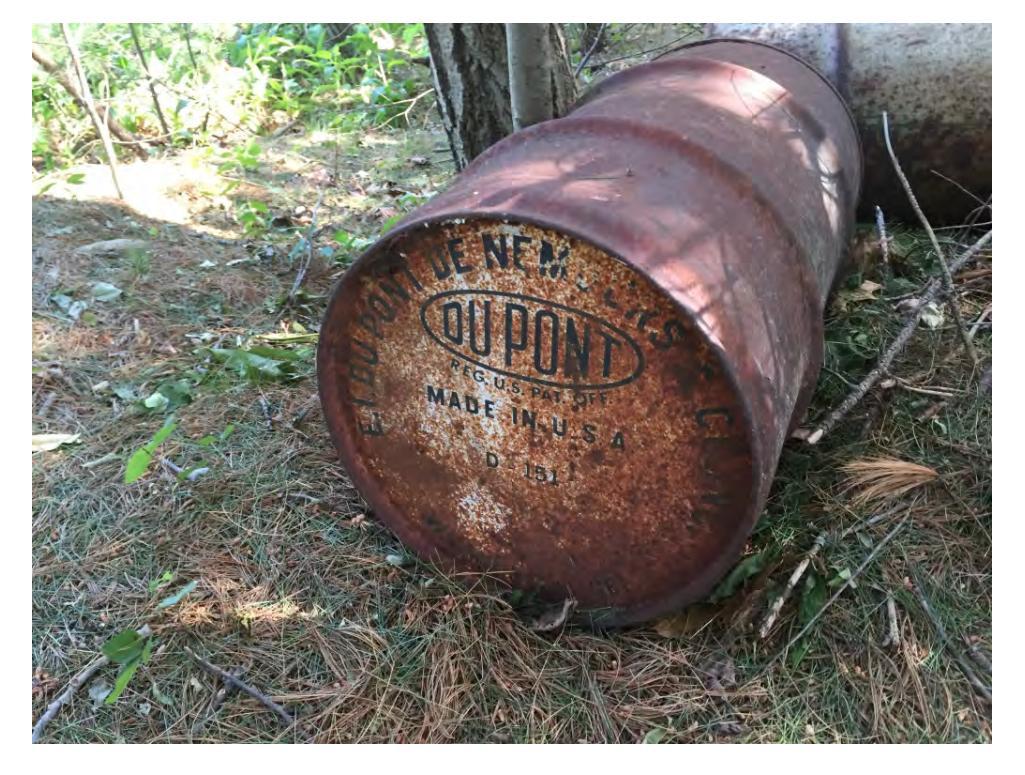
SCENE: View of "DuPont" label on the empty, partially corroded 30-gallon steel drum located at the northwest side of the<br/>red garage/storage shed. Photograph taken facing north.DATE: 23 June 2016TIME: 0936 hoursPHOTOGRAPHER: S. EvartsCAMERA: iPhone 6

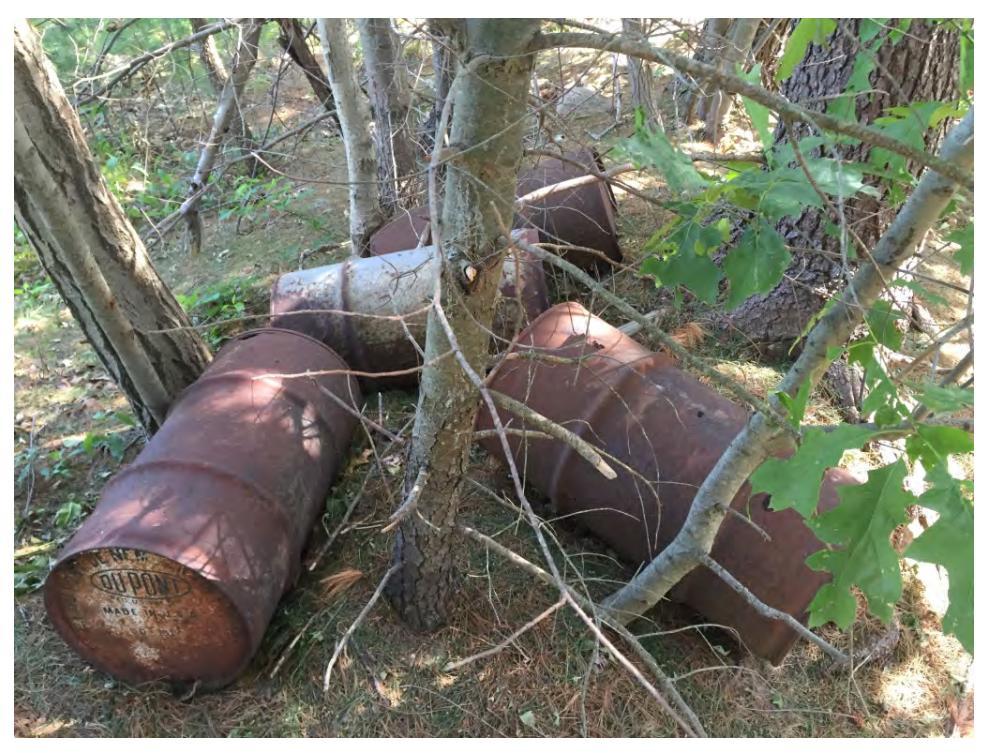
SCENE: View of four empty, partially corroded 30-gallon steel drums located at the northwest side of the red<br/>garage/storage shed. Photograph taken facing north.DATE: 23 June 2016TIME: 0936 hoursPHOTOGRAPHER: S. EvartsCAMERA: iPhone 6

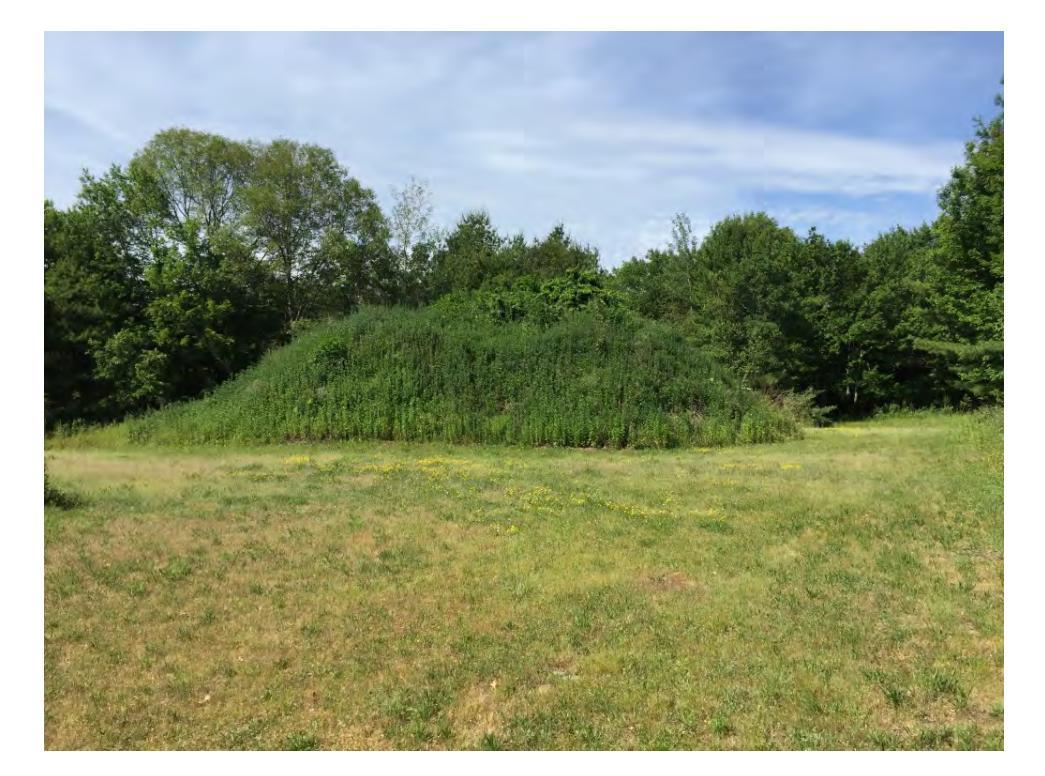
SCENE: View of large soil pile west of the residence. Photograph taken facing southwest.

A large Soil/Loam Pile, approximately 80 feet in diameter by 15 to 20 feet high, was observed located behind (west of) the residence. Mr. David Laliberte stated that he did not know the origin of the large screened loam pile. The private drinking water well which supplies the on-site residence is located along the south side of the Soil/Loam Pile [1; 2].

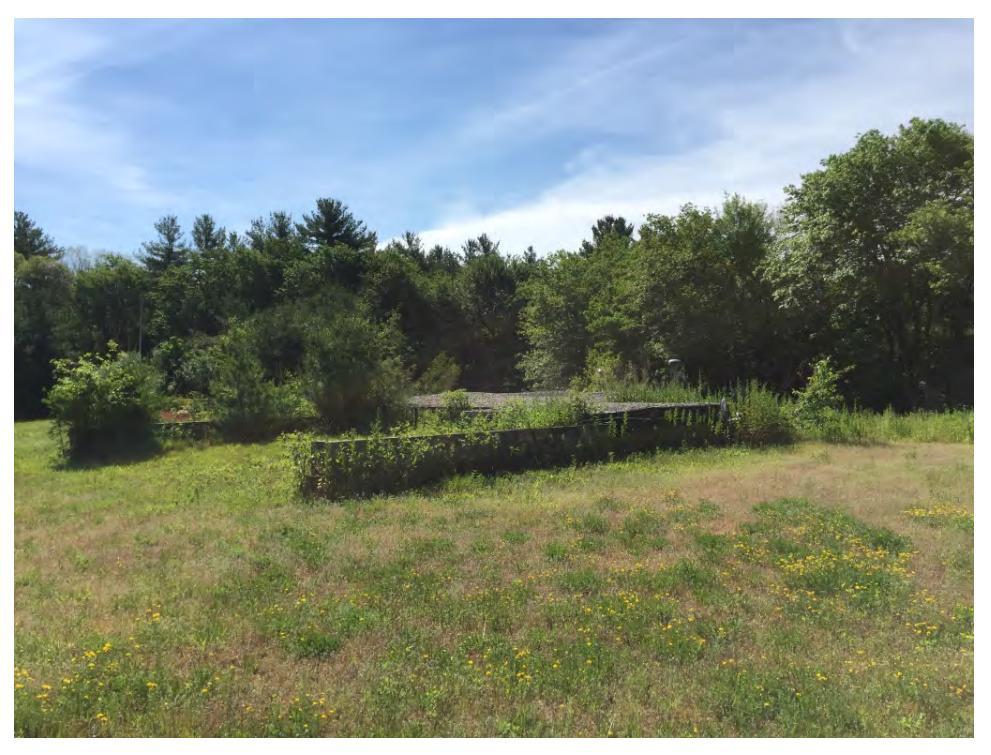
**SCENE:** View of the flat, gravel/tar rooftop of the residence. Photograph taken facing south.

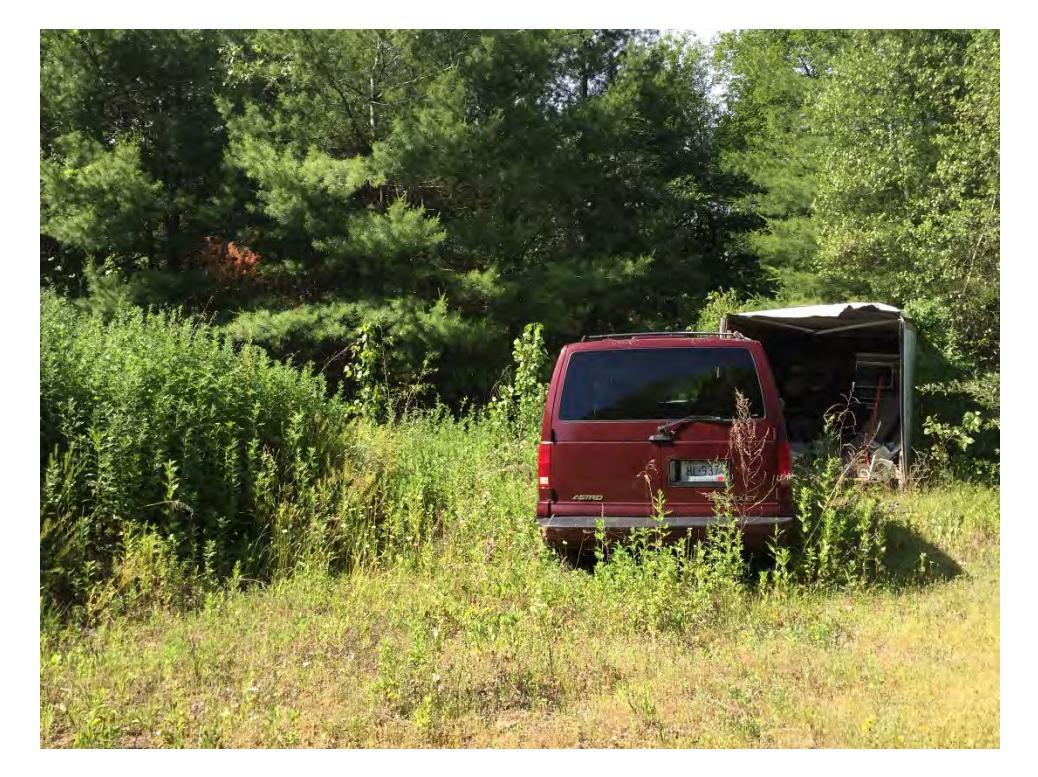
SCENE: View of junked passenger van and open trailer body containing duct work and other equipment. Photograph takenfacing southwest.DATE: 23 June 2016TIME: 0942 hours

To the southwest of the Soil/Loam Pile, START observed a junked passenger van, an open trailer body, and a partially closed tractor trailer body (Labeled T-165). The open trailer body contained duct work, electrical panels, and what appeared to be a stove. A small 5-gallon pail of a tar-like material was located in a wooden bin outside of the trailer. The partially closed tractor trailer body contained office supplies (chairs, desk, cubicle walls, metal shelves, etc.) and a water pressure tank [1; 2].

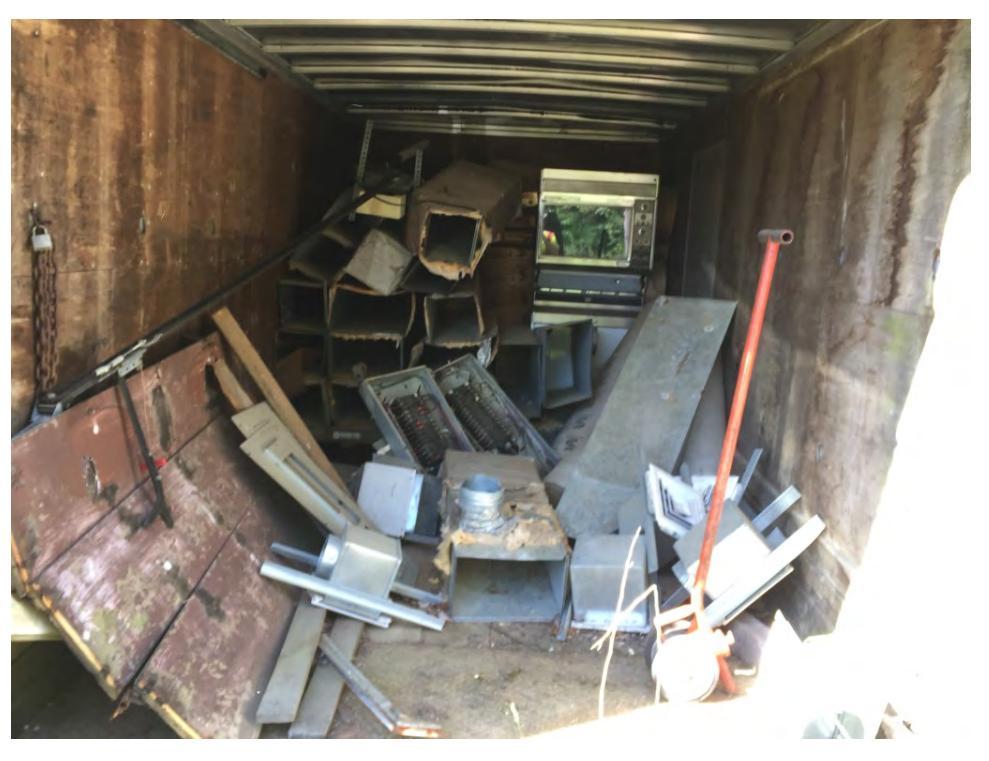
SCENE: View of the open trailer containing duct work, electrical panels, and a stove. Photograph taken facing southwest.

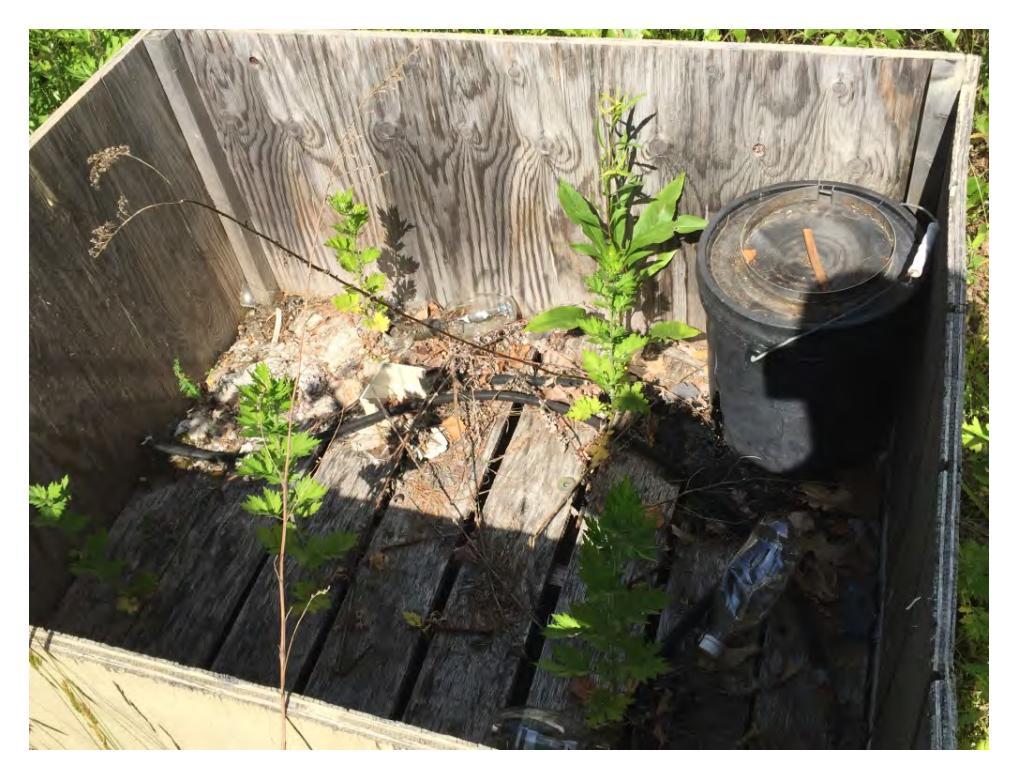
SCENE: View of the 5-gallon container containing tar-like material inside a wooden bin. Photograph taken facing south.

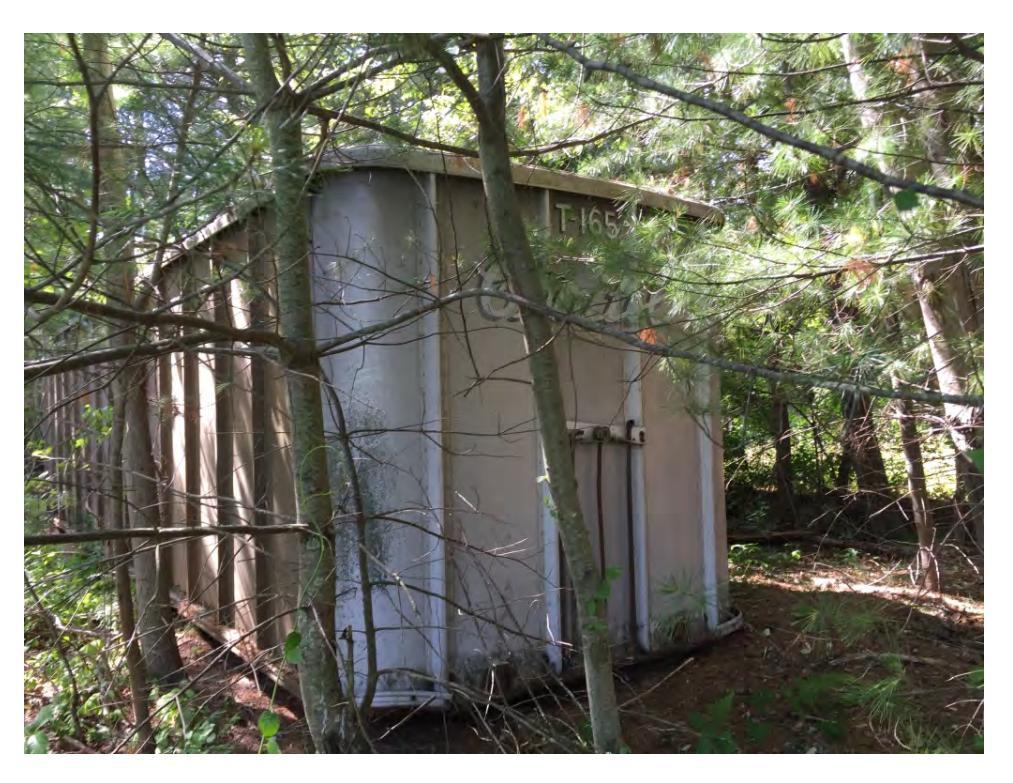
**SCENE:** View of the tractor trailer body containing office supplies. Photograph taken facing south.

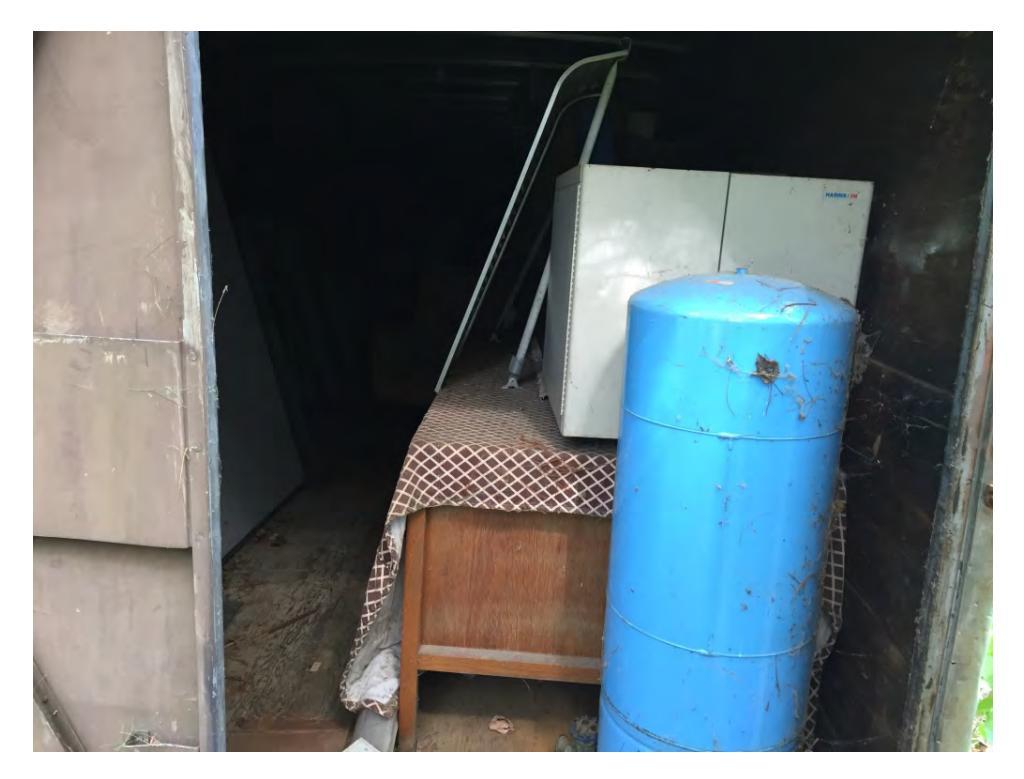
SCENE: View of the partially closed tractor trailer body containing office supplies and a water pressure tank. Photograph<br/>taken facing northwest.DATE: 23 June 2016TIME: 1006 hoursPHOTOGRAPHER: J. KellyCAMERA: iPhone 6

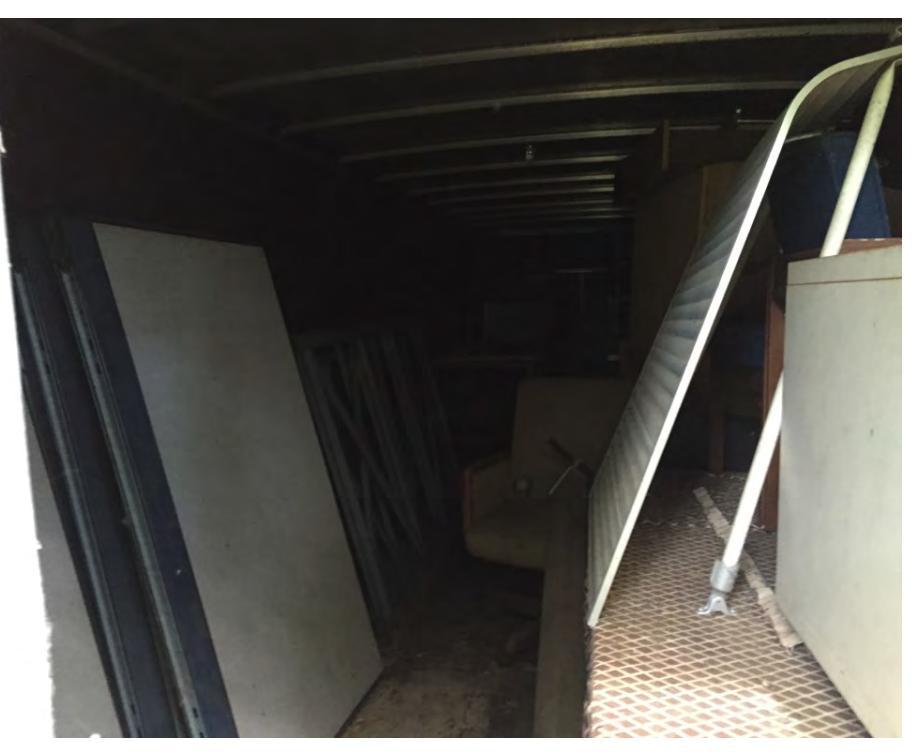
SCENE: View of the partially closed tractor trailer body containing office supplies and a water pressure tank. Photograph taken facing northwest.

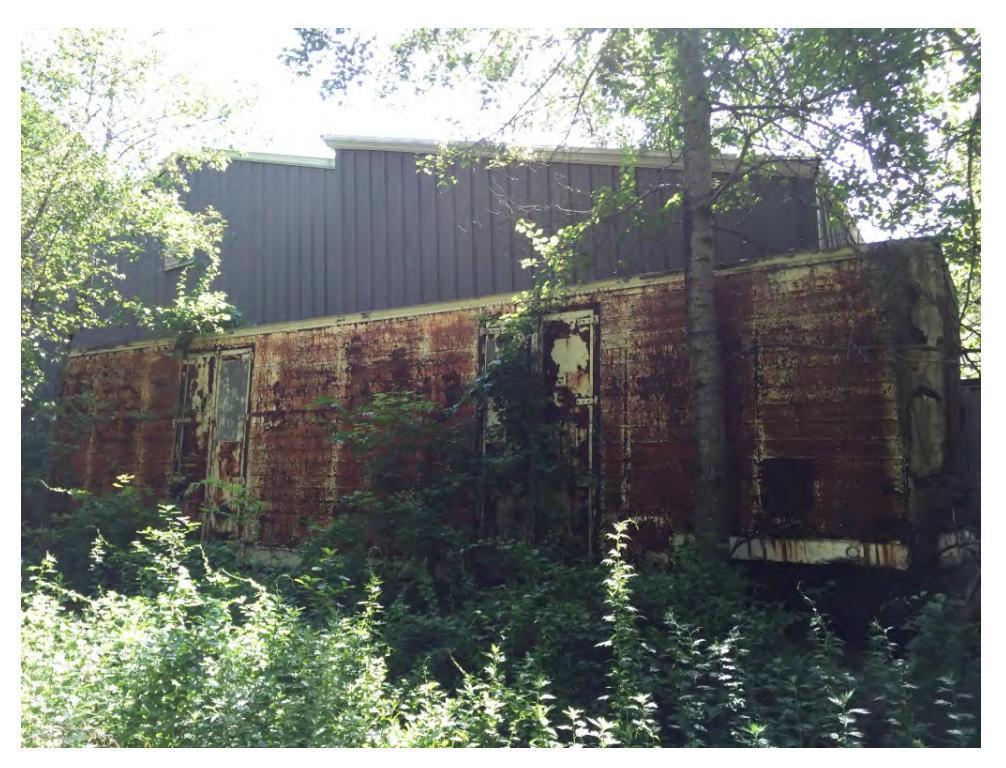
SCENE: View of the tractor trailer body located along the northwestern side of the large steel garage/warehouse building located in the southwestern portion of the property. Photograph taken facing east. TIME: 0949 hours DATE: 23 June 2016

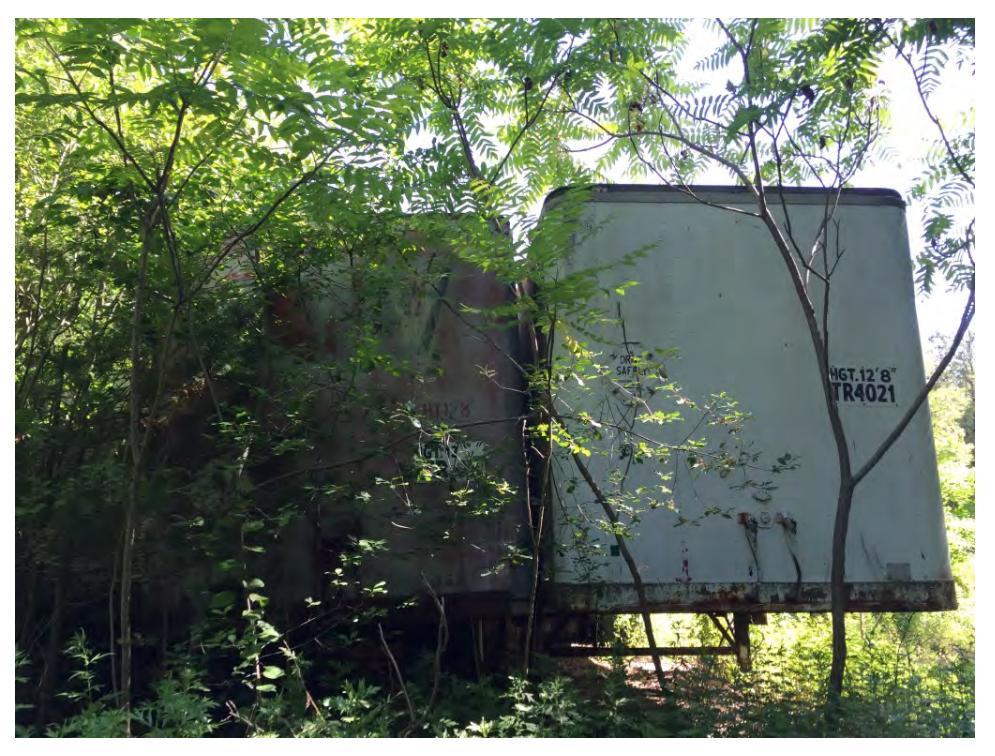
SCENE: View of the tractor trailer bodies located along the southwestern side of the large steel garage/warehouse building. Photograph taken facing northeast.

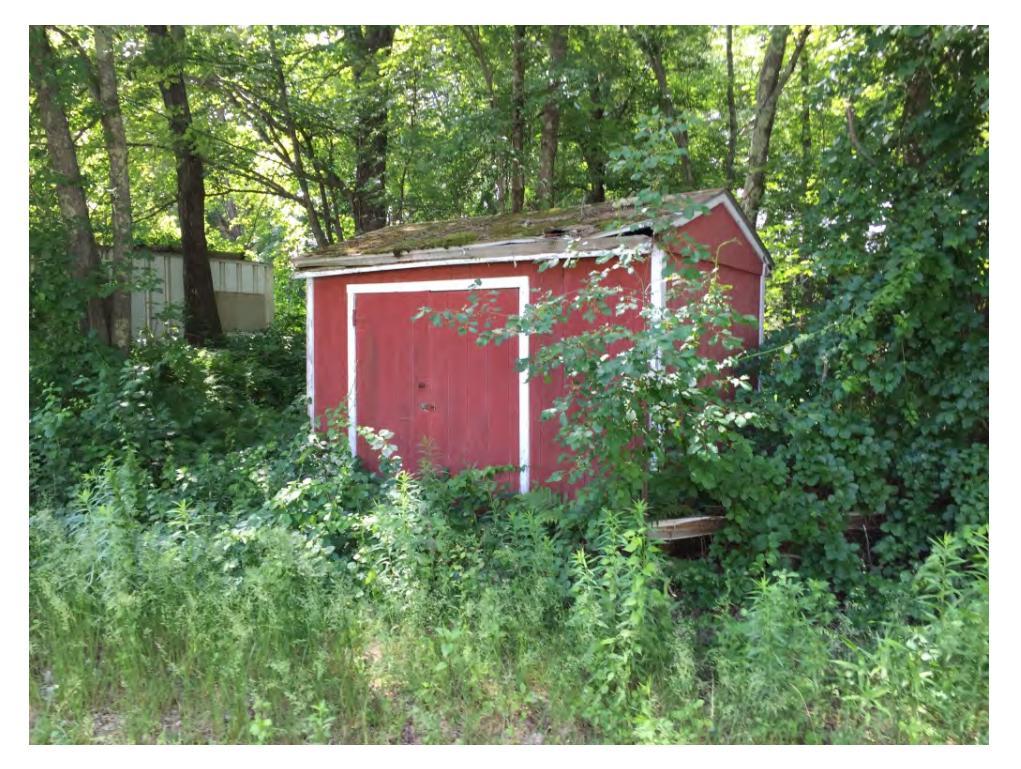
SCENE: View of the small red wooden shed, containing construction supplies, located at the southern end of the property. Photograph taken facing south. DATE: 23 June 2016 TIME: 1011 hours

Along the west side of the Dirt Parking Lot, START observed the Small Red Wooden Shed approximately 12 feet by 9 feet and containing construction supplies, including several pieces of plywood, mesh fencing for concrete reinforcement, and approximately nine 5-gallon bucket containers of unknown contents. START also observed three 55-gallon polyethylene (poly) drums and two 5-gallon bucket containers behind (west of) the Small Red Wooden Shed. These 55-gallon poly drums appeared to be empty, and the 5-gallon containers were labeled "sheetrock compound".

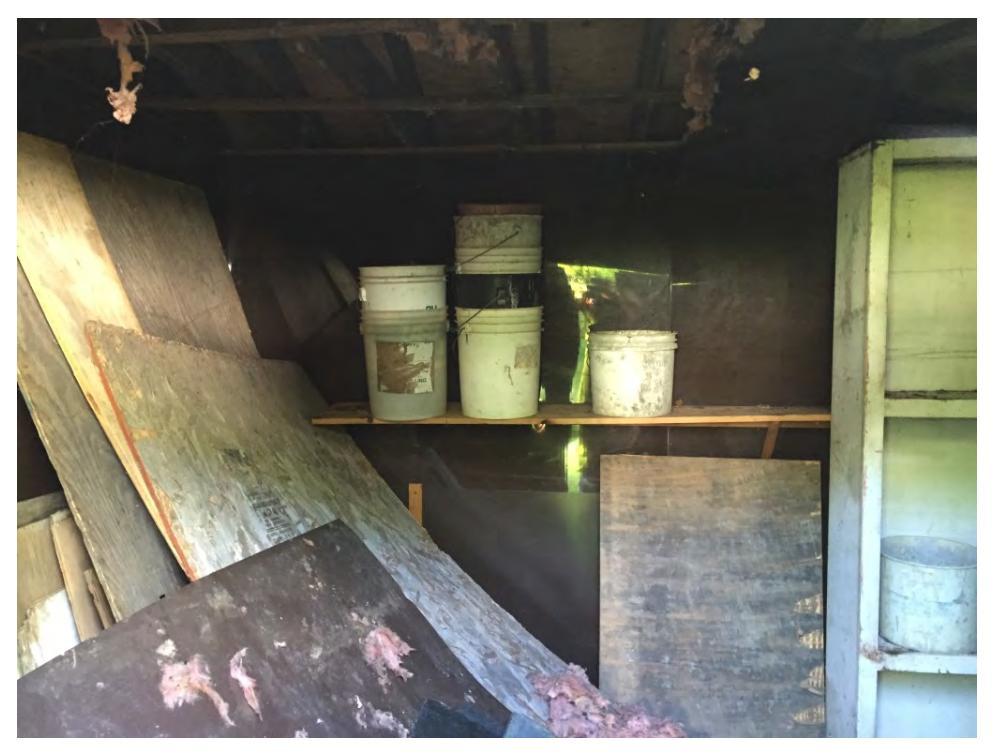
SCENE: View of the contents of the small red wooden shed (construction supplies). Photograph taken facing southwest.DATE: 23 June 2016TIME: 1012 hoursPHOTOGRAPHER: J. KellyCAMERA: iPhone 6

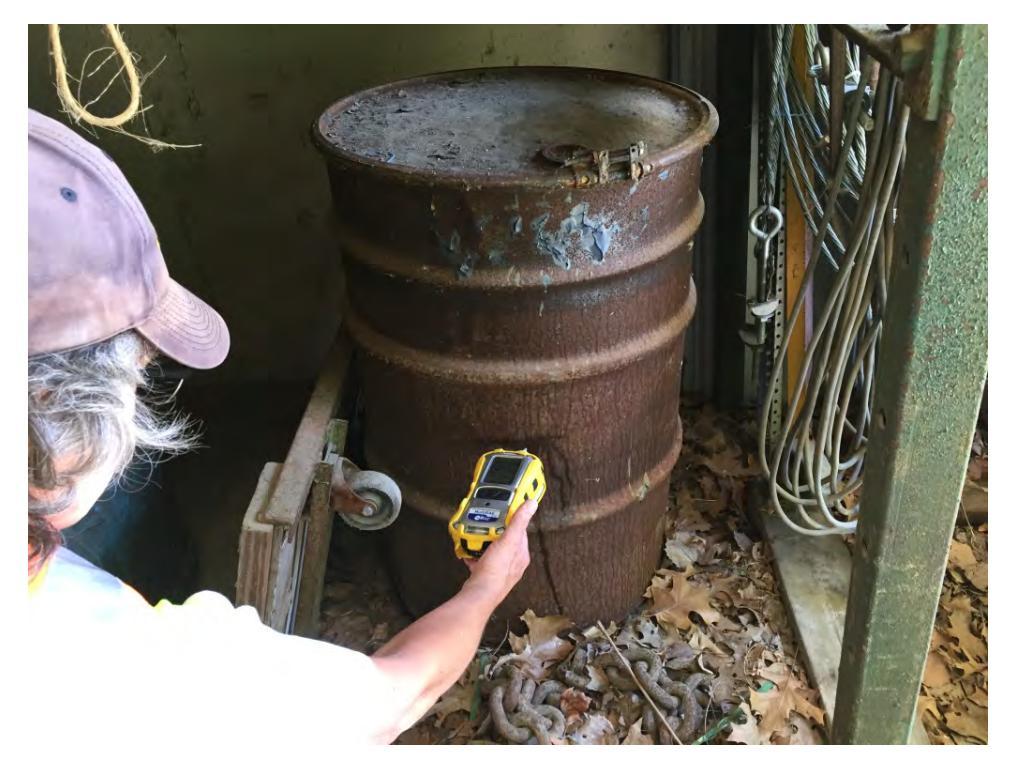
SCENE: View of the rusty, partially corroded 55-gallon steel drum inside the large steel garage/warehouse building.Photograph taken facing northeast.DATE: 23 June 2016PHOTOGRAPHER: J. KellyCAMERA: iPhone 6

A rusty, partially corroded 55-gallon steel drum was observed in southwest corner of the large Steel Garage/Warehouse building. This closed drum appeared to contain an unknown solid

material at the bottom and an unknown liquid material at the top of the drum. No elevated PID readings were noted in the ambient air in the building or adjacent to the closed 55-gallon steel drum. Dark stains (possibly oil) were observed on the concrete floor inside the western portion of the building, including adjacent to the rusty, partially corroded 55-gallon steel drum. Dark staining was also observed on the Dirt Parking Lot area immediately outside the large Steel Garage/Warehouse building doors [1; 2].

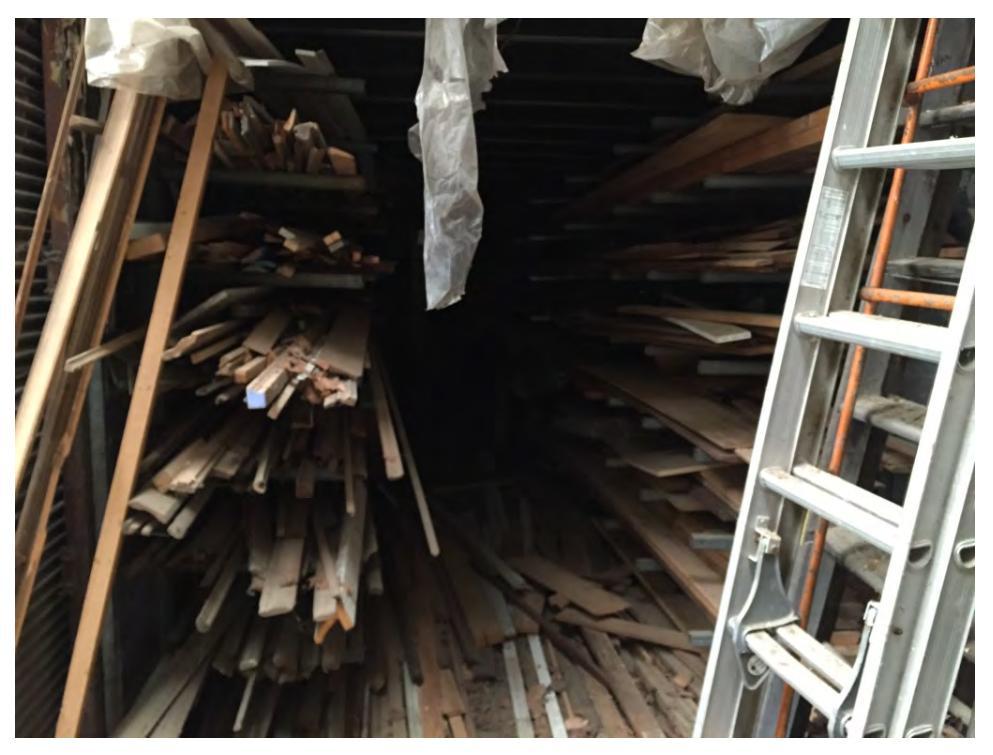
SCENE: View of wood pieces and planks located inside a tractor trailer body nested and opening up to the large steel garage/warehouse building. Photograph taken facing southwest. **DATE: 23 June 2016** TIME: 1015 hours

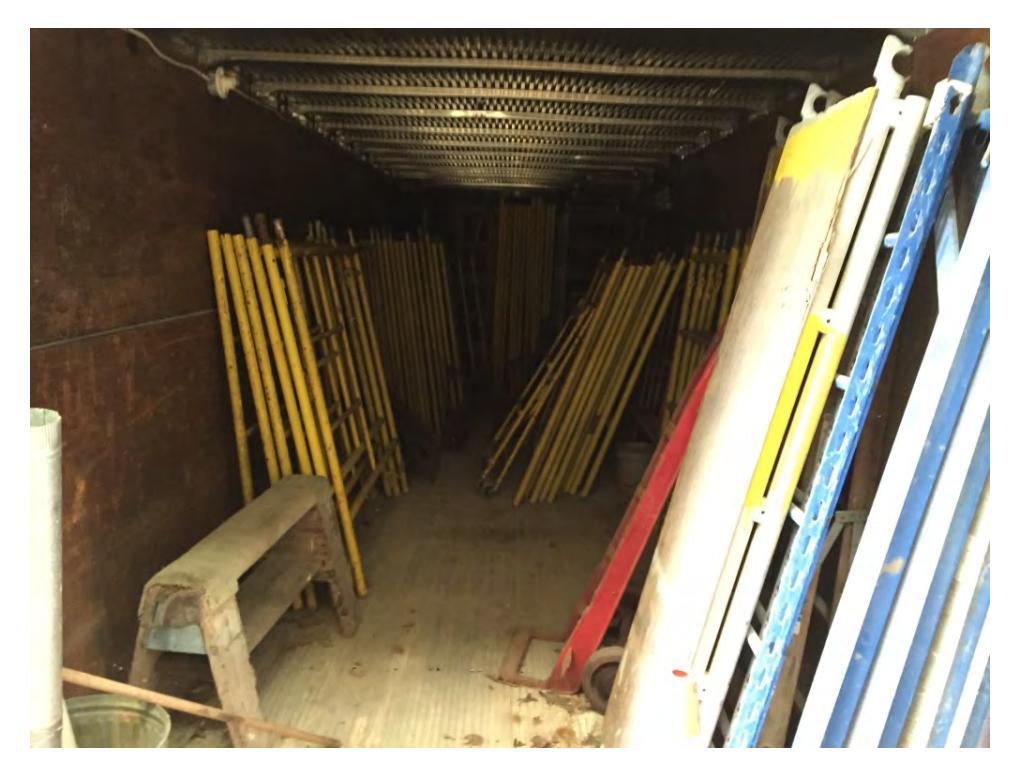
SCENE: View of scaffolding materials located inside a trailer a tractor trailer body nested and opening up to the large steel garage/warehouse building. Photograph taken facing southwest. TIME: 1015 hours DATE: 23 June 2016 **PHOTOGRAPHER: S. Evarts** CAMERA: iPhone 6

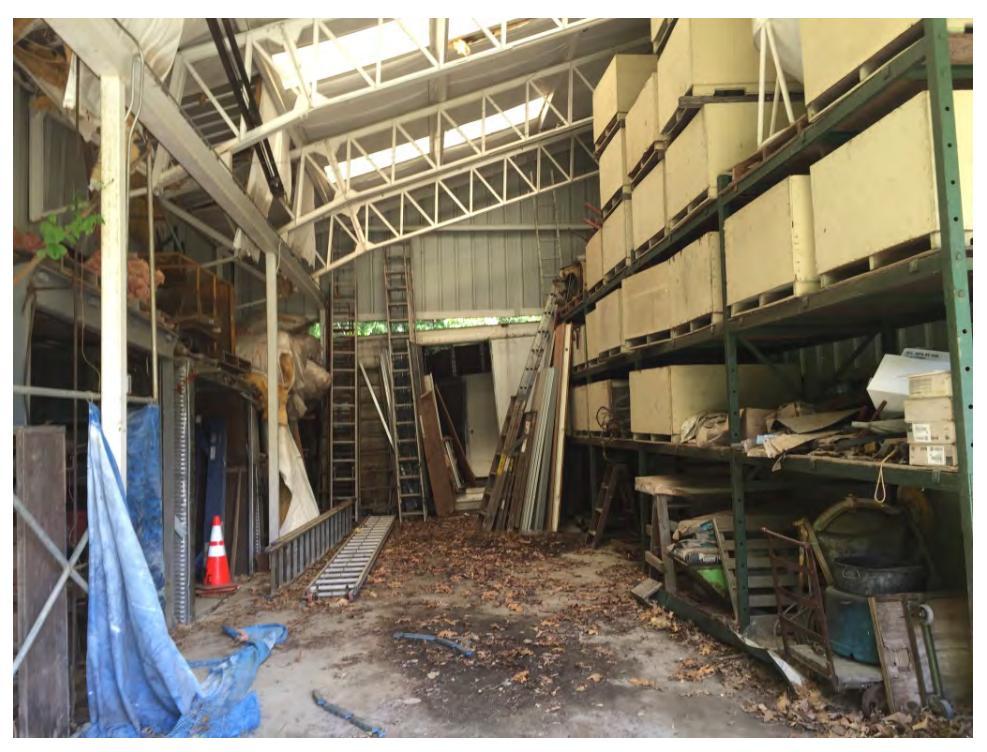
SCENE: View of the inside of the southwestern portion of the large steel garage/warehouse building. Bins of construction materials are located to the right and stained concrete is visible in the foreground. Photograph taken facing northwest. DATE: 23 June 2016 TIME: 1016 hours

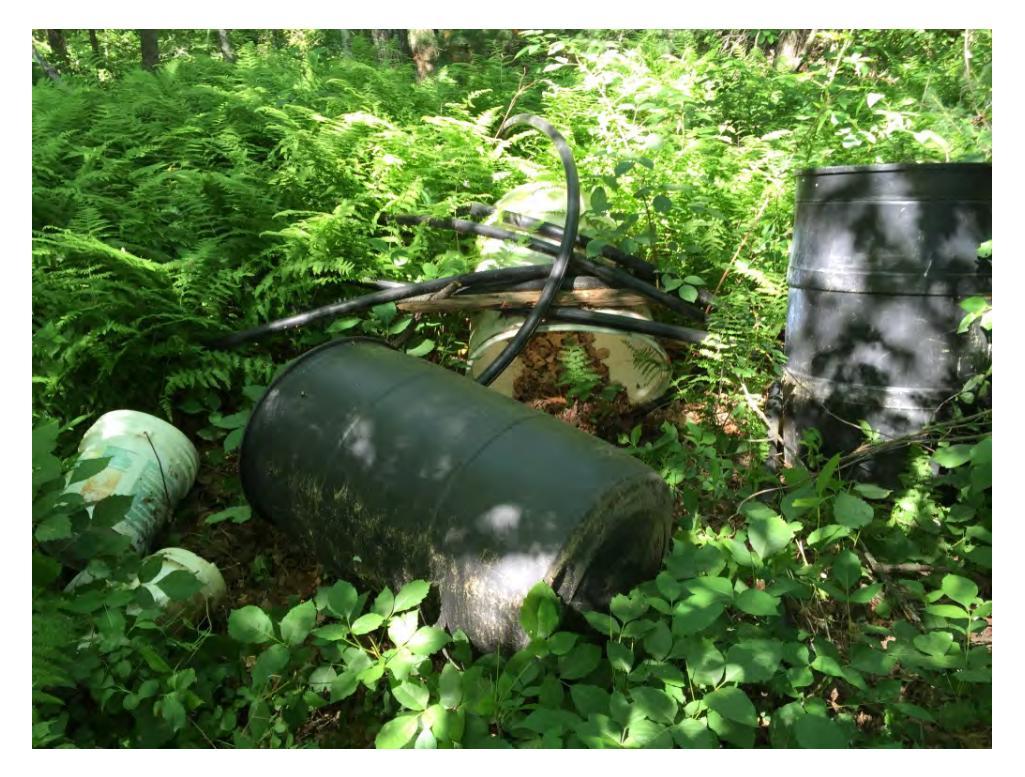
SCENE: View of three empty 55-gallon polyethylene drums and two empty 5-gallon containers located behind (south of)the small red wooden shed. Photograph taken facing south.DATE: 23 June 2016TIME: 1018 hours

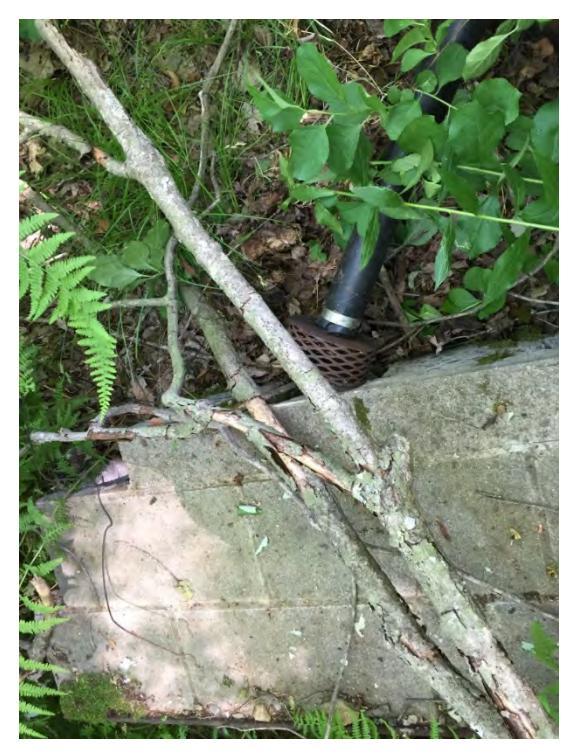
**SCENE:** View of the black high density poly tubing with a syphon screen observed at the stone wall located along the southwestern property boundary. Photograph taken facing south.

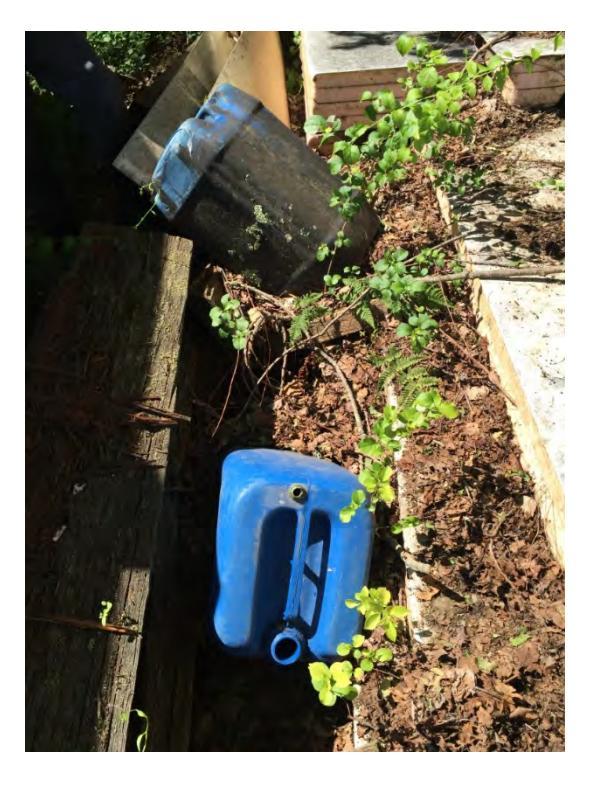
SCENE: View of the two 5-gallon poly containers between the two old white storage trailers. Photograph taken facing<br/>south.DATE: 23 June 2016TIME: 1025 hours<br/>CAMERA: iPhone 6

START observed two secured/locked "Old White Storage Trailers" located in this area. The contents of these trailers could not be observed. However, START did observe two 20-gallon white poly containers, two blue poly 5-gallon containers, and two estimated 40-pound propane cylinders located next to the these trailers. Black staining was observed on the outside of one of the two blue 5-gallon containers [1; 2].
